SUBARU PHASE II P0741 TORQUE CONVERTER SLIP

COMPLAINT: Before or after overhaul, 1998 and up Subaru vehicles equipped with the Phase II Four Speed transmission may exhibit a Diagnostic Trouble Code P0741 Torque Converter Slip.

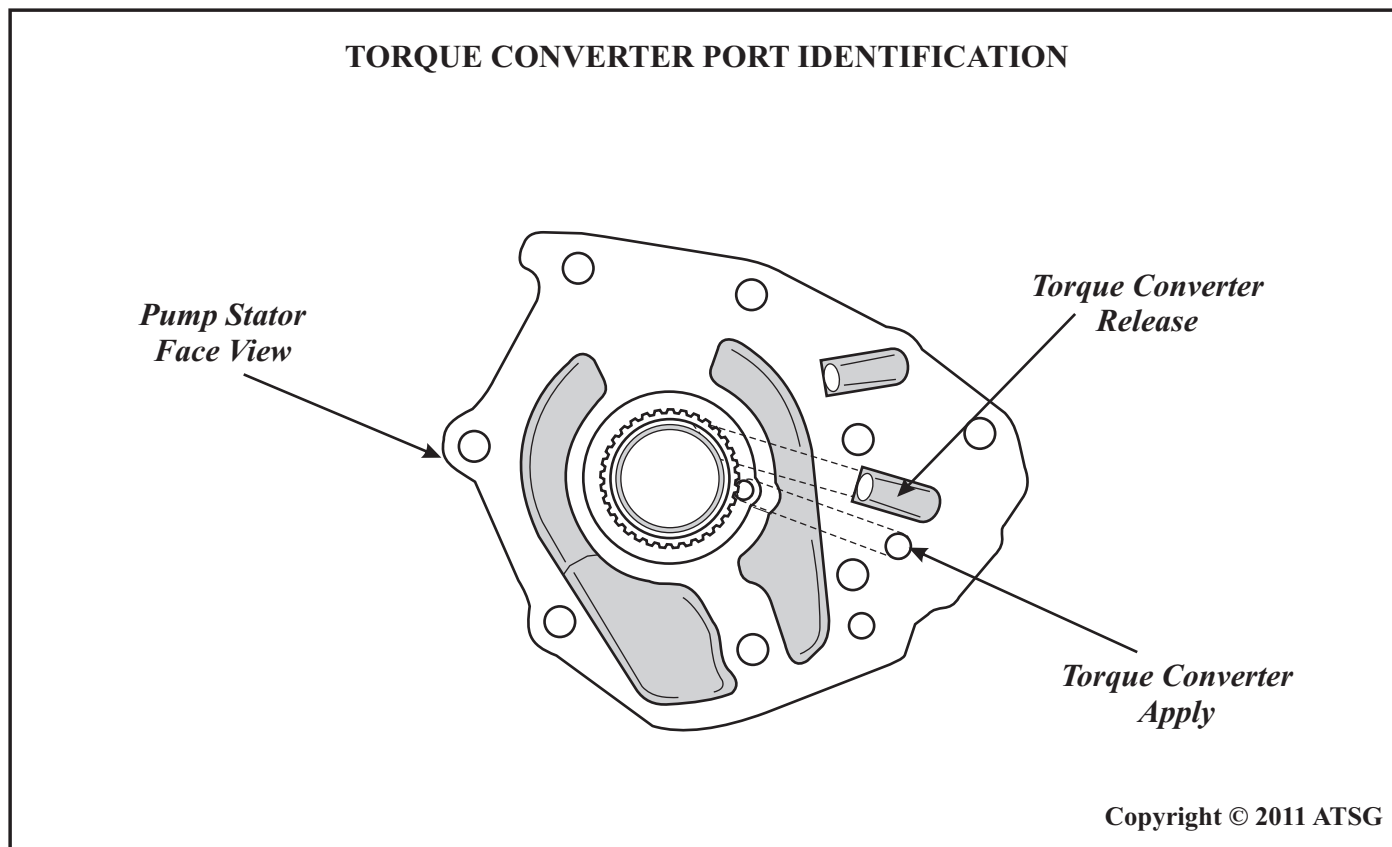
CORRECTION: Refer to Figure 1 to identify the Torque Converter release port and the Torque Converter apply port in the face side of the Stator assembly. See Figure 2 for an illustration of the Torque Converter Apply Circuit and how the TCC Apply pressure can be lost with the worn stator bushings. Refer to Figure 3 and assemble the Turbine shaft into the Stator shaft. Locate the Torque Converter release port on the face view of the stator and close it off with your finger. Apply 80-100 psi of air pressure to the center of the turbine shaft, and ensure no leakage past the bushing that is illustrated in Figure 3. **Note: This is the only sealing surface separating Torque Converter Off and Torque Converter Apply.**

At the time of this printing there are no bushings available from aftermarket suppliers. It may be necessary to replace the stator to repair this condition.

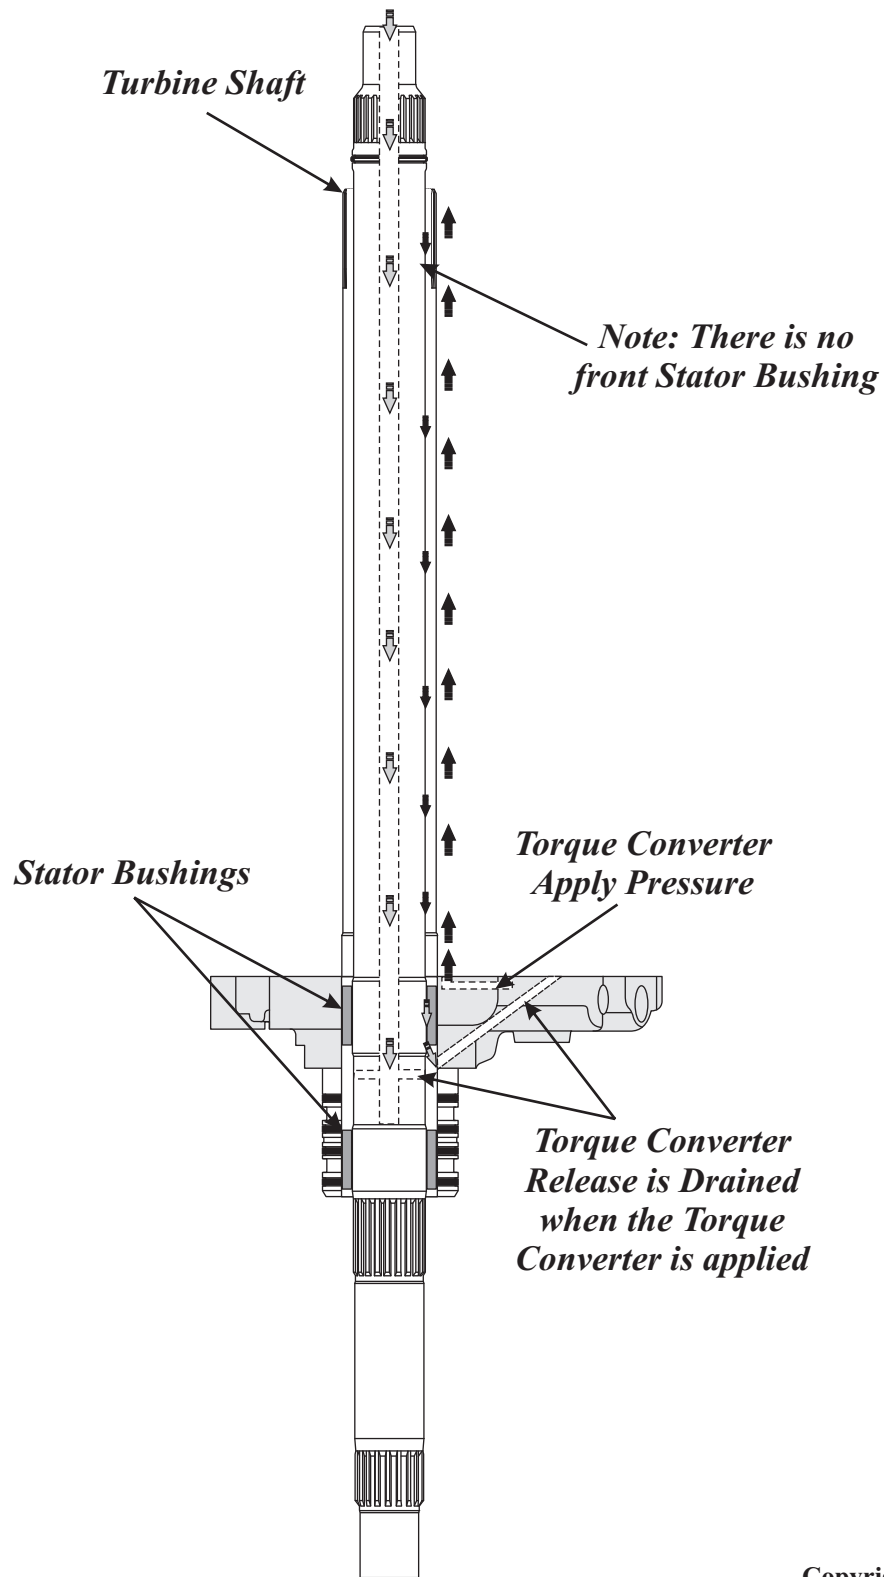
Figure 2

CAUSE: The cause may be, worn stator bushings allowing a pressure loss in the Torque Converter apply circuit.

Note: Torque Converter Apply Pressure will be lost to the already exhausting Torque Converter release circuit, when the stator bushings are worn.

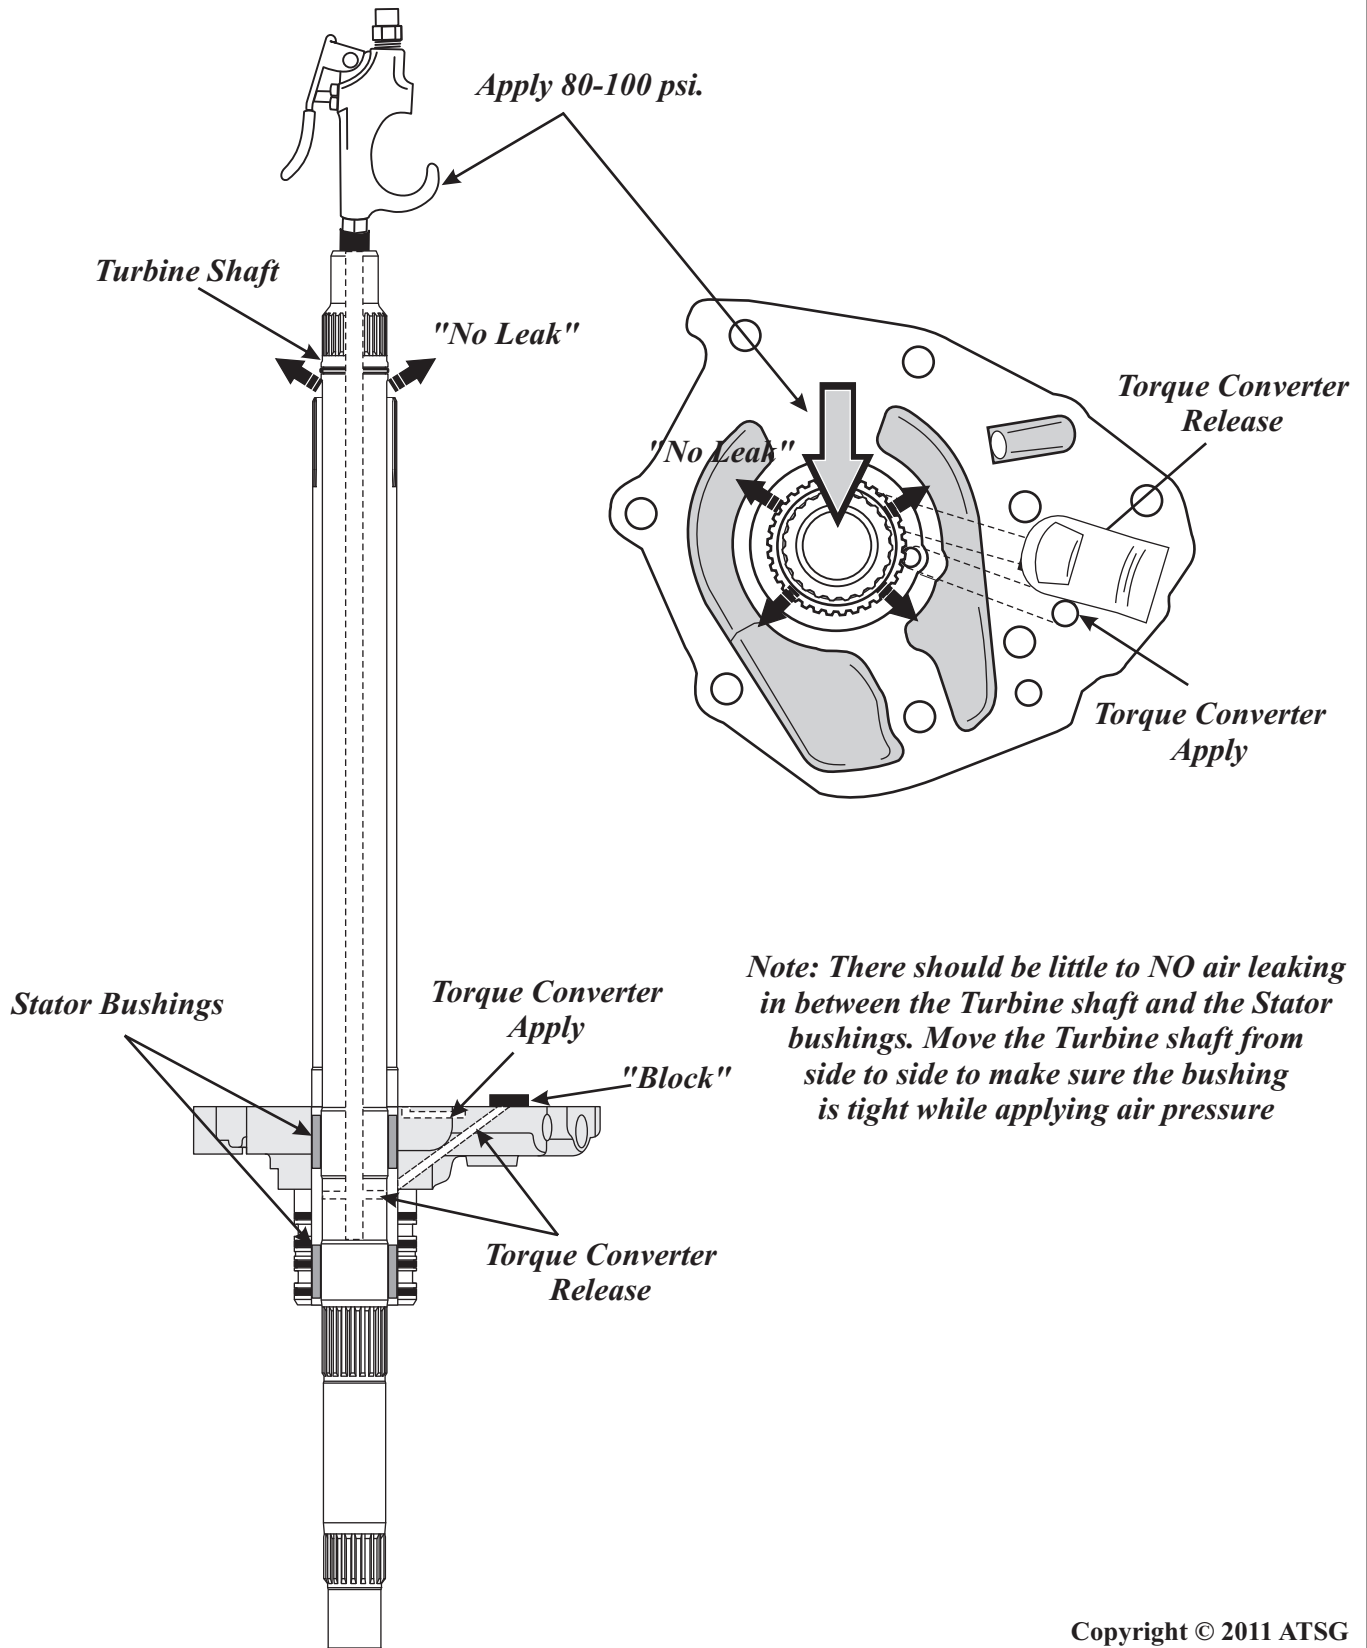
Figure 3

STATOR BUSHING AIR CHECK
