Technical Service Information

FORD A4LD HARSH 2-3 BACKOUT SHIFT

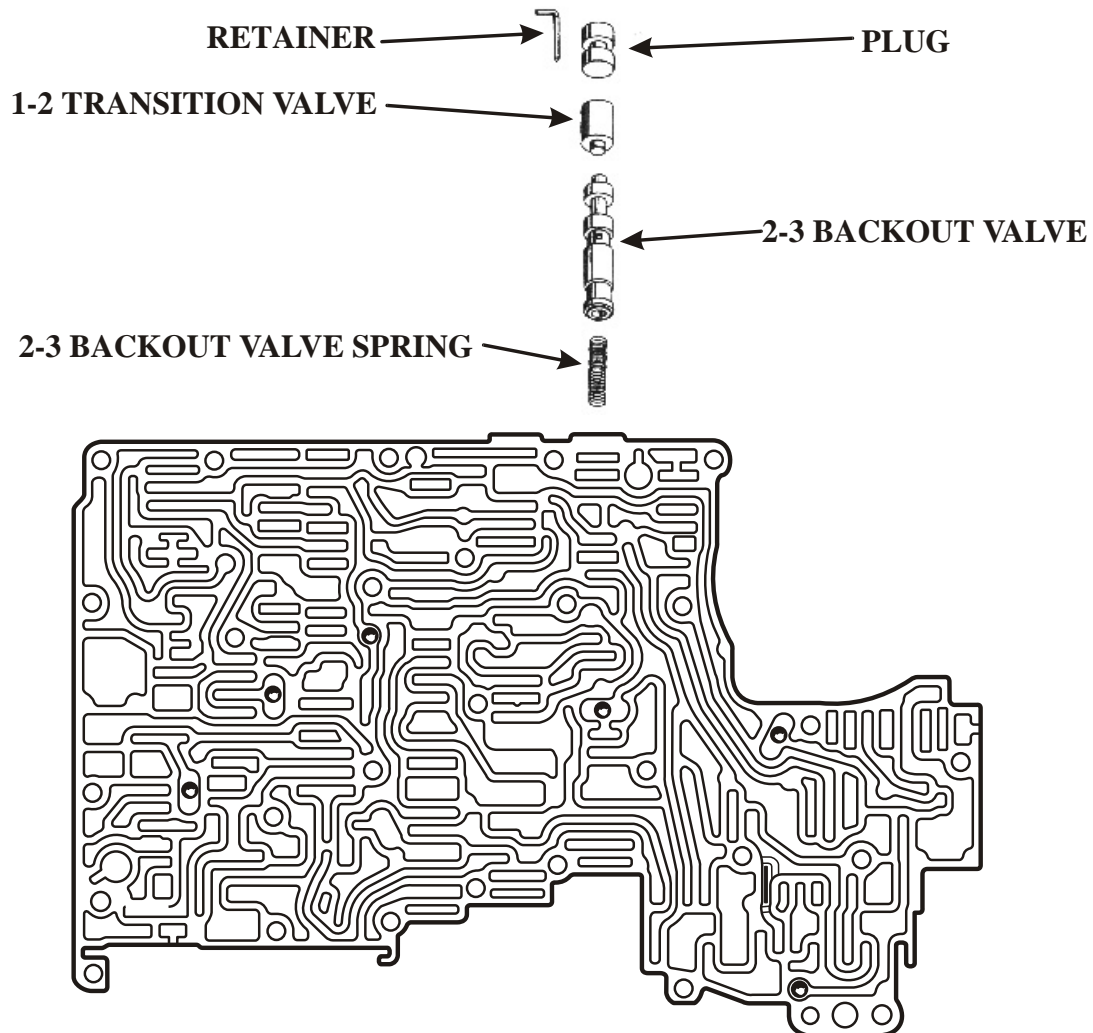
- COMPLAINT:** Some of the involved vehicles with the A4LD transmission may exhibit a harsh 2-3 backout upshift under certain conditions. This may be better described as being harsh when releasing the accelerator pedal during the 2-3 upshift. This condition is most evident when the vehicle is operating at higher altitudes.
- CAUSE:** This is caused by the incorrect calibration of the 2-3 backout valve spring in the valve body.
- CORRECTION:** A new 2-3 backout valve spring is available from Ford that has a revised calibration. It is light blue in color. The part # is F3TZ-7D230-B. See Figure 1 for the proper bore identification and spring location.
