# Technical Service Information

## CHRYSLER A500/518

### BIND UP ON 3-4 SHIFT

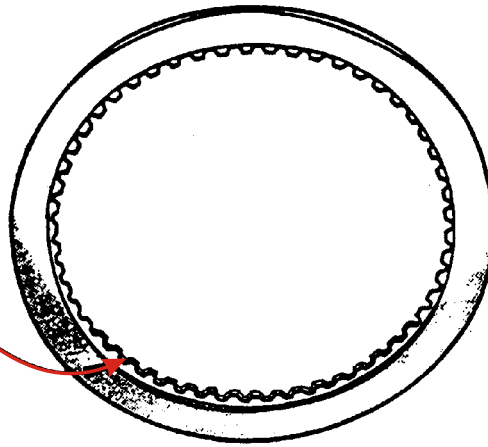
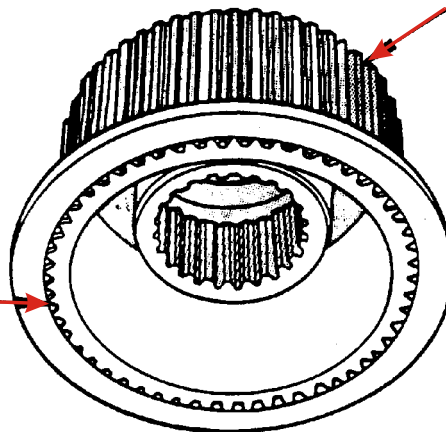
Figure 1

**COMPLAINT:** Bind-up on a 3-4 shift, after overhaul.

**CAUSE:** The cause may be, the overdrive direct clutch reaction plate installed upside down on the sliding clutch hub.

OVERDRIVE DIRECT CLUTCH REACTION PLATE COUNTERBORE  
FACES DOWN OVER THE SLIDING HUB.  
WHEN INSTALLED CORRECTLY, THE REACTION PLATE WILL  
BE FLUSH WITH THE BOTTOM OF SLIDING HUB.

**CORRECTION:** Install the overdrive direct clutch reaction plate with the counterbore side facing down, so that the counterbore fits over the lugs of the direct clutch sliding hub, as shown in Figure 1. The reaction plate, when installed correctly, should be flush with the end of the sliding hub, as shown in Figure 1.
