Technical Service Information

THM 4L60 (700-R4) NO 4TH GEAR

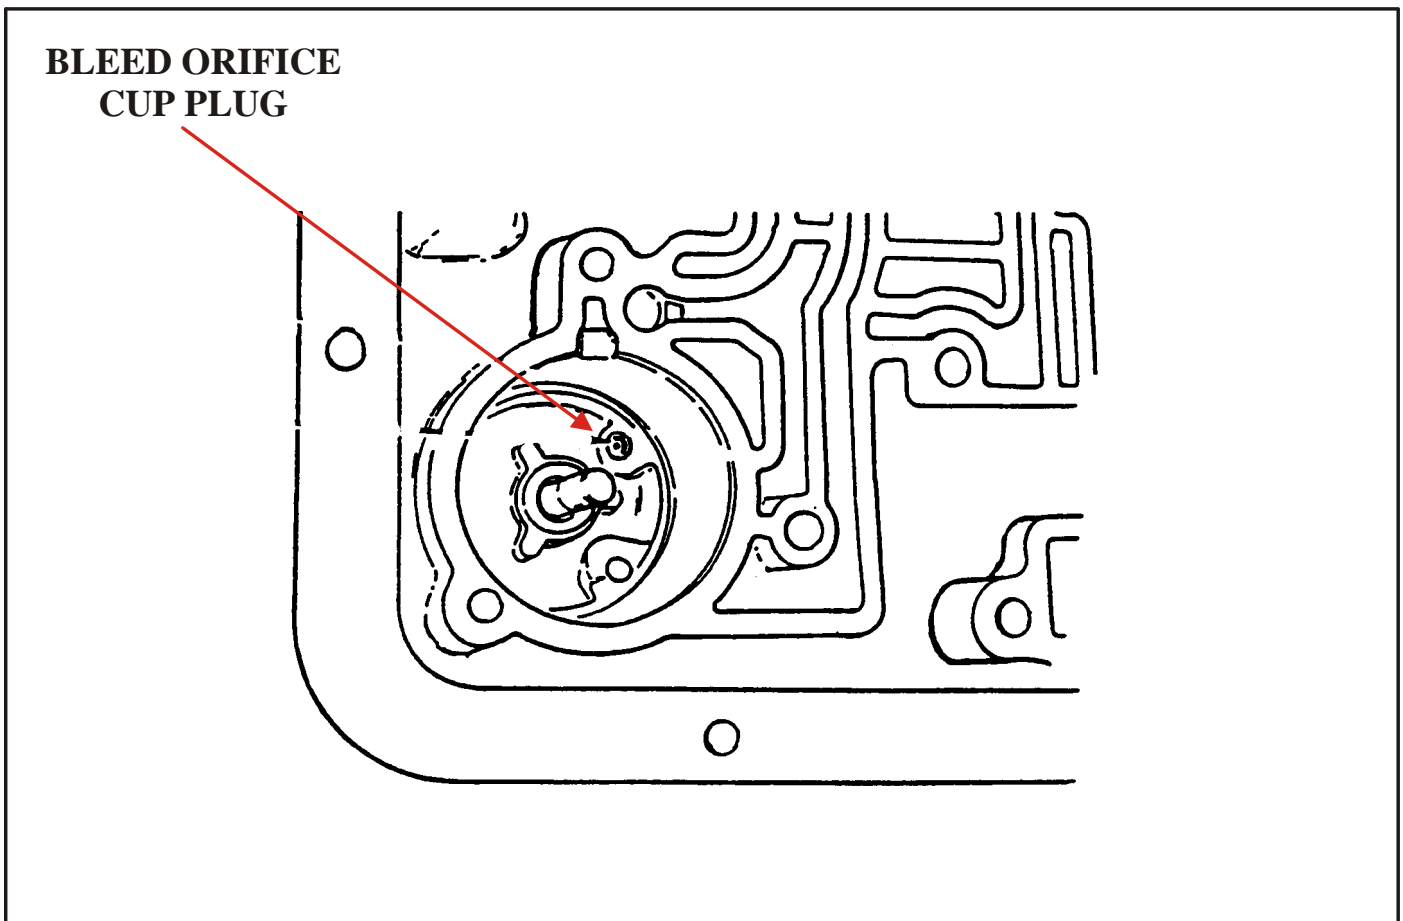
Figure 1

COMPLAINT: No 4th gear; 2nd and 4th pressure lower than line pressure.

CAUSE: The cause could be the bleed orifice cup plug missing from the case in the bottom of the 3-4 accumulator bore (see Figure 1).

CORRECTION: Install bleed orifice cup plug, OEM Part Number 8628864.
