Technical Service Information

GM 5L40E / BMW A5S360R

LOW & ERRATIC LINE PRESSURE

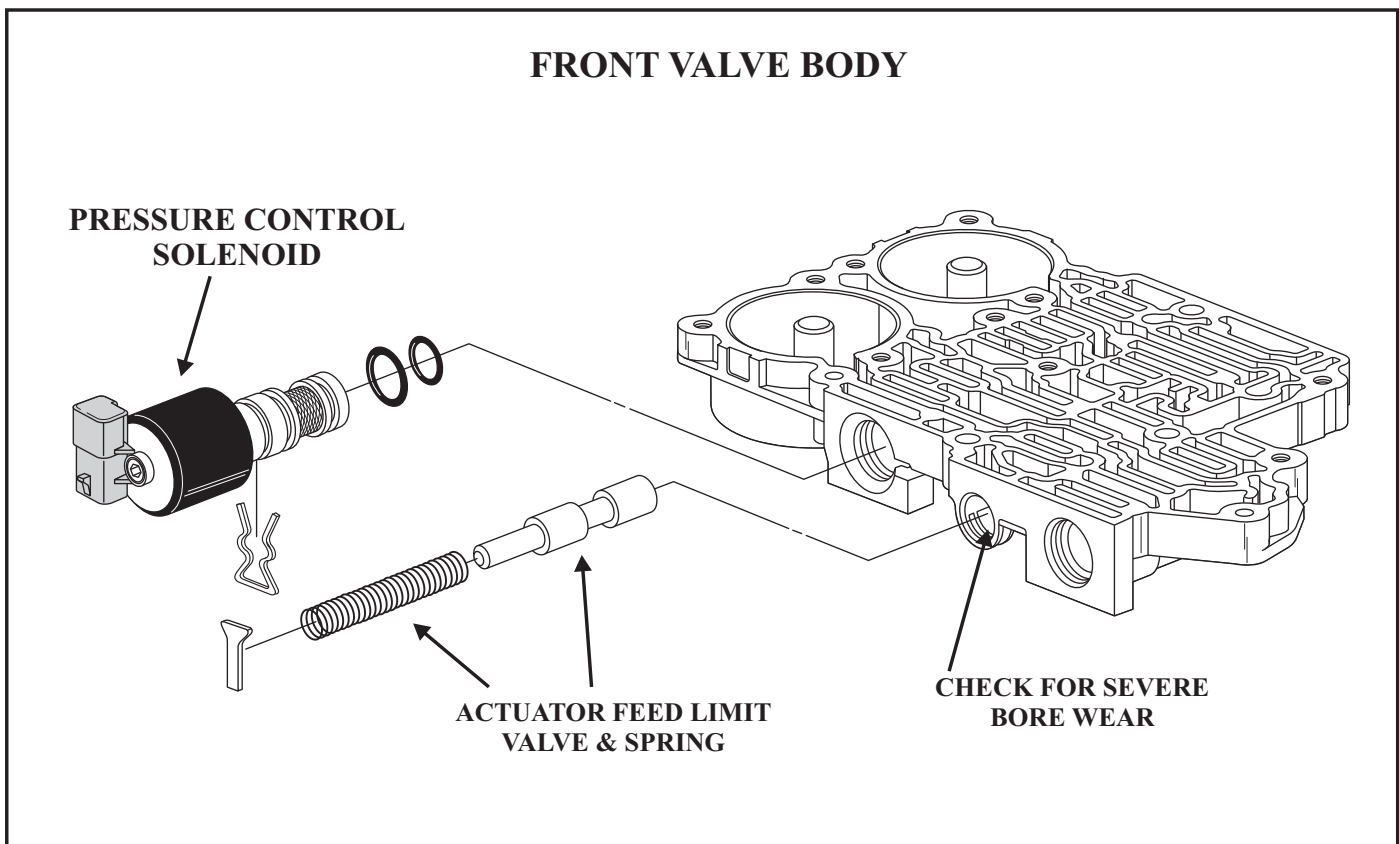
COMPLAINT: The transmission slips through the gears, line pressure is low and unstable. Inspection of the internal transmission parts indicates that clutch damage is present.

CAUSE: The Actuator Feed Limit Valve (AFL) bore is severely worn and the anodized valve is damaged, (Refer to Figure 1 Below).

The AFL valve regulates line pressure to the pressure control solenoid and the shift solenoids. The AFL valve keeps line pressure from flooding the solenoid circuits. At some point during normal operations line pressure and AFL pressure will be the same. When the valve wears the solenoids are starved for oil resulting in the above mentioned conditions.

CORRECTION: Since no repair kits are available at this time for this transmission a valve body will be required.
