Technical Service Information

BMW ZF-5HP-18 NO MOVE OR DELAYED ENGAGEMENT

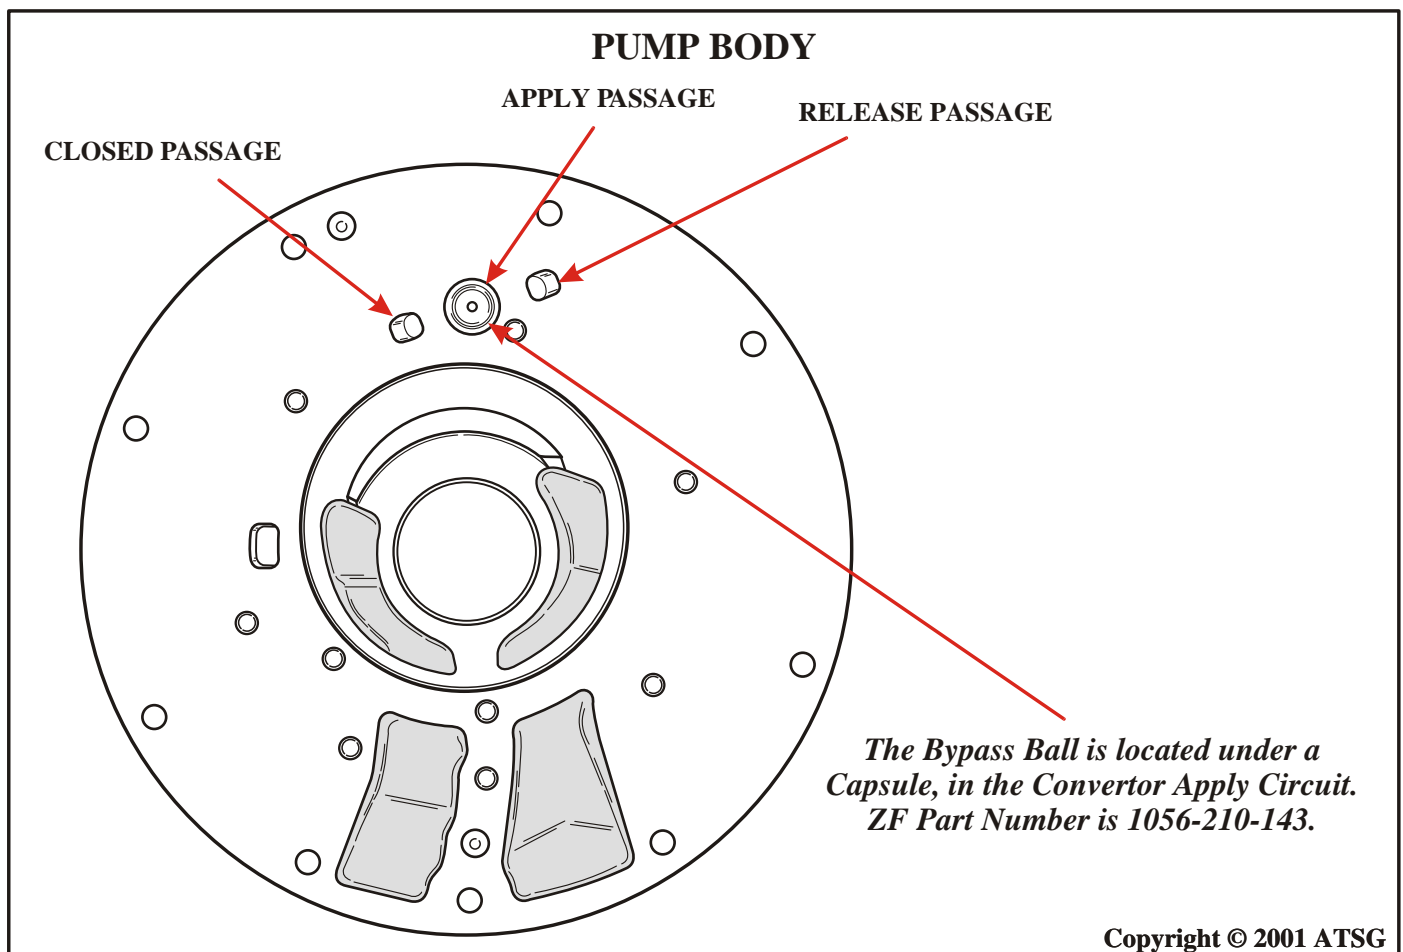
Figure 1

CAUSE: The cause may be, that the "Bypass Ball," located in the pump as shown in Figure 1, may have shrunken down and traveled back through the pump passage leading to the Torque Converter Valve, sticking the valve in the "stroked" position (See Figure 2). When this valve is stuck in this position it may cause the Torque Converter to drain-back after sitting for a prolonged period of time. When the vehicle is started after sitting, it may take 10 to 15 minutes for the Torque Converter to fill back up, and this all depends on the positioning of the stuck Torque Converter Valve.

CORRECTION: Locate the Torque Converter Valve, as shown in Figure 3 , and free the valve up, removing the shrunken Bypass Ball from binding the valves movement. Replace the assembly in pump body with a new one from ZF, available under ZF part number 1056-210-143, if the capsule can be removed from the pump body (See Figure 1).

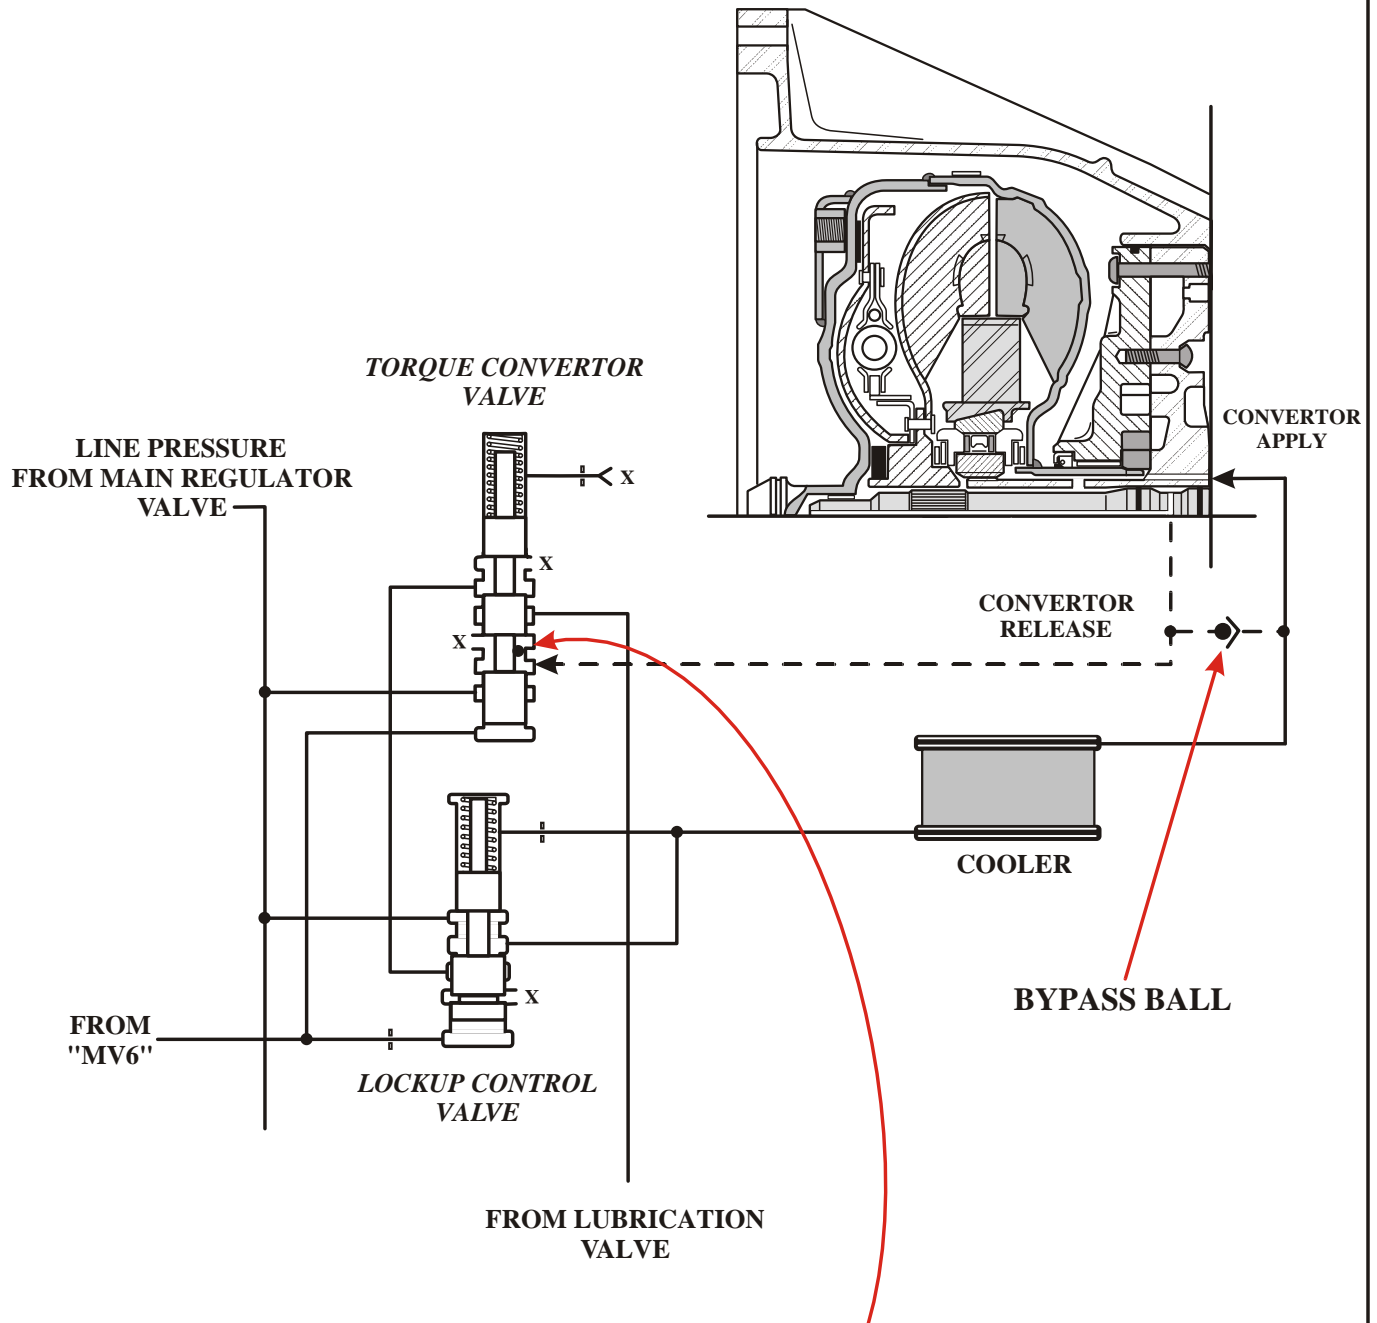
ZF-5HP-18 LOCKUP HYDRAULIC CIRCUIT

The "Bypass Ball" shrinks and travels back through to the Torque Converter Valve and lodges itself in this passage, sticking the valve in this approximate position.
