Technical Service Information

THM 440-T4 SLIPS IN REVERSE

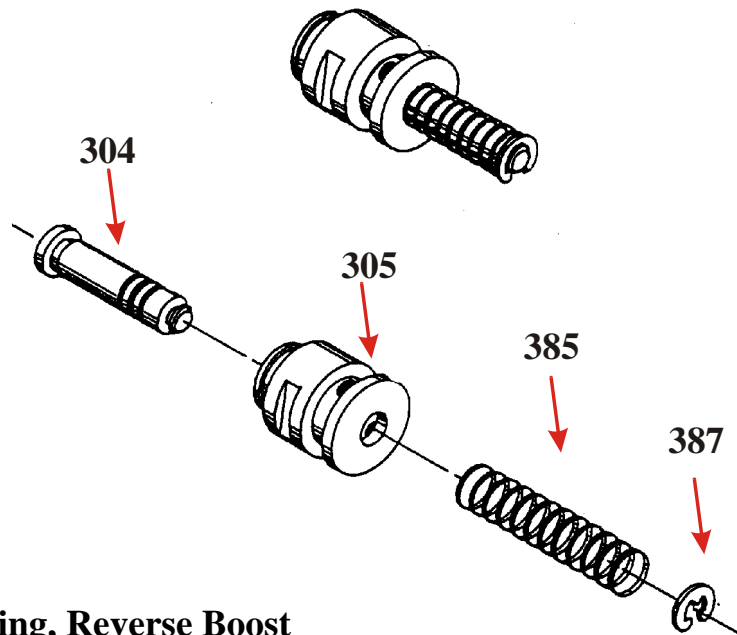
Figure 1

COMPLAINT: Slips in reverse under light or medium throttle only - heavy throttle OK.

CAUSE: Not enough line pressure in reverse to keep reverse band firmly applied.

CORRECTION: Remove 4 coils from the reverse boost valve spring (see figure below). This will raise line pressure in reverse to approximately 85 PSI, which is 15 PSI higher than original and provides more holding power for the reverse band.
