Technical Service Information

THM 4T60-E NO UPSHIFT, AFTER REBUILD

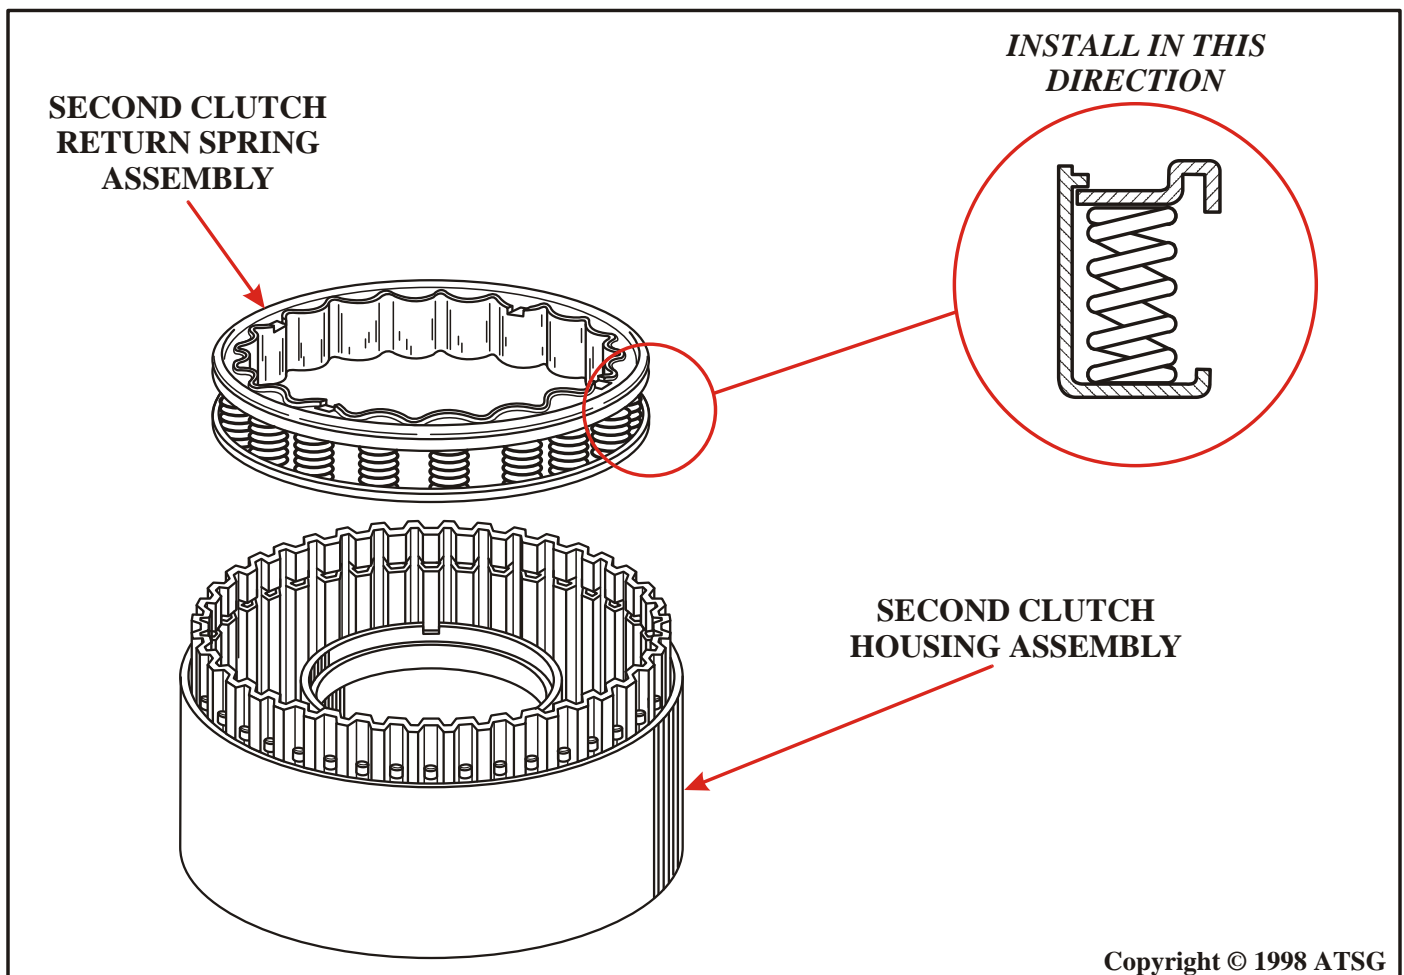
Figure 1

CAUSE: The cause may be, the 2nd Clutch Return Spring installed upside down in the second clutch housing. The 2nd clutch is the driving member for 2nd, 3rd and 4th gears. With the 2nd clutch return spring upside down, the 2nd clutch cannot be applied. If the 2nd clutch cannot be applied you will remain in 1st gear.

CORRECTION: Install the 2nd Clutch Return Spring assembly into the 2nd clutch housing in the proper direction, as shown in Figure 1. The return spring assembly has four tabs that are bent over to hold the assembly together that should face up. After installation of the complete clutch pack, air check the 2nd clutch housing and ensure that the lined plates are clamped.
