Technical Service Information

Ford 4R44E/4R55E

SLIPPING AND/OR NO 1-2,2-3,3-4 SHIFT AND POSSIBLE FLASHING "OD OFF" LAMP

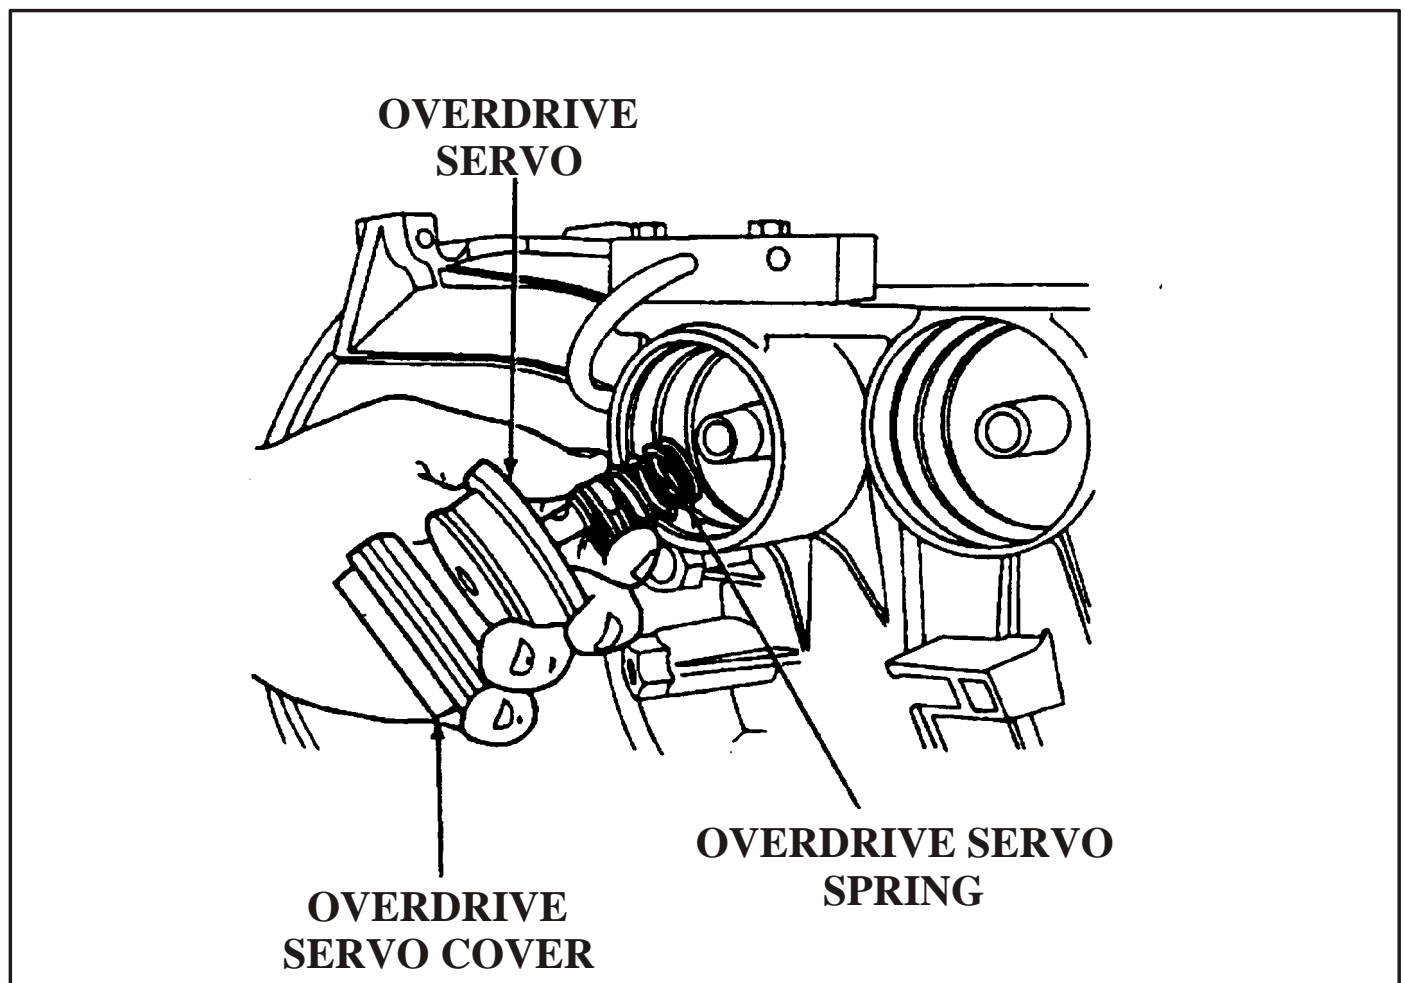
Figure 1

COMPLAINT: Some 1995 Ranger and Explorer vehicles equipped with the 4R44E/4R55E transmission may exhibit a slipping condition on upshifts and/or possibly a no upshift condition. If the "OD OFF" lamp is flashing, Diagnostic Trouble Codes (DTCs) 645, 646, 647, 648, P0731, P0732, P0733, P0734 may be stored in the PCM memory. These symptoms are more prevalent on transmissions built before June 20, 1995.

CAUSE: The cause may be, a damaged intermediate and/or overdrive servo piston seal, and may be damaged on the release (Case Bore) side.

CORRECTION: Replace the intermediate and/or overdrive servo pistons as necessary (See Figure 1).
