# Technical Service Information

## THM 440-T4 / 4T60-E CONVERTER SEAL LEAK

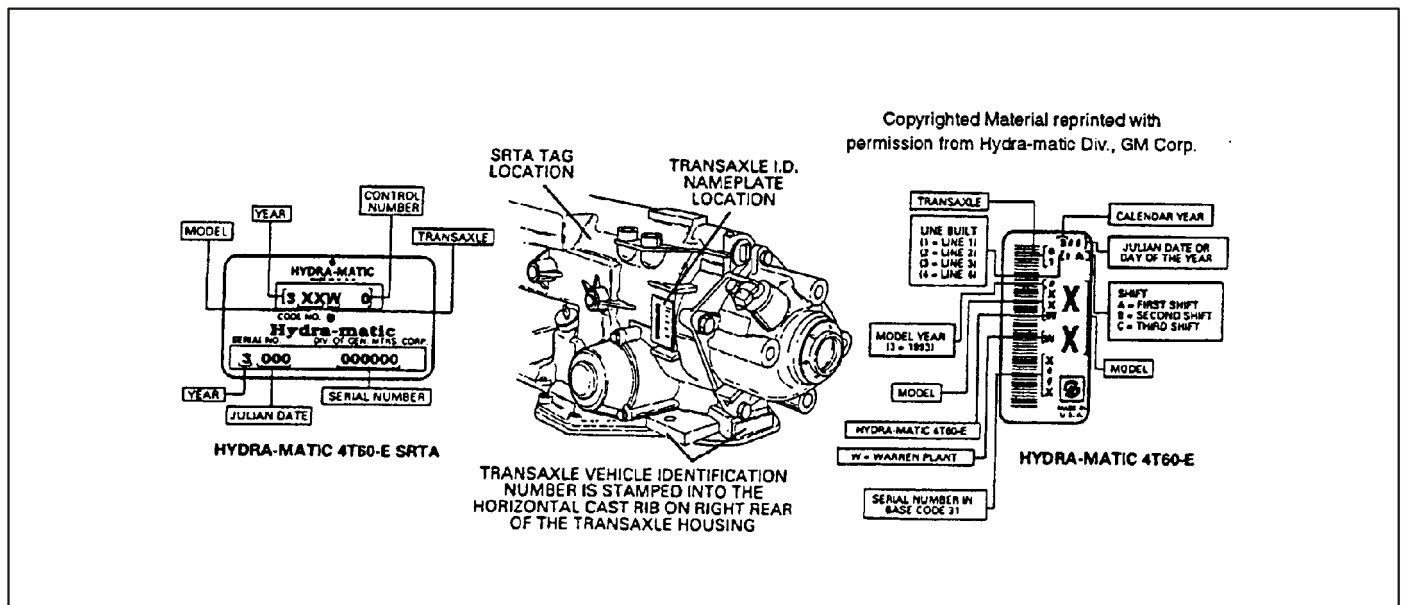
Figure 1

**COMPLAINT:** Some 1991-1993 4T60-E transaxles built on or before Oct.28,1992 ,(Julian Date 302) (SEE FIGURE 1) may exhibit a leak at the converter housing area or the seal may completely blow out onto the converter, especially in hot weather and/or under extreme conditions.

**CAUSE:** Because of the taper and surface finish of the converter seal bore, the converter seal may become unseated and partially walk out of the converter housing.
