# Technical Service Information

## LEXUS A341E HARSH 3RD AND REVERSE

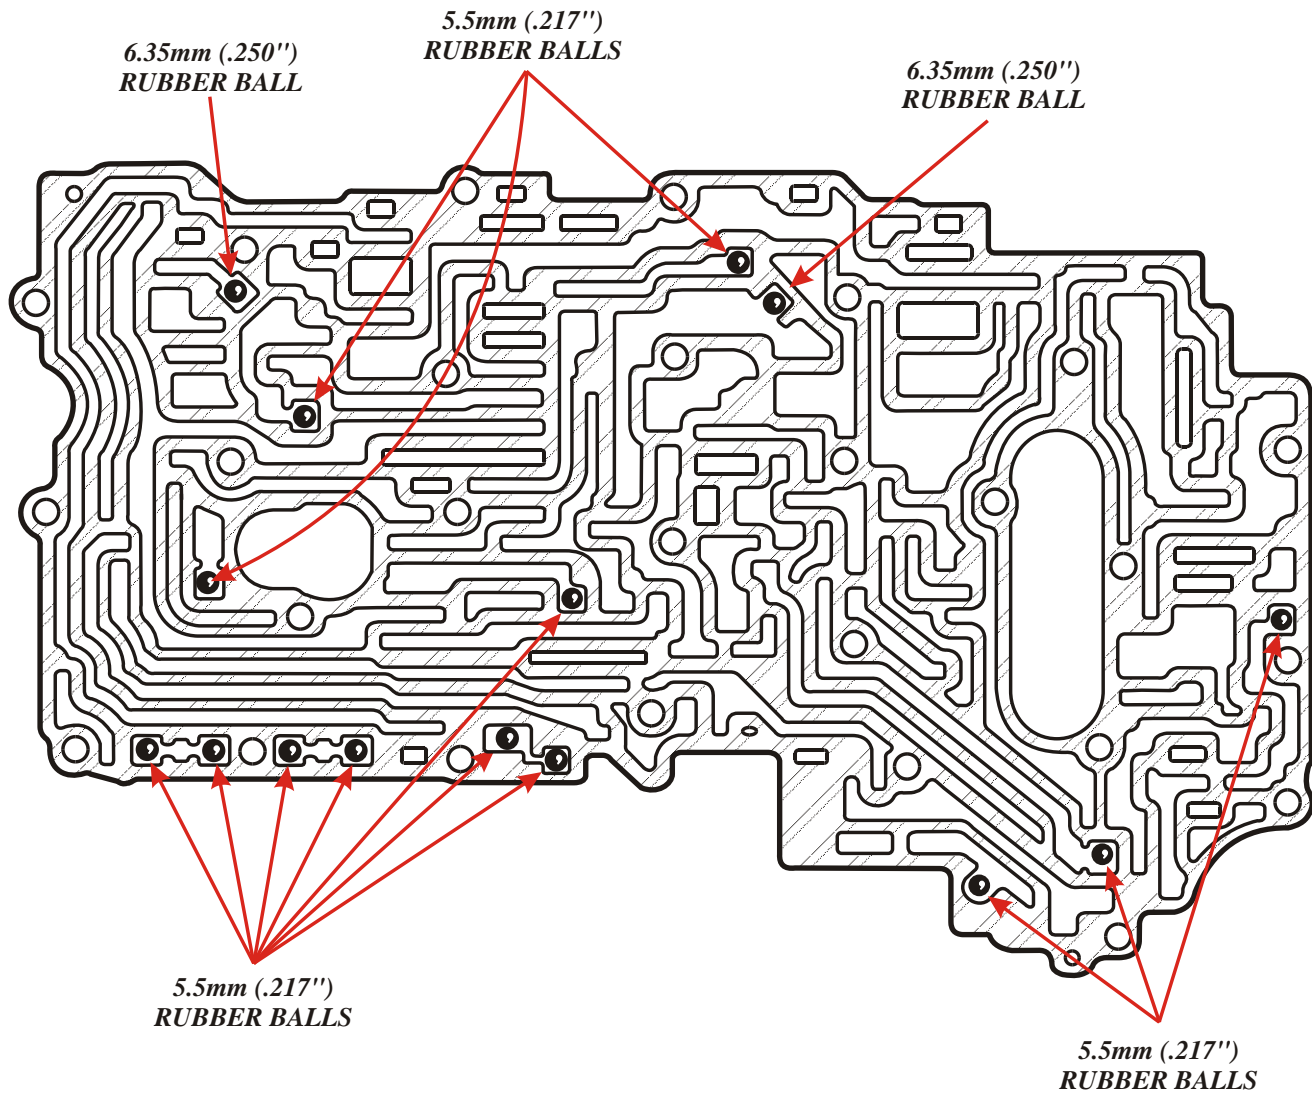
**CAUSE:** The cause may be, a check ball was added to the Upper Valve Body for the 93 and up checkball locations as shown in Figure 2. When this happens, the C2 or Direct clutch can apply at a faster rate, because the passage to the C2 or Direct accumulator piston is restricted by the ball.

## "UPPER" VALVE BODY 93 AND LATER "ONLY" A341E MODELS

**CORRECTION:** Refer to Figure 1 for the correct checkball location for 1991-92 model applications and Figure 2 for 1993 and later models.
