Technical Service Information

ALL NISSAN ELECTRONIC UNITS 3RD GEAR STARTS

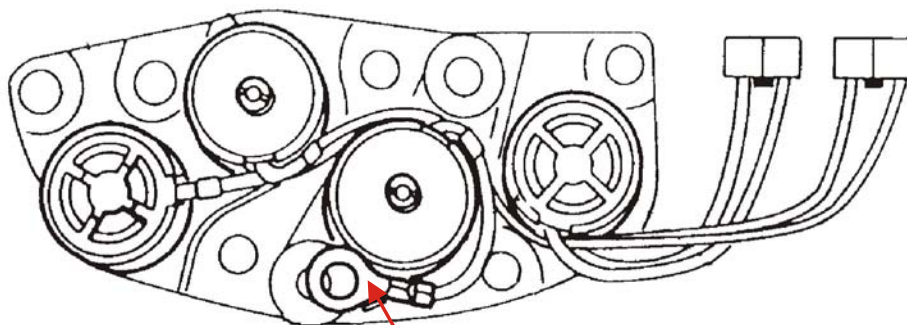
Figure 1

Late model solenoid packs will not have separate ground wire for each solenoid,, but will retro-fit back on the earlier units. They are grounded internally.

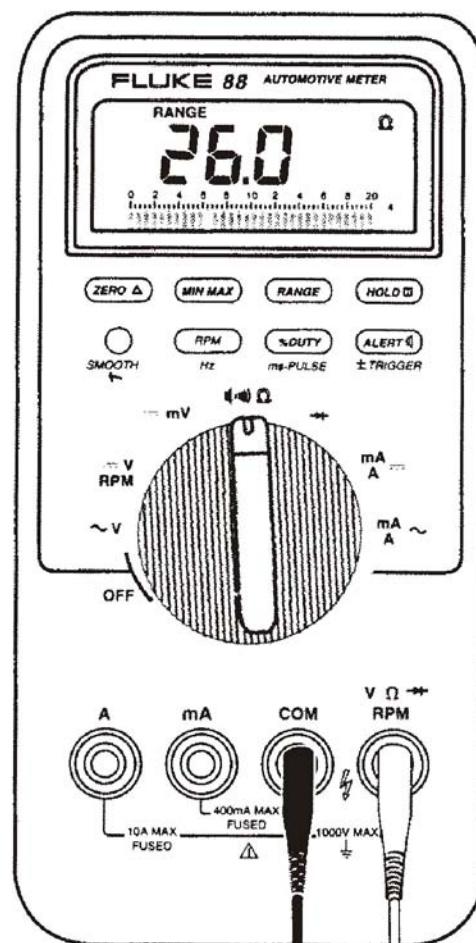
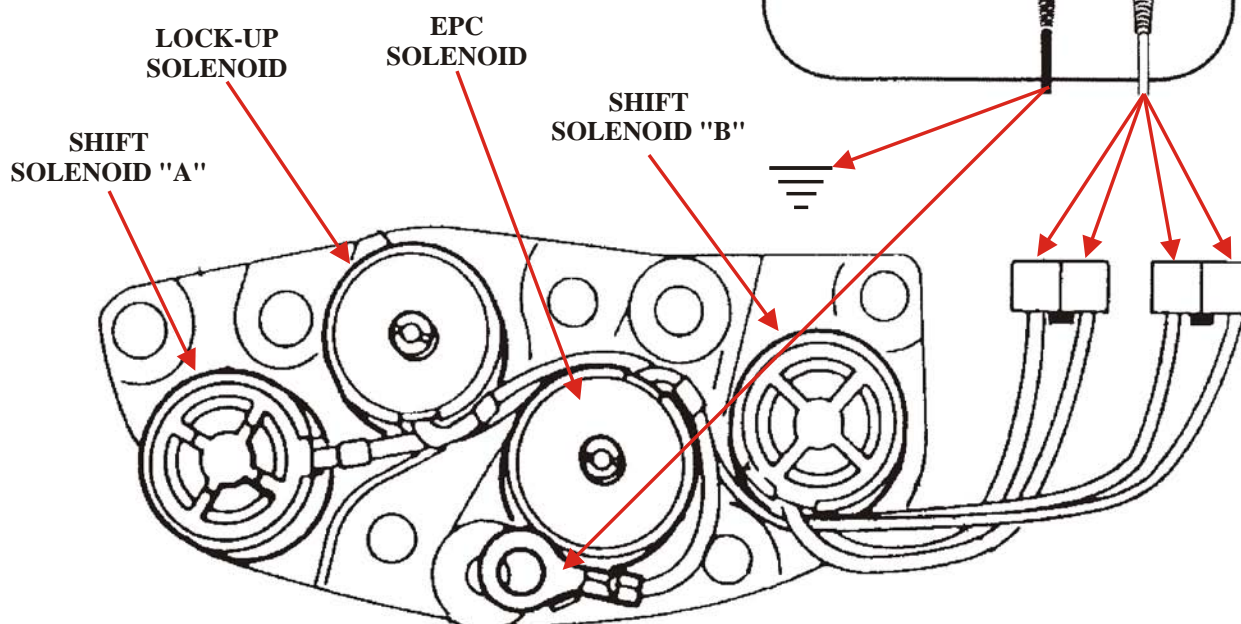
Figure 2

CAUSE: The cause may be, a defective solenoid pack that can be verified with a resistance check on the solenoids with your DVOM, using the chart and illustrations in Figure 2.

SOLENOID RESISTANCE CHART	
Solenoid	Ohms Resistance
Shift "A"	20 - 40
Shift "B"	20 - 40
Overrun (RE4R01A Only)	20 - 40
Lock-up	10 - 16
EPC	2.5 - 5.0

RE4FO2A SOLENOID LOCATION
IS SHOWN BELOW

CORRECTION: Replace the solenoid pack with the appropriate part number as listed below in the "Service Information" section. The part numbers that are listed are Nissan, but will also fit the Mazda units as well.

Solenoid Pack (Rear Wheel Drive Models) 31940-41X-09
Solenoid Pack (Front Wheel Drive Models) 31940-27X-66
