# Technical Service Information

## FORD 5R55E 2-3 FLAIR

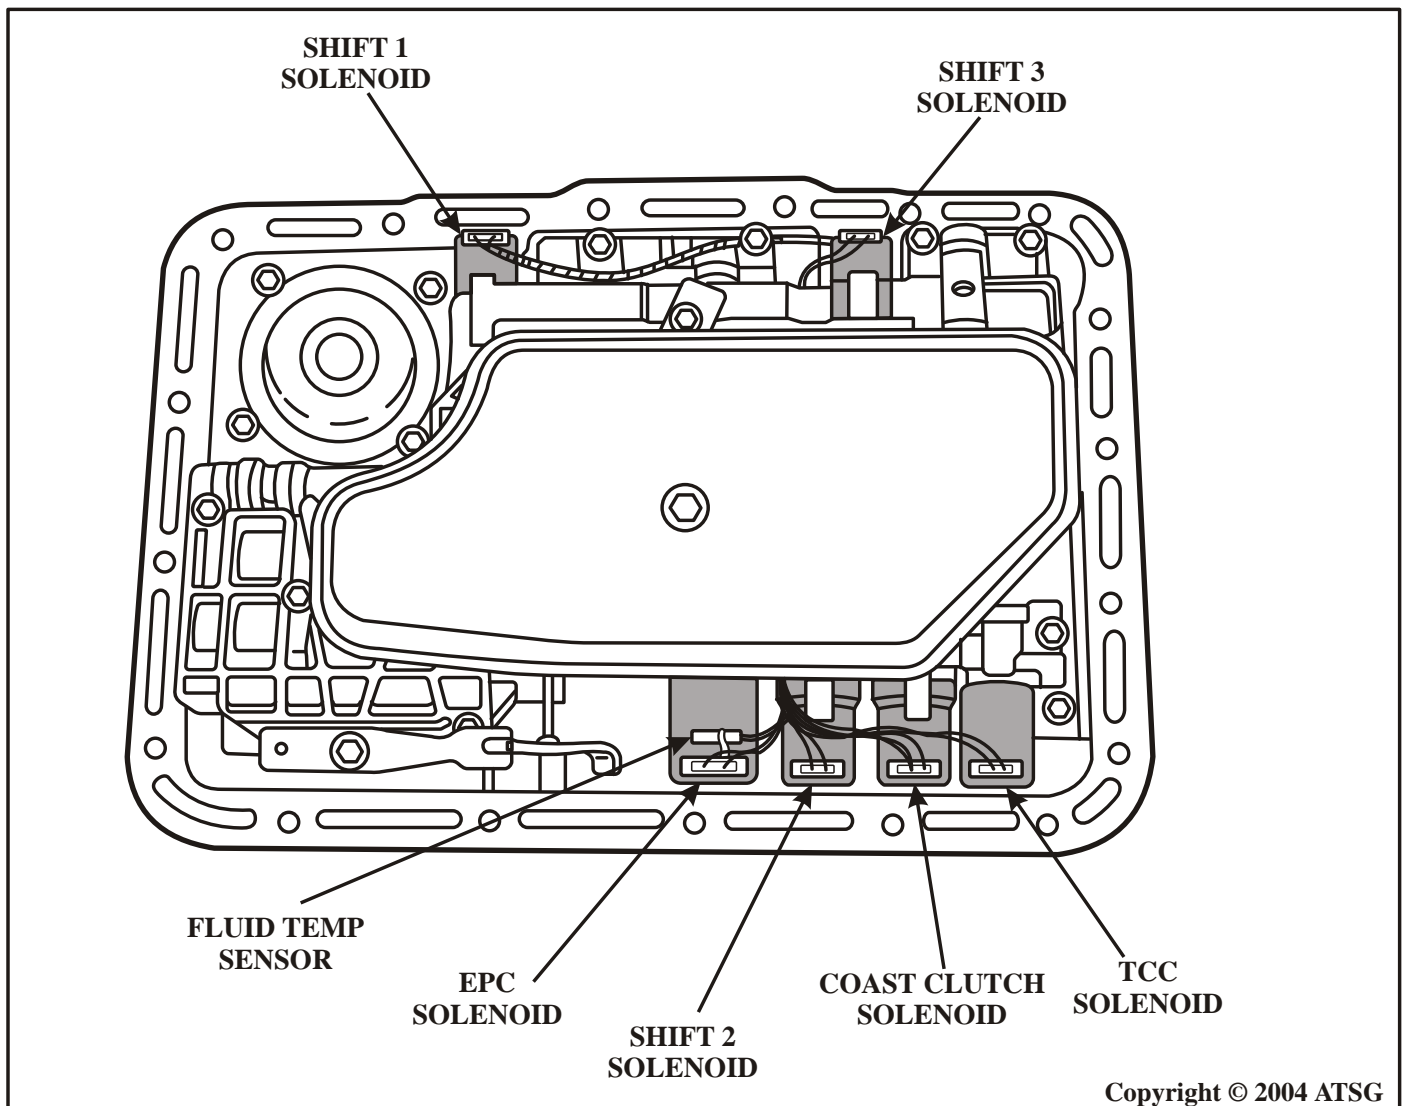
**COMPLAINT:** Some vehicles equipped with the 5R55E transmissions may exhibit a flare on the 2-3 upshift, before and/or after overhaul.

**CAUSE:** One cause may be, a mechanically sticking No. 2 shift solenoid.

**REASON:** On a 2-3 up shift the overdrive band has to release and the intermediate band has to apply at the same time. If the No. 2 shift solenoid is stuck open the transmission will fall back to 1st then up shift into 3rd creating the flare shift feeling. Proper operation of shift solenoid is shown in Figure 2

**CORRECTION:** Replace shift solenoid No. 2 as shown in Figure 1

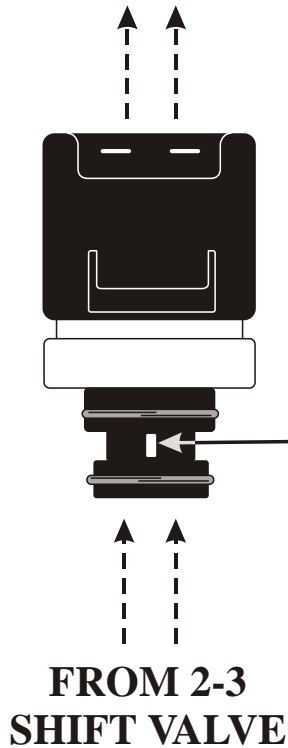
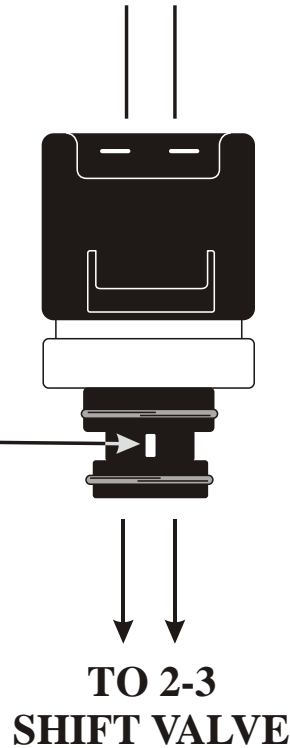
Figure 2

*Shift solenoid no. 2 is a normally open solenoid. When it is OFF, oil from the 2-3 shift valve exhausts out the backside. When the solenoid is ON the exhaust closes and the 2-3 shift valve is stroked.*
