Technical Service Information

THM 325/325-4L NO UPSHIFT, CUP PLUG MISSING

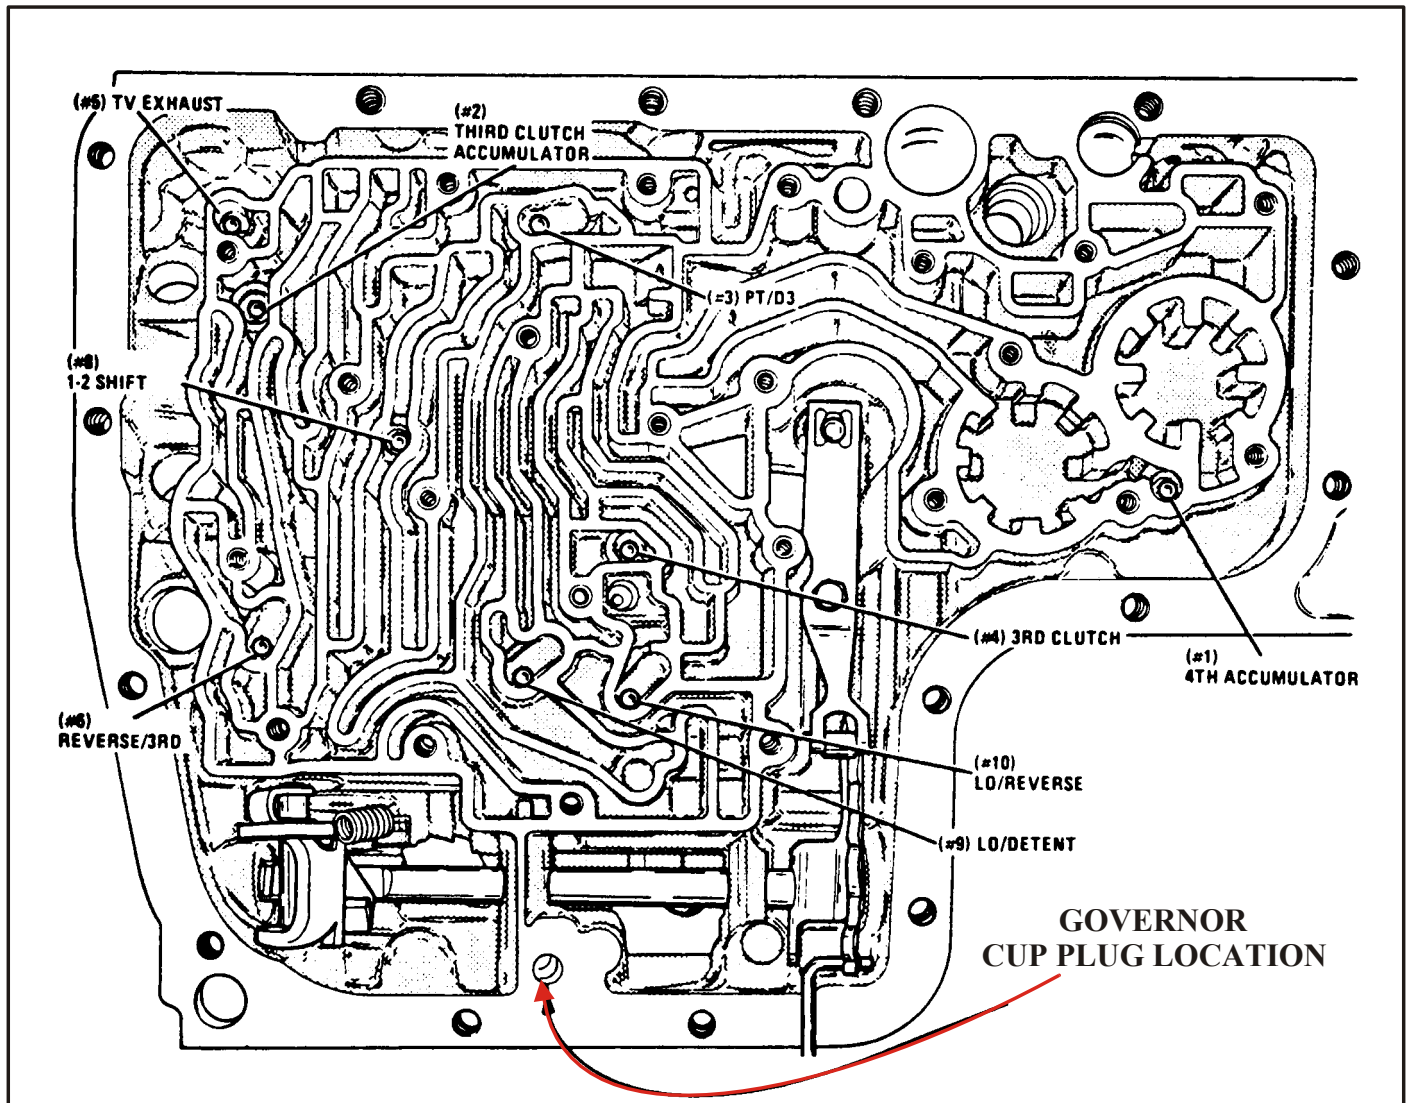
Figure 1

COMPLAINT: No upshift at any vehicle speed.

CAUSE: The cause may be the governor passage cup plug missing from the case (See Figure 1).

CORRECTION: Replace cup plug, available under OEM part number 8620318. This is a 3/8" diameter cup plug and may be available locally.
