THM 3T40 (125C) NO TCC ON RELEASE ON COAST DOWN OR STALLS AFTER DRIVEN

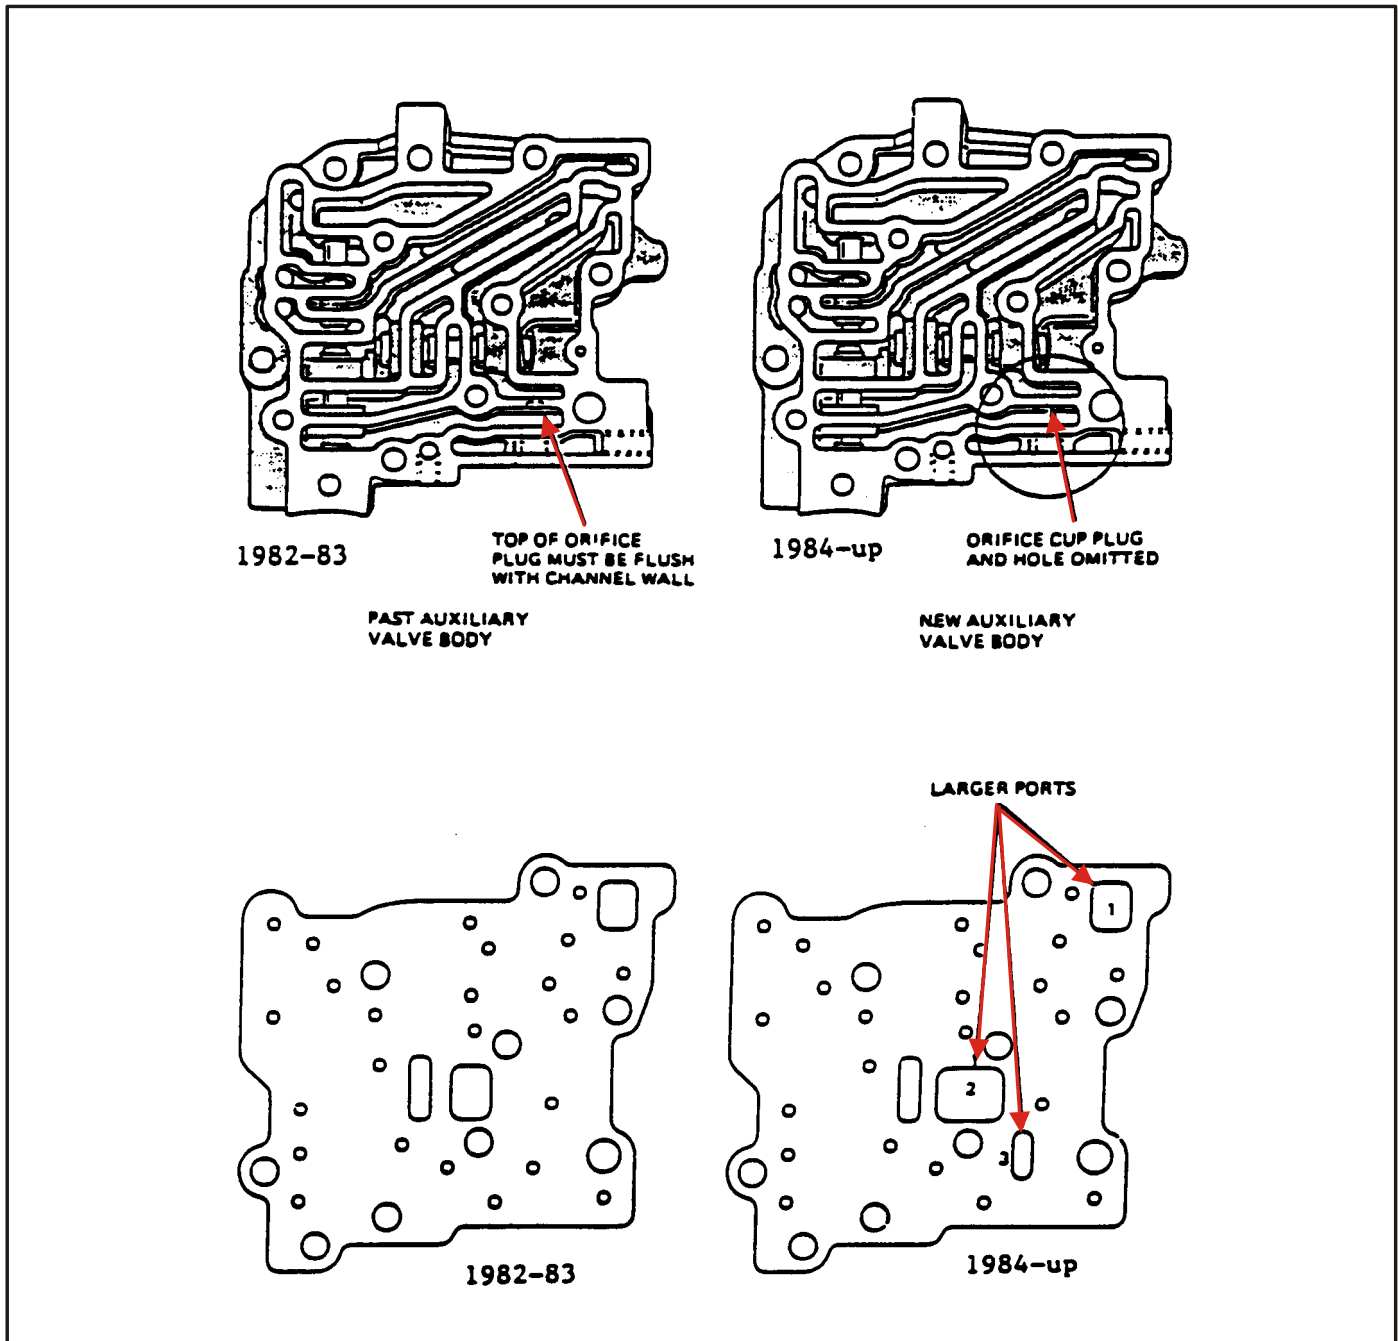
A complaint of no converter release on coast down shift or stalls engine after vehicle has been driven, can be caused by mismatch of gasket Figure 1 (1984 installed in 1982) or a cup plug off location in the Aux Valve body. A mismatch of a 1982 gasket in a 1984 gives a no converter clutch apply condition
