# Technical Service Information

## FORD MOTOR COMPANY AX4N 1999 - UP MOMENTARY NEUTRAL ON ACCELERATION SHIFT SELECTOR IN OD POSITION ONLY

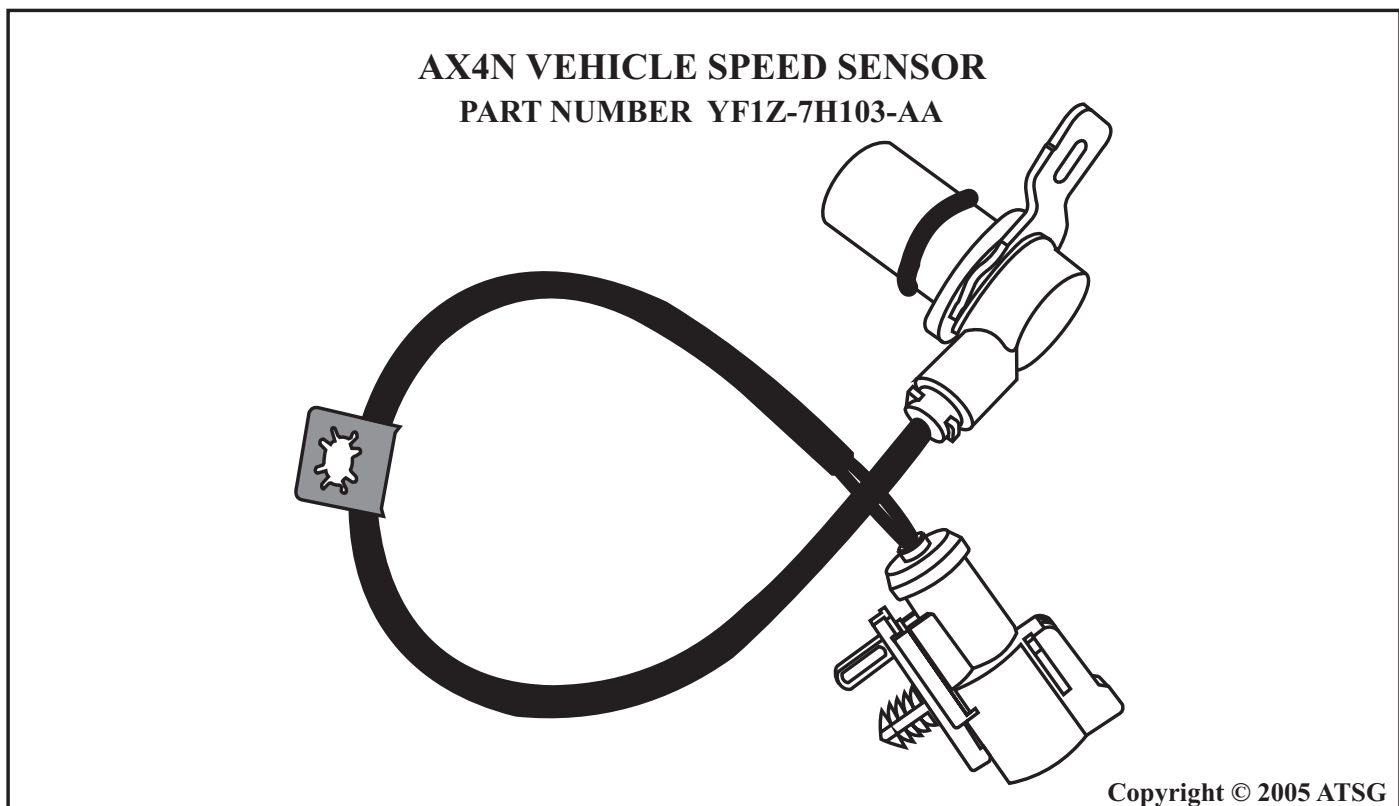
Figure 1

**CAUSE:** The cause may be that a faulty Vehicle Speed Sensor is causing this complaint. See Figure 1. It is a new design Vehicle Speed Sensor that is a Permanent Magnet Sensor that reads off the park gear. See figure 2. **Reason:** when the neutral feeling occurs it is a fault in the signal that is sent to the PCM, telling it that the vehicle speed has just increased from approximately 15 mph to approximately 35 to 40 mph. When this happens the trans is still in first gear, the PCM turns on Shift Solenoid 3 momentarily and then turns it back off again. At the time that Shift Solenoid 3 is on it allows the Forward Clutch Control Valve to move to a downshifted position, at which time the Forward Clutch exhausts causing the trans to slip into a neutral condition. Figure 3 shows Shift Solenoid 3 off, and the Forward Clutch applied. Figure 4 shows Shift Solenoid 3 on, and the Forward Clutch off.

**CORRECTION:** Replace the Vehicle Speed Sensor with Ford Part Number YF1Z-7H103-AA
