Technical Service Information

FORD A4LD OVERRUN CLUTCH RETURN SPRINGS AND RETAINER DESTROYED

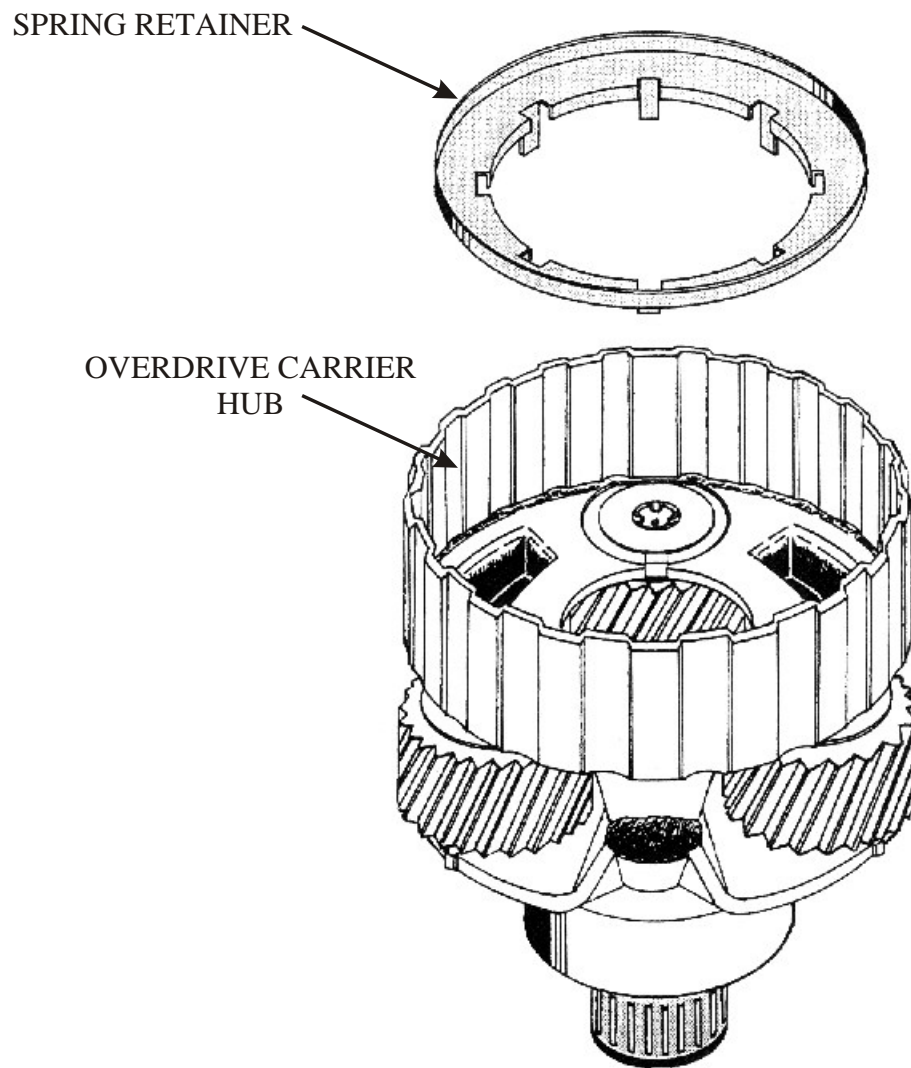
Figure 1

COMPLAINT: Before and/or after rebuild, the overrun clutch springs, and the overrun clutch spring retainer are destroyed, from what looks to be a *twisting* motion.

A. Poorly supported overdrive planetary carrier, allowing the inside diameter of the hub on the overdrive carrier to contact, and turn in a *twisting* motion, the overrun clutch spring retainer. This will destroy the retainer and return springs in a very short period of time (See Figure 1).
NOTE: The dimension between the outside diameter of the overrun clutch spring retainer, and the inside diameter of the overdrive carrier hub, *is critical*. (See Figure 1).

B. Bent or improperly installed overrun clutch spring retainer will also drastically affect the clearance between the retainer and the carrier hub.

B. Ensure that the overrun clutch spring retainer is supported evenly, using an outer pump gear, when compressing the return springs to avoid *ANY* distortion. This is critical, and is easily distorted with any uneven pressure.

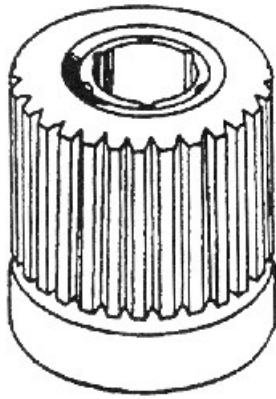
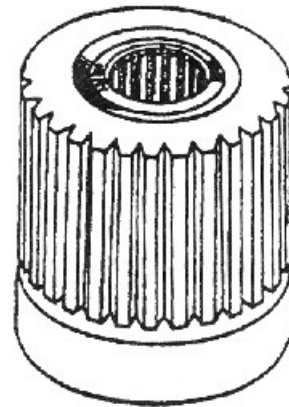
Figure 2

**EARLY DESIGN
WITH BUSHING**

**LATE DESIGN
WITH BEARING**

1. Turbine shaft bushings in the pump stator for wear and/or damage.
2. Turbine shaft splines (Overdrive Carrier End) for wear and/or damage.
3. Turbine shaft splines in overdrive planetary carrier, for wear and/or damage. Ensure a “snug” fit when installing the turbine shaft into the overdrive carrier,
4. Bushing in the front end of the output shaft for wear and/or damage. This will support the forward clutch drum and the overdrive center shaft. Replace this bushing on *All* units during rebuild (See Figure 2).
NOTE: In later applications a caged needle bearing is used in this location.
Inspect and replace as necessary (See Figure 2).
5. Overrun clutch housing bushing for wear and/or damage (See Figure 3).

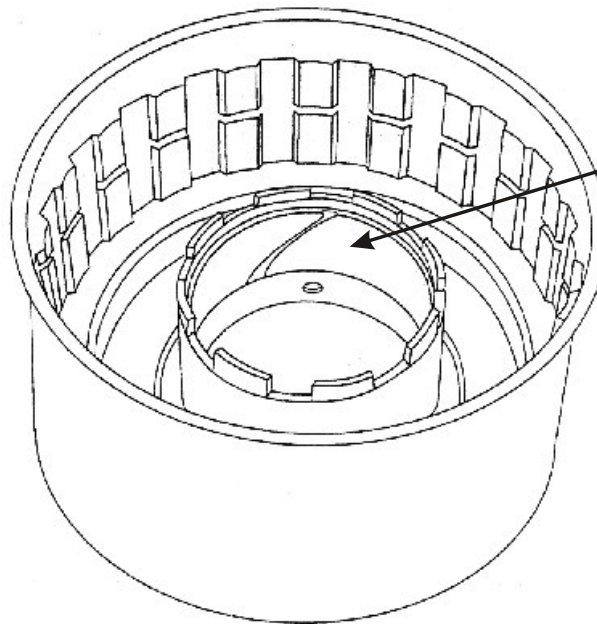
Figure 3

**OVERRUN CLUTCH
DRUM BUSHING**
