Technical Service Information

ZF5HP24

SLIPPING OR NO REVERSE

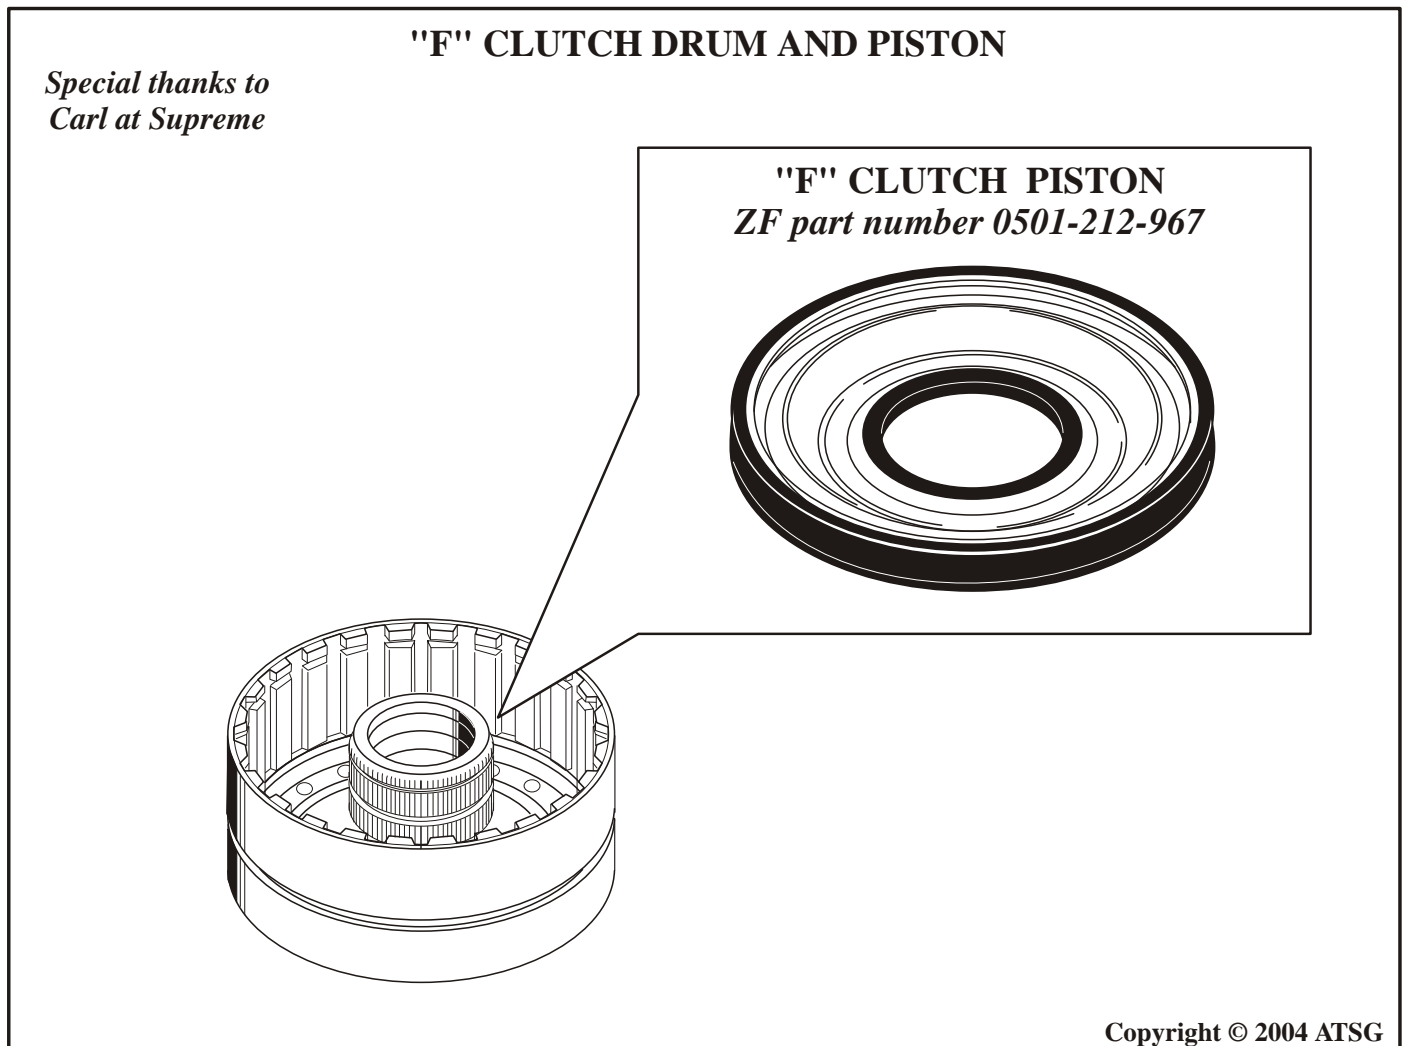
Figure 1

COMPLAINT: Some 1999 to 2000 vehicles equipped with the 5HP24 transmission may exhibit a slipping or no engagement in Reverse.

CAUSE: The cause may be, a defective "F" clutch bonded piston. The "F" clutch is the Low and Reverse Clutch, which holds to provide Reverse application and Engine braking in Manual Low. The "F" clutch piston on some of these later versions have had problems with the bonding coming off of the piston.

CORRECTION: Replace the "F" clutch piston as shown in Figure 1.

"F" CLUTCH BONDED PISTON (ZF part number).....0501-212-967
