Technical Service Information

MAZDA MPV R4A-EL NO 4TH GEAR CONDITION INHIBITOR SWITCH CORRECTION

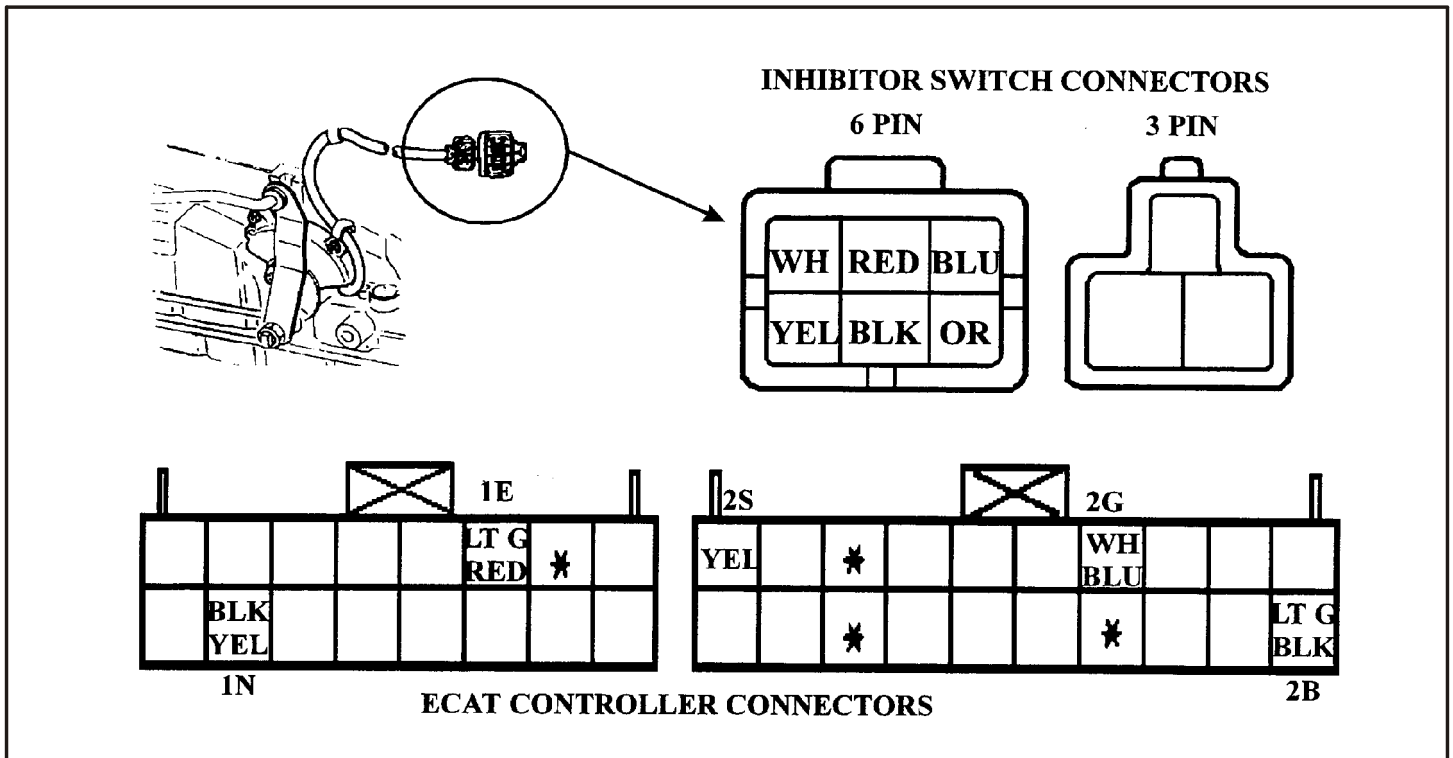
CAUSE: The cause may be, the NEW Inhibitor Switch wired incorrectly at the factory. The Red and Orange wires were inadvertently reversed in the 6 pin connector. Figure 1 shows the Red and Orange wires in the correct locations. The 3 pin connector is NOT affected.
The wires that have been mislocated (Red and Orange) must be removed from the 6 pin connector and relocated to their proper locations. Figure 1 shows the Red and Orange wires in the correct locations.

INHIBITOR SWITCH		ECAT CONTROLLER
WHITE	connects to	YELLOW
RED	connects to	LT. GREEN/BLACK
BLUE	connects to	LT. GREEN/RED
YELLOW	connects to	BLANK
BLACK	connects to	BLACK/YELLOW
ORANGE	connects to	WHITE/BLUE

CORRECTION: Make certain that the wire colors and locations in the inhibitor switch 6 pin connector, match the wire color and location in the ECAT control unit, as it is shown in the charts and illustrations in Figure 1.
