Technical Service Information

CHRYSLER A500/518

PREMATURE WEARING OF THE LOW/REV BAND

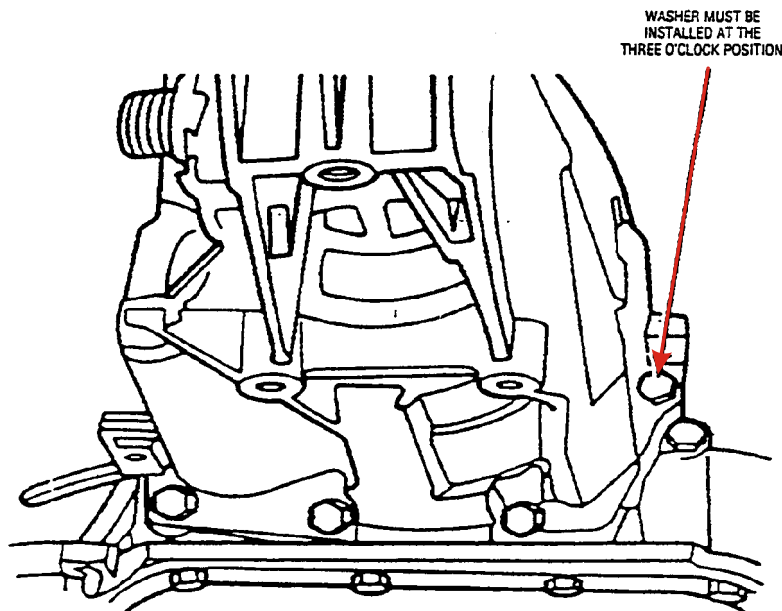
Figure 1

COMPLAINT: Some A-518 transmissions may experience premature wearing of the low/reverse band.

CAUSE: This condition may be the result of one of the overdrive-to-transmission mounting bolt's making light contact with the band strut, resulting in an incomplete release of the band.

CORRECTION: To prevent the possibility of this condition occurring, a washer was installed in production on the overdrive-to-transmission mounting bolt at the **THREE O'CLOCK POSITION** (See Figure 1). The washer entered transmission production in September 1989 beginning with date code 0283.

If a transmission experiences premature wearing of the low/reverse band, or when performing any servicing operation that requires the removal of the overdrive unit from the transmission, be sure the overdrive-mounting bolt in the three o'clock position has a washer installed between the bolt head and the overdrive housing.

If there was no washer on the bolt at the three o'clock position, install a 3/8 inch zinc-coated lock washer such as PN J0120382.
