# Technical Service Information

## FORD 4R70E/4R75E DTC P0715/P0717 OR ERRATIC SHIFTS

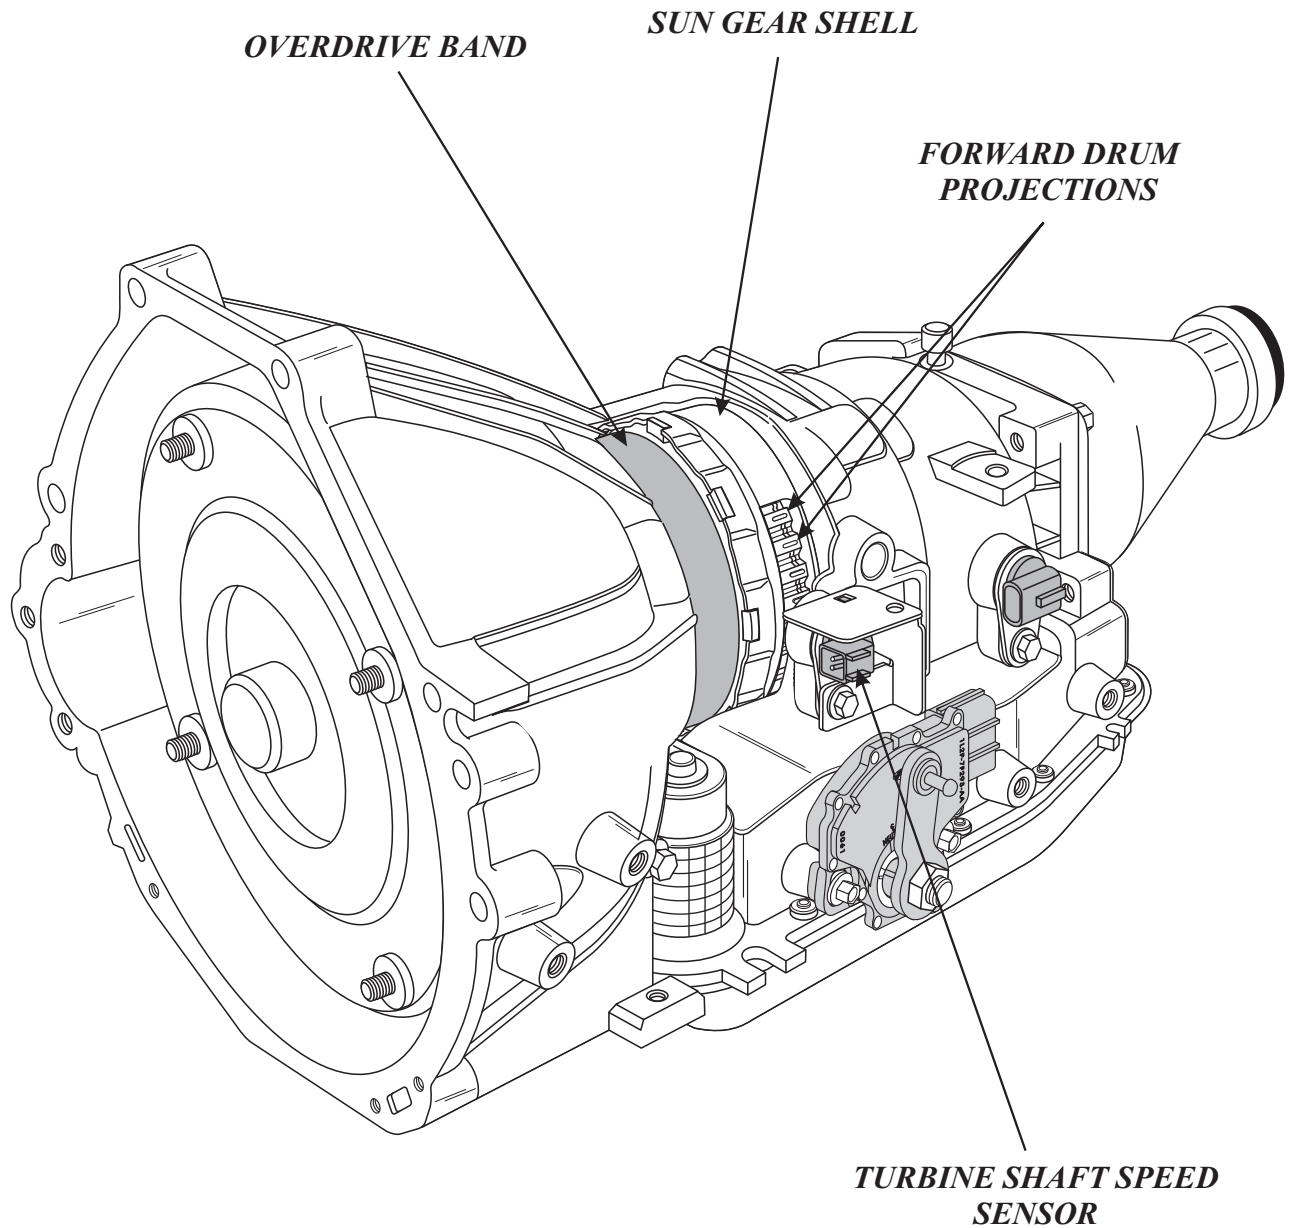
Figure 1

## TRANSMISSION CASE CROSS-SECTION

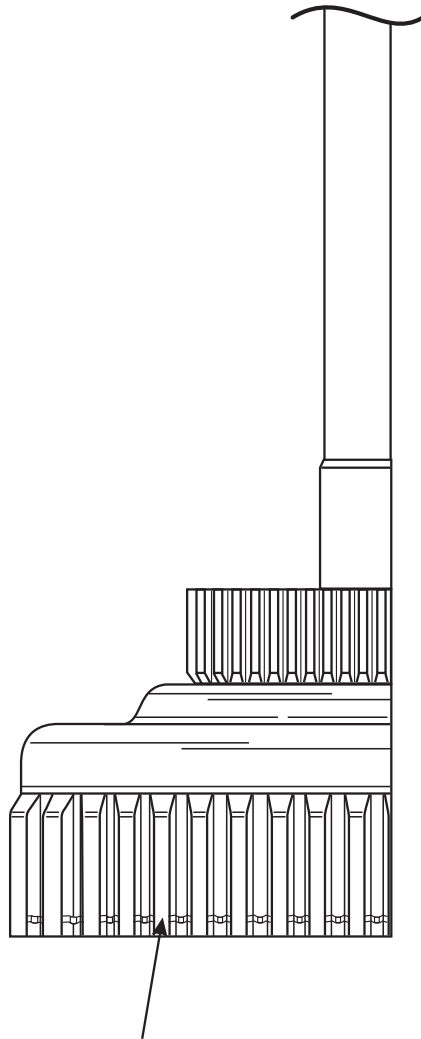
Figure 2

**CAUSE:** The cause may be, that the Forward Clutch Drum, as shown in Figure 2, or Sun gear Shell, as shown in Figure 3, were replaced with the previous design parts causing the Turbine Speed Sensor to return a false reading to the Powertrain Control Module. In the start of production for 2004 the Sun gear shell was made of a non-magnetic material to allow the new Turbine Shaft Speed Sensor to read the Forward Clutch Drum, calculating Turbine shaft speed for the PCM. At the same time the Forward Clutch Drum received a new stamping process, to provide 34 projections for the sensor to read from. See Figure 1 for a cross-sectional view.

***NO PROJECTIONS***

**CORRECTION:** Install the correct Forward Clutch Drum or Sun gear shell into the transmission and or replace the Turbine Shaft Speed Sensor as shown in Figure 4.

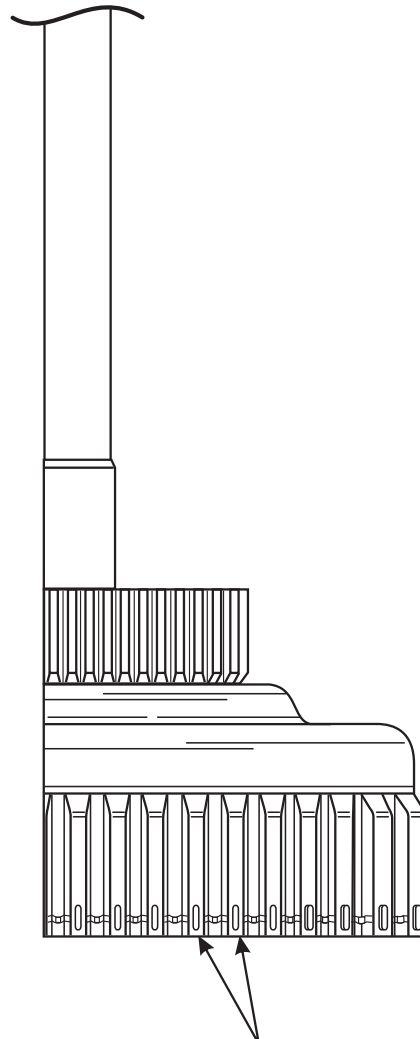
***34 STAMPED PROJECTIONS  
ON THE OUTSIDE OF THE DRUM  
THAT THE ADDED TURBINE SENSOR  
READS FROM***

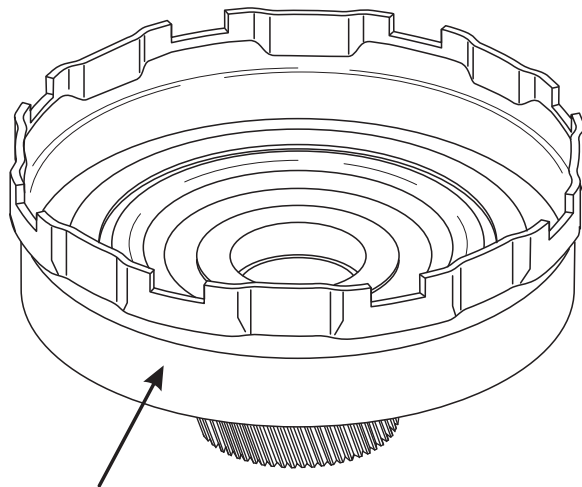
Figure 3

*MAGNETIC SHELL*

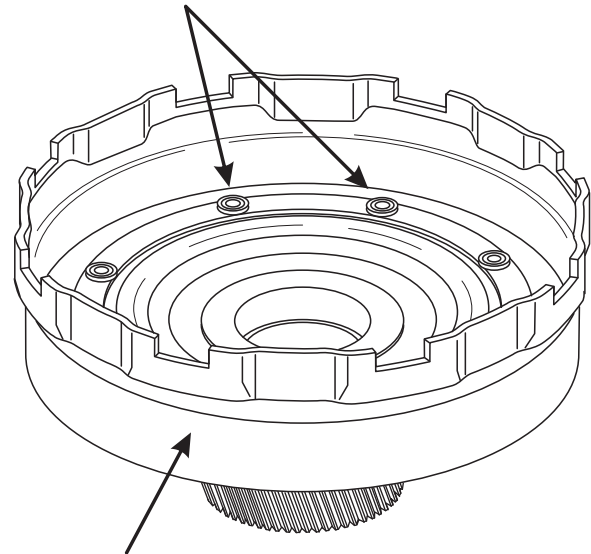
*New Sun Shell Is Now Riveted  
To The Sun Gear And Hub*

*NON-MAGNETIC SHELL*

*NOTE: The New Sun Shell is made from  
a non-magnetic material so the Turbine sensor  
can read the Forward drum.*

*2005 models use the same type of Sun Shell  
and there are no rivets for identification.*

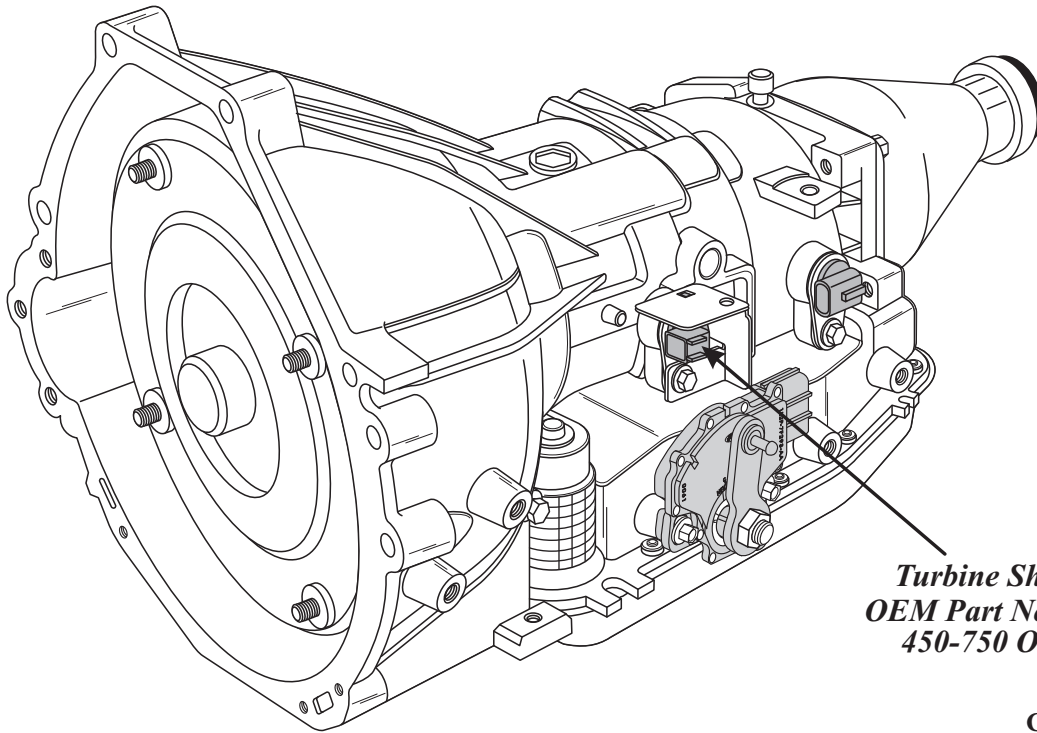
Figure 4

*Turbine Shaft Speed Sensor  
OEM Part No. 3L3Z-7M101-AA  
450-750 Ohms Resistance*
