# Technical Service Information

## THM 4L60 (700-R4) LOSS OF LINE BOOST AT WOT

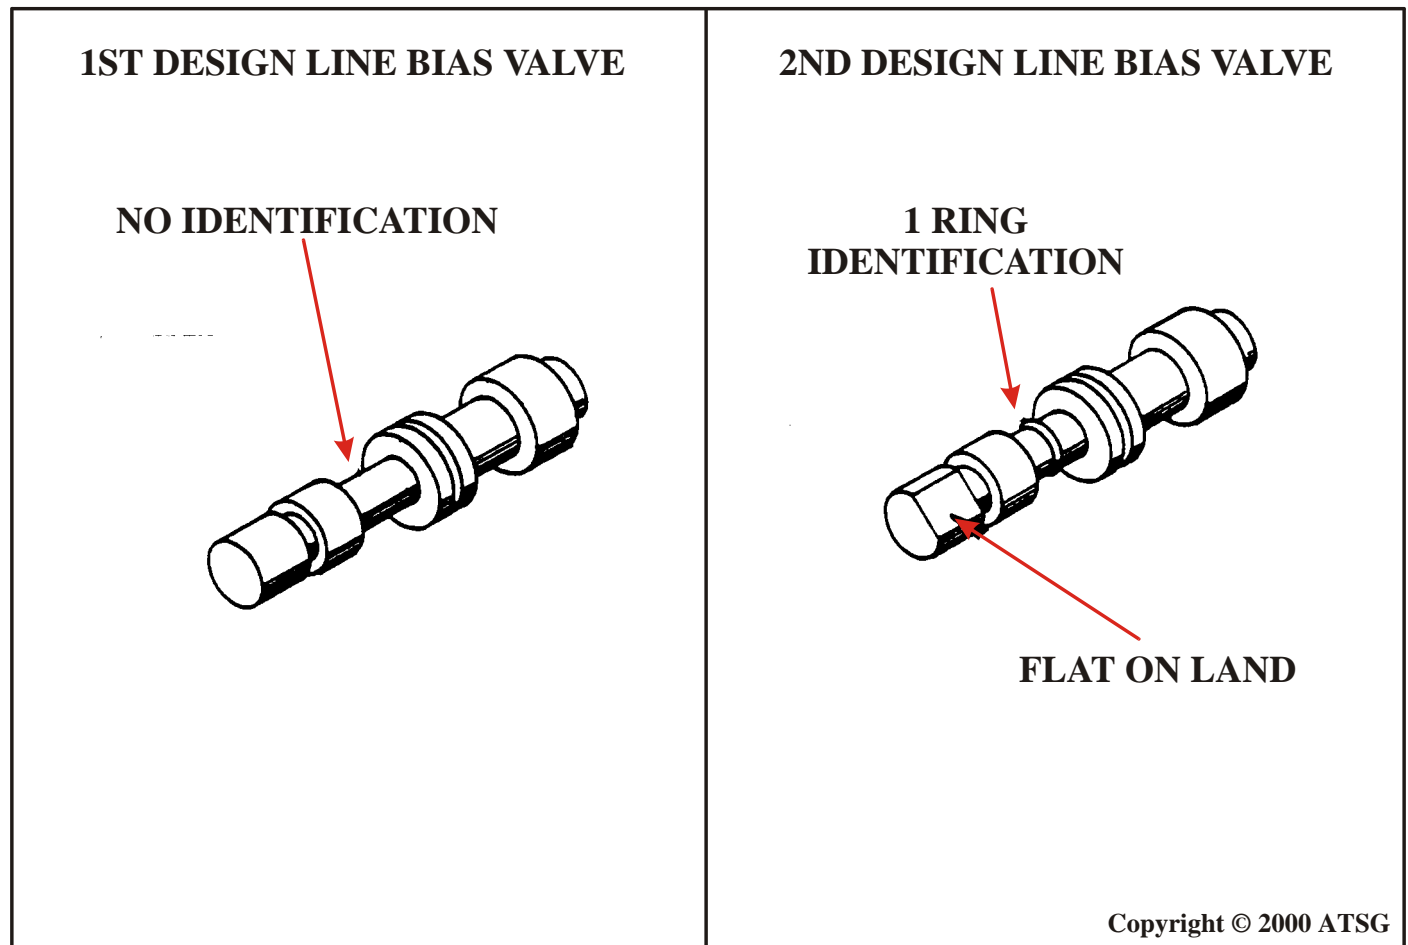
Figure 1

The cause may be a mis-matched line bias valve, and spacer plate. Beginning in 1987, a 2nd

**CORRECTION:** design line bias valve was introduced that has a "Flat" on the small land (See Figure 1). This change required that the detent hole in the spacer plate be eliminated (See Figure 2).

If the 2nd design line bias valve (With **Flat**) is installed with the 1st design spacer plate (With Detent Hole), all T.V. oil will be exhausted at full throttle positions.

Install matching line bias valve and spacer plate.

Line bias valve **WITHOUT** flat, requires spacer plate **WITH** detent hole. (Refer to Figures 1 and 2).

Line bias valve **WITH** flat, requires spacer plate **WITHOUT** detent hole. (Refer to Figures 1 and 2).
