MAZDA MPV R4A-EL 3RD GEAR STARTS

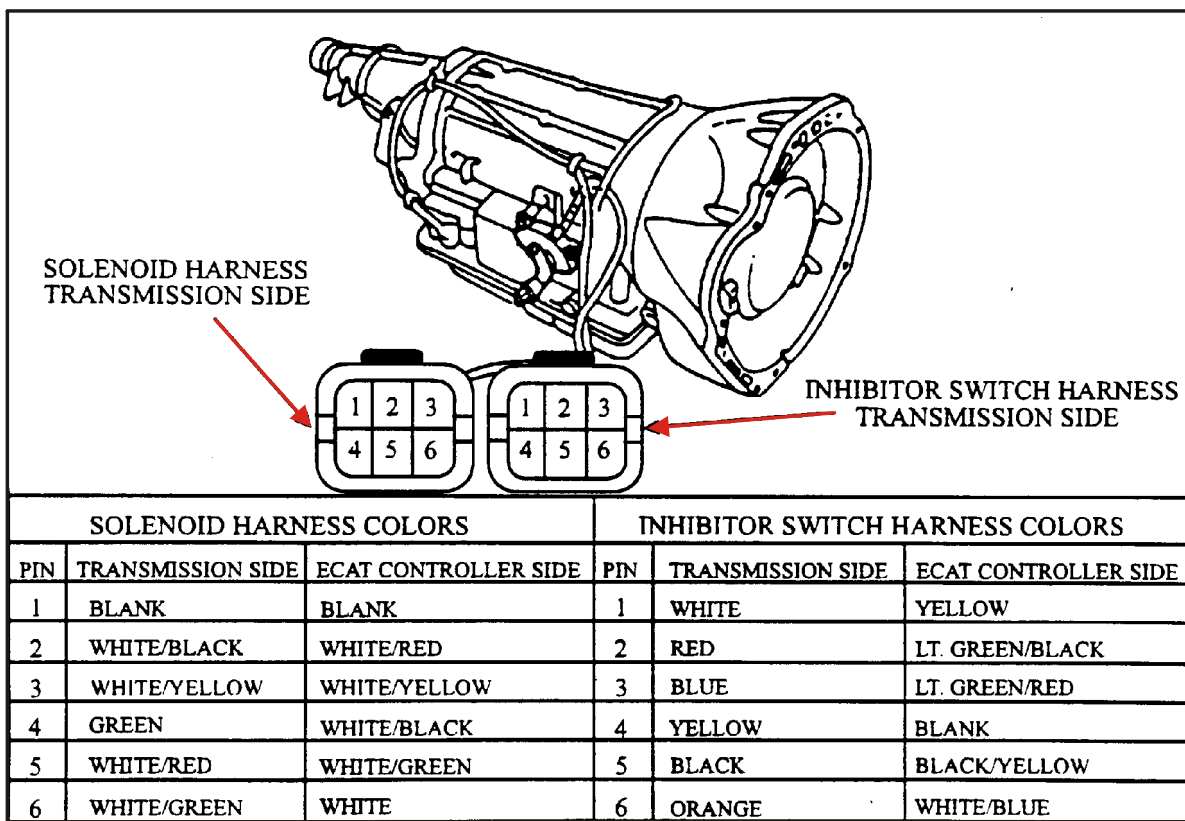
COMPLAINT: On early model MPV'S equipped with R4A-EL transmission's, after overhaul the vehicle exhibits 3rd gear starts in the Drive range and the "HOLD" light is continuously flashing.

CAUSE: The cause may be, the "Computer" side shift solenoid harness was connected to the "Inhibitor Switch," and the "Computer" side "Inhibitor switch" harness was connected to the shift solenoids. This will result in "NO" voltage sent to the shift solenoids, a 3rd gear start in the Drive range. This will also result in "Trouble Codes" being stored and causing the "HOLD" light to flash because the ECAT control unit now will see "Open Circuit's" at the solenoid wiring harness.

CORRECTION: Refer to Figure 1 to correctly identify "Inhibitor Switch" and "Solenoid" common wiring colors and switch the "Computer" side connectors to cure the problem.
