Technical Service Information

NISSAN MAXIMA AND STANZA RE4F02A

POOR SHIFTS AND FRICTION MATERIAL FAILURE

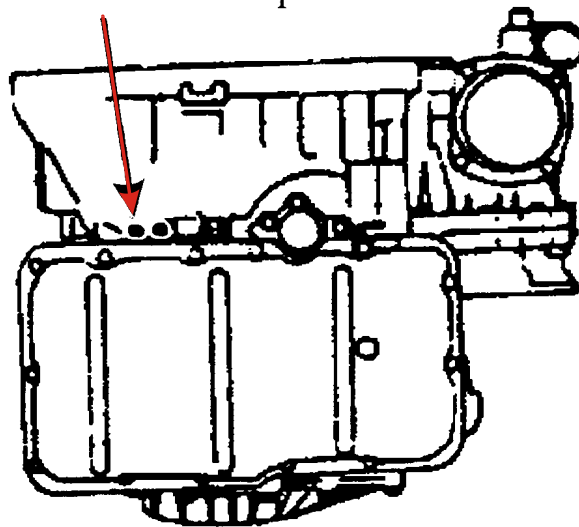
Figure 1

CAUSE: No line pressure rise with throttle opening. This can be easily checked by connecting a pressure gauge to the line pressure tap on top of the case, near the front of the transaxle. See figure 1. Test the line pressure in drive at idle. It should be around 60 psi. At increased throttle opening, pressures should smoothly increase to a maximum of around 180 psi. at stall. If the line pressure stays at or near idle pressure, the cause is a weak or clogged pressure control solenoid.

Line Pressure Tap

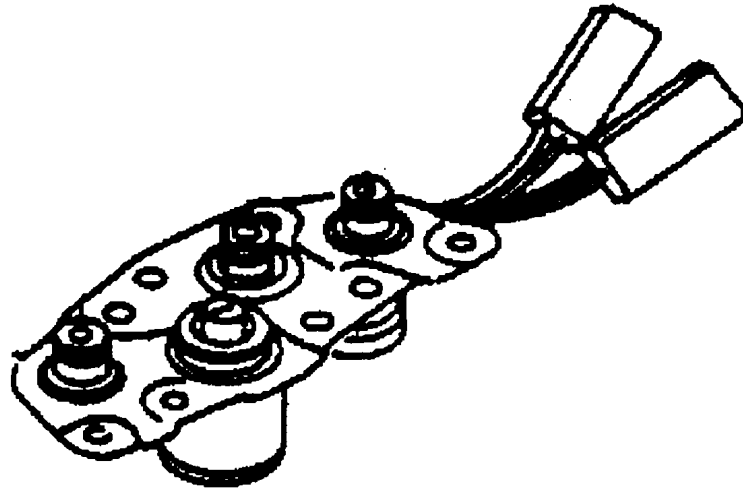
Figure 2

4-Unit Solenoid Assembly

CORRECTION: Remove the valve body and replace the 4-Unit Solenoid Assembly which contains the pressure control solenoid. See figure 2. The pressure control solenoid is not serviced separately. A new solenoid assembly is available from the Nissan dealer. The part number for the solenoid pack is 31940-27X66.
