Technical Service Information

THM 440-T4 2ND GEAR STARTS

MODELS AFFECTED: 1985-1987 DE VILLES AND FLEETWOODS
1986-1987 ELDORADOS AND SEVILLES

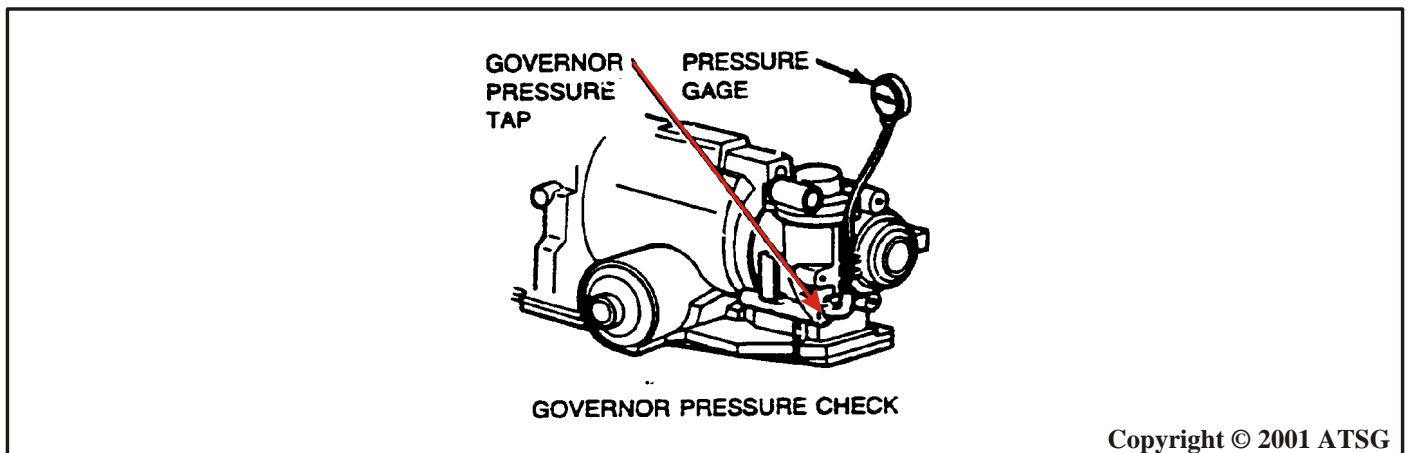
Figure 1

- 5 Install a 0-100 PSI pressure gauge at the governor pressure tap and monitor governor pressure while the condition is occurring (refer to Figure 1).
- 6 If governor pressure is 3.0 PSI (21 kPa) or below at 0 mph (0 kmh), go to Step 9.
- 7 If governor pressure exceeds 3.0 PSI (21 kPa) at 0 mph (0 kmh), install a known good governor assembly and verify transaxle operation. If second gear starts are still experienced, continue to Step 8.

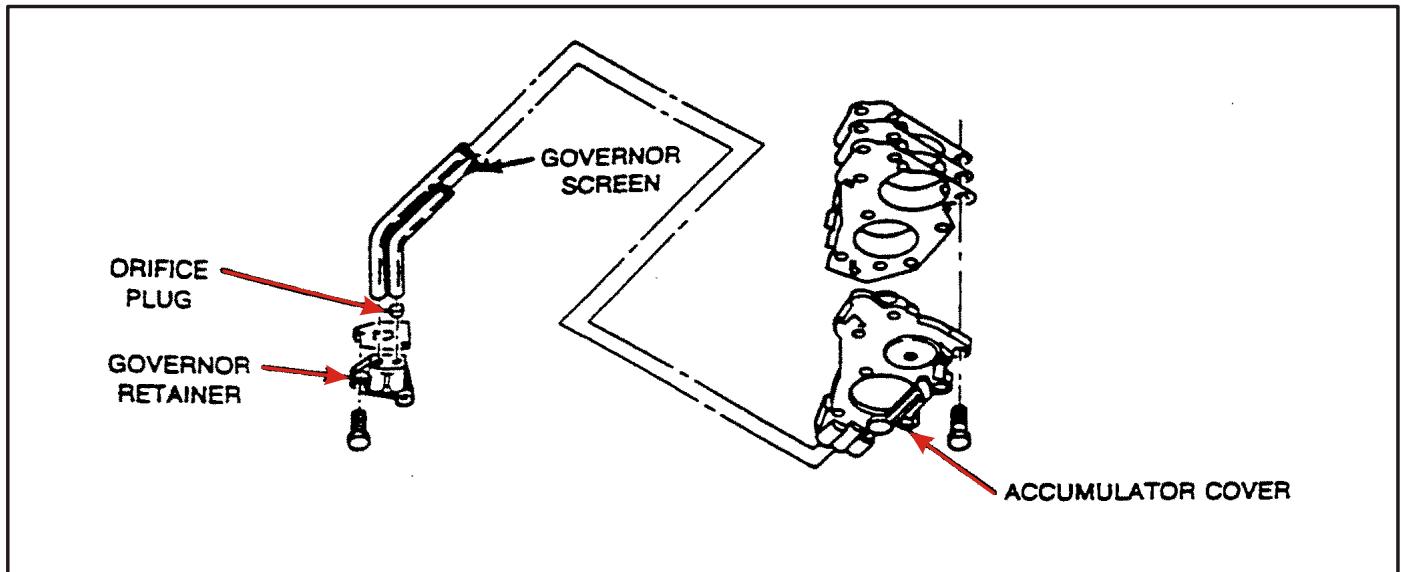
Figure 2

- 8 Remove bottom pan, inspect accumulator cover and governor retainer for damage of gasket and/or sealing surfaces. Inspect governor orifice for damage or missing orifice plug refer to Figure 2). Inspect and remove any foreign material that may be lodged in this area.

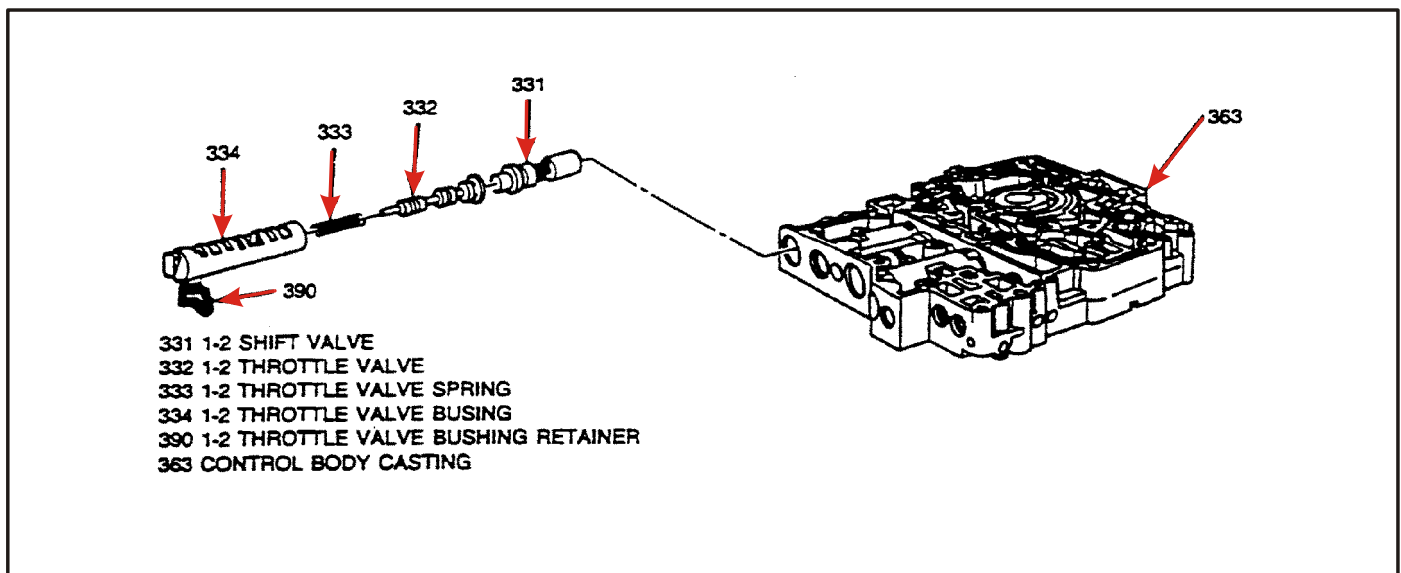
Figure 3

- 9 Governor pressure below 3.0 PSI (21 kpa) at 0 mph (0 kmh) indicates the 1-2 shift valve is in the up shifted position. Remove the control valve assembly. Refer to the appropriate Service information Manual. Inspect for the following conditions:

Sticking 1-2 shift valve (331)

Sticking 1-2 throttle valve (332)

Binding 1-2 throttle valve spring, due to a mis-positioned 1-2 throttle valve bushing retainer (390).

Ensure the throttle valve bushing retainer (390) is installed flush with the mating surface of the control body casting (363).
