SATURN VUE WITH AF33-5 TRANSMISSION

LIMP MODE WITH CODE P0717 SET

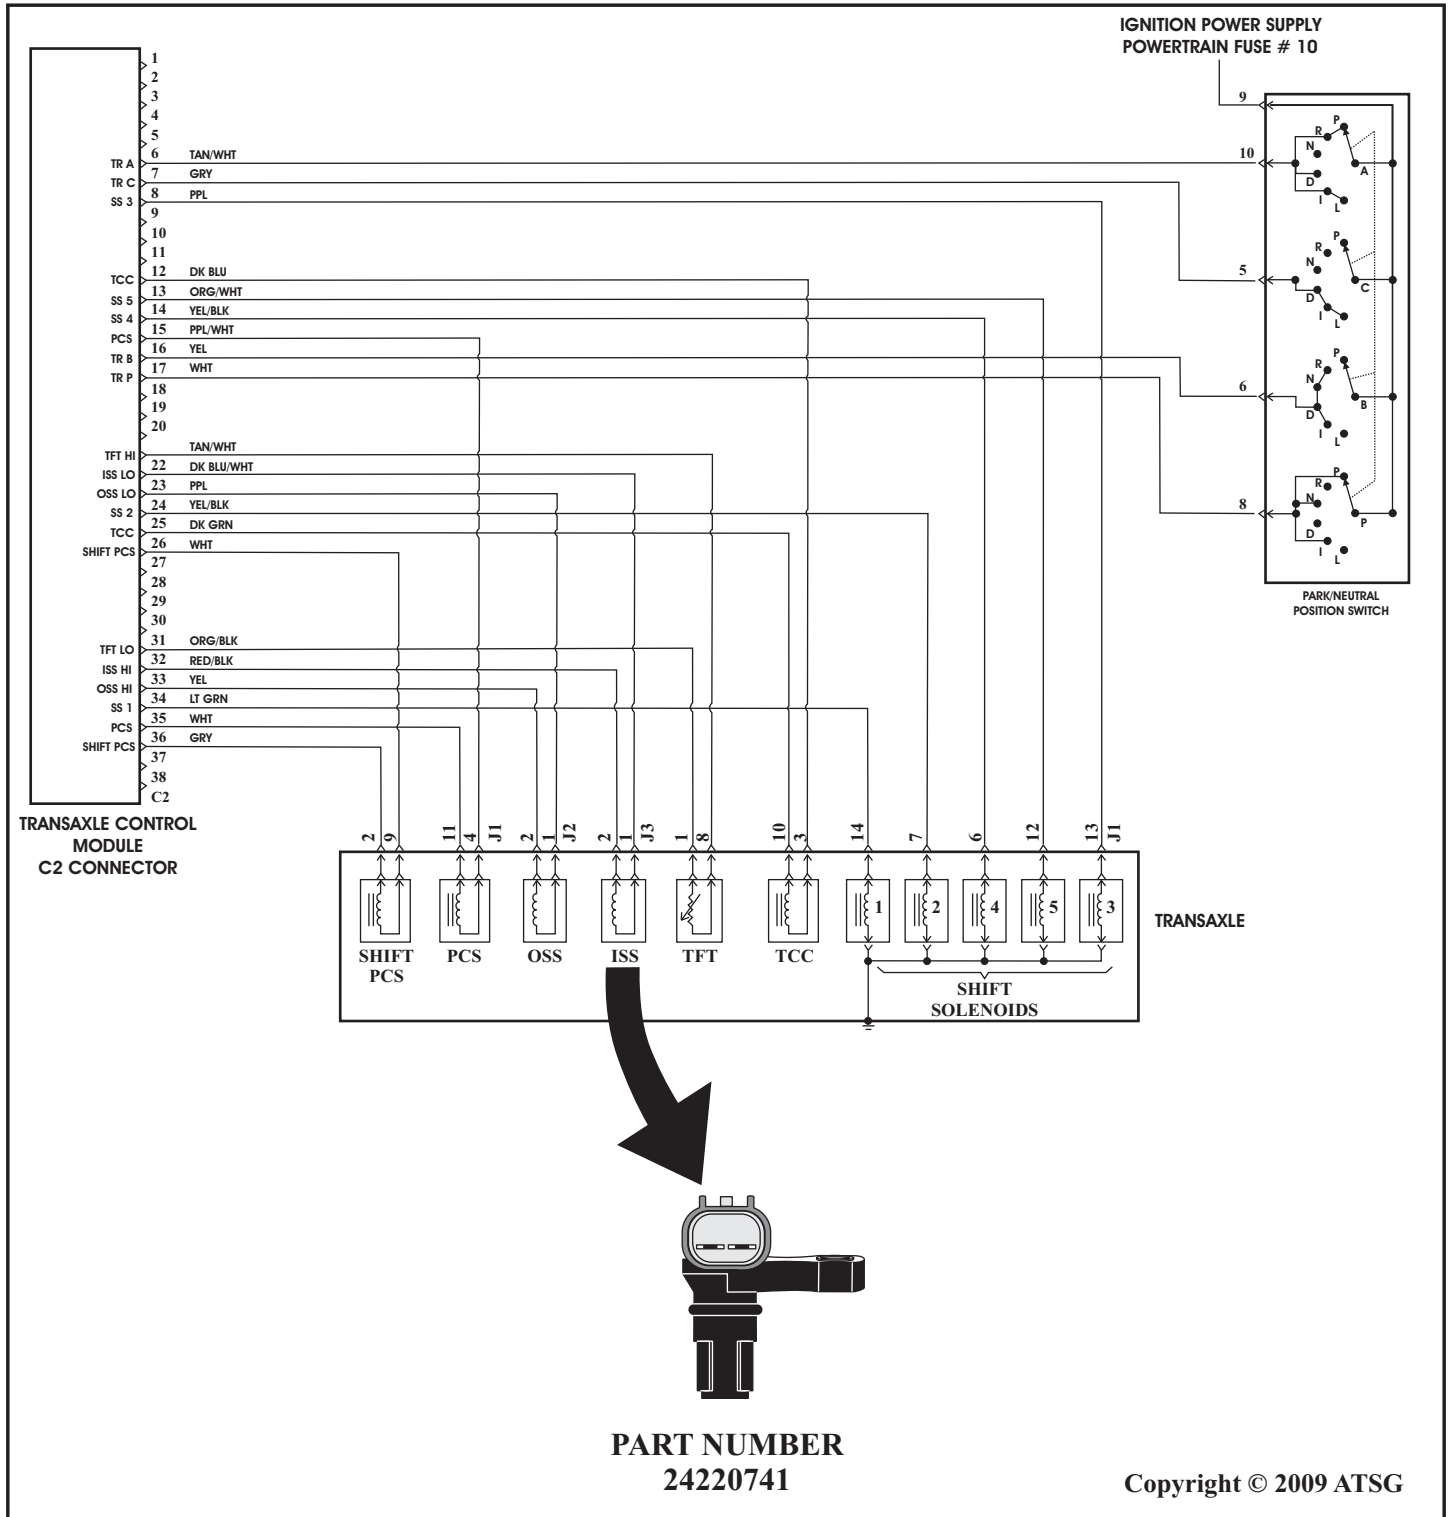
CAUSE: The Input Speed Sensor like the output speed sensor are two wire Hall Effect type sensors. They are supplied system voltage on the “ISS/OSS HI” circuit and then produce a toggled voltage signal on the “ISS/OSS LO” circuit, as seen in the electrical schematic in Figure 1 as well as TCM connector view and terminal assignment in Figure 2. The voltage signal is unique in as much as the low end of the signal is 0.6 volts, and the high end of the signal is 1.6 volts. This means that the actual switched voltage is one volt.

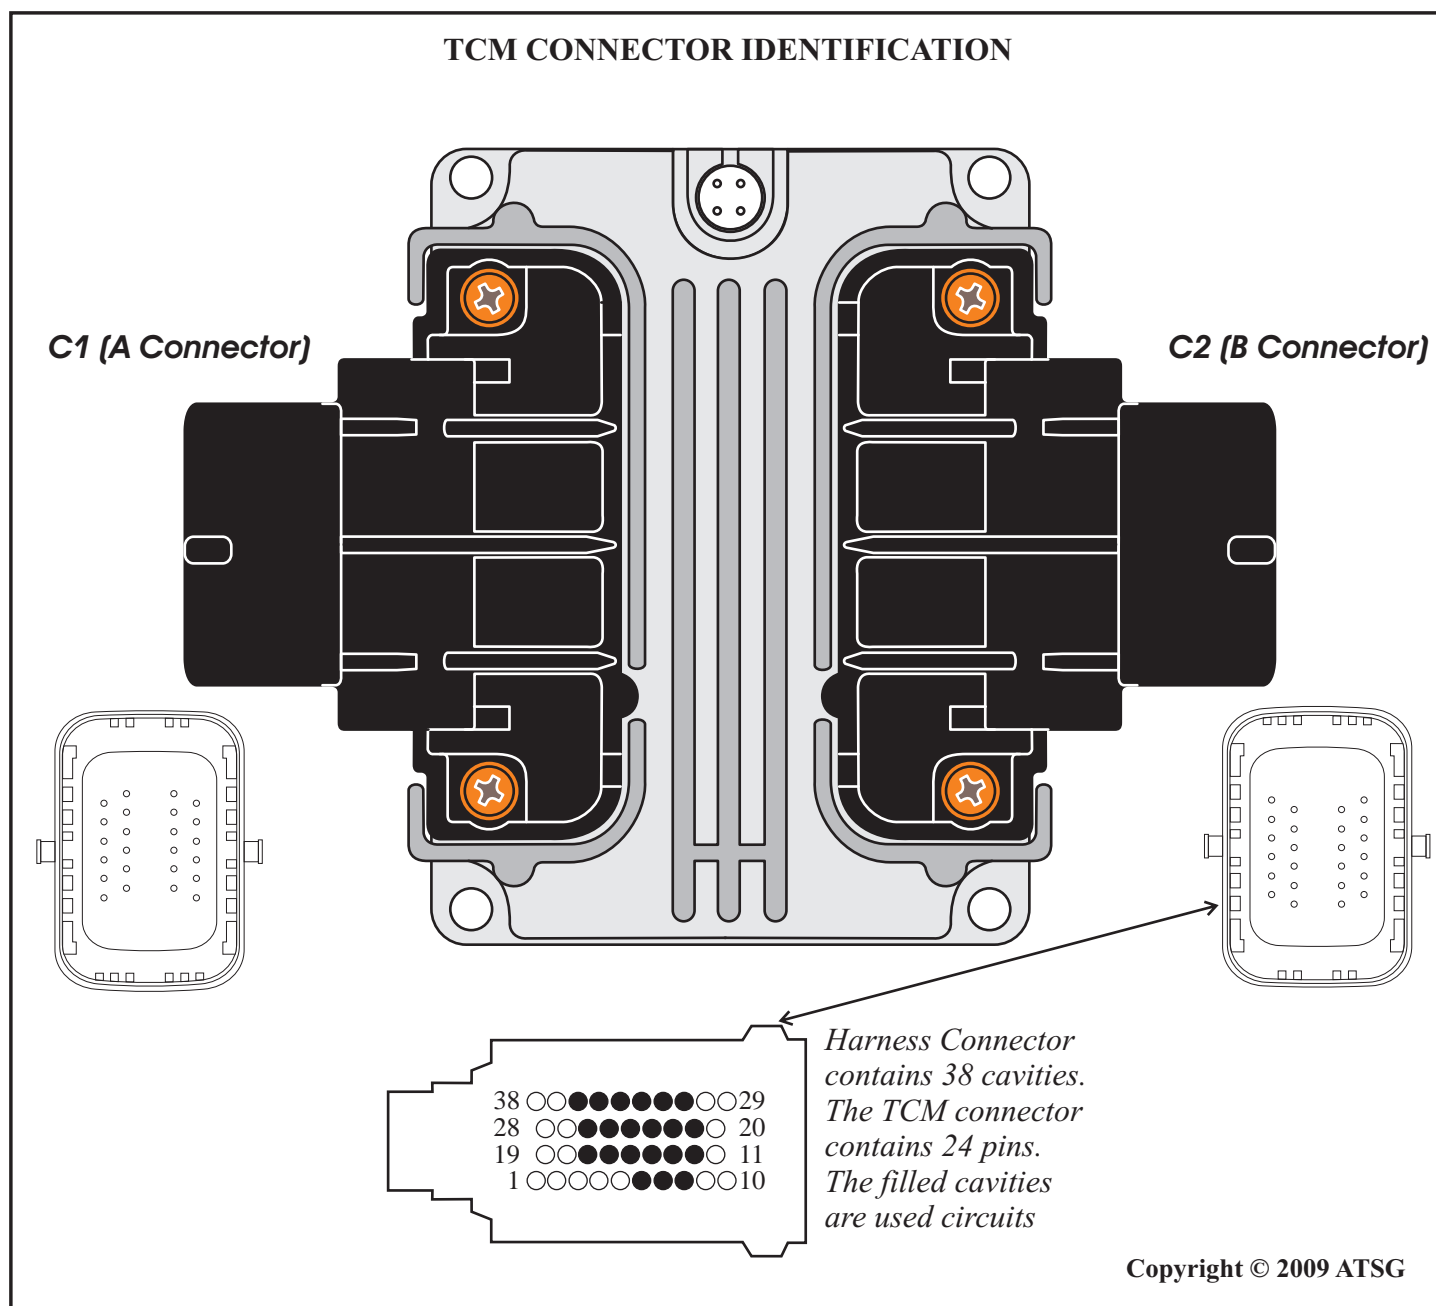
Figure 2

The scan tool displayed an engine rpm of 776, but the ISS parameter was zero. With the ignition on, engine off, the voltmeter indicated that the ISS signal wire had 7.6 volts on it while the OSS signal wire had 1.6 volts. This could only mean that the ISS signal wire was shorted to power or the sensor was bad. The ISS was unplugged and checked for voltage, there was none, this lead to a faulty ISS.

CORRECTION: Once the ISS was replaced, the signal readings were normal, the ISS rpm and engine rpm were close to each other.
