# Technical Service Information

## MAZDA G4A-HL NO 3-4 UPSHIFT

**COMPLAINT:** The transaxle does not make a shift into overdrive at any speed.

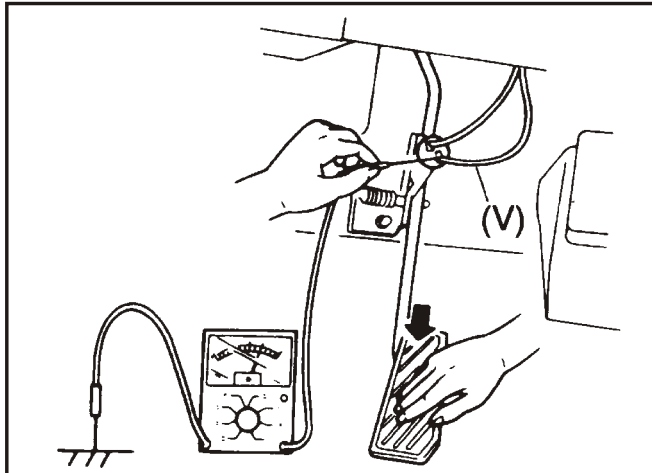
Figure 1

## KICKDOWN SWITCH Inspection of Terminal Voltage

1. Turn the ignition switch ON.
2. Check the voltage at terminal marked (V) with a volt meter.
3. Approximately 12 volts should be seen at 7/8 throttle to wide open throttle. From closed throttle to 7/8 throttle, less than 1.5 volts should be seen.
4. If not correct, check the wiring harness, switch, or adjust the switch position.

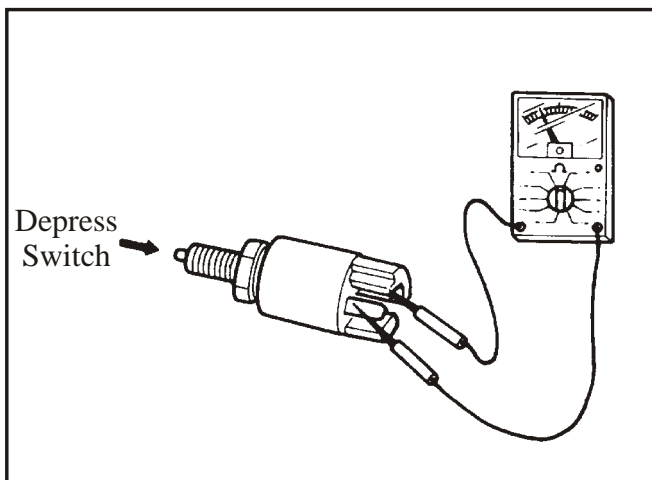
Figure 2

## KICKDOWN SWITCH Inspection of Continuity

1. Disconnect the kick-down switch connector.
2. Check for continuity of the switch with an ohmmeter.
3. With the switch pushed in, continuity should be seen. With the switch released, an open should be seen.
4. If not correct, replace the switch.

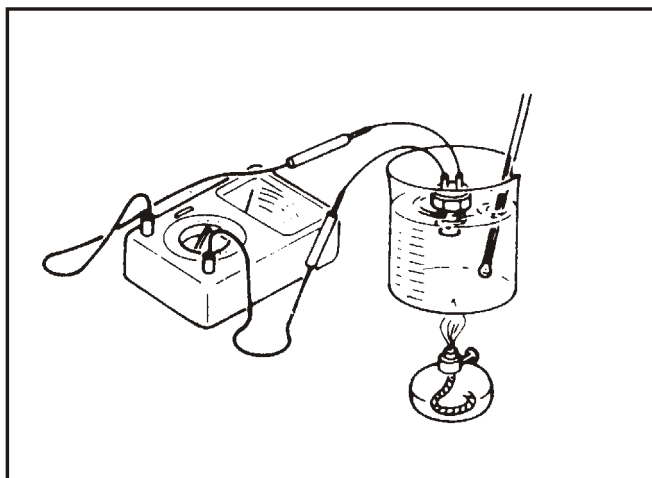
Figure 3

## WATER TEMPERATURE SWITCH Inspection

1. Remove the water temperature switch.
2. Place the switch in water with a thermometer and heat up the water gradually.
3. Check for continuity of the switch with an ohmmeter.
4. Continuity should be seen when the switch is 149°F or less. When the switch is 162°F or higher, an open should be seen.
5. If not correct, replace the switch.

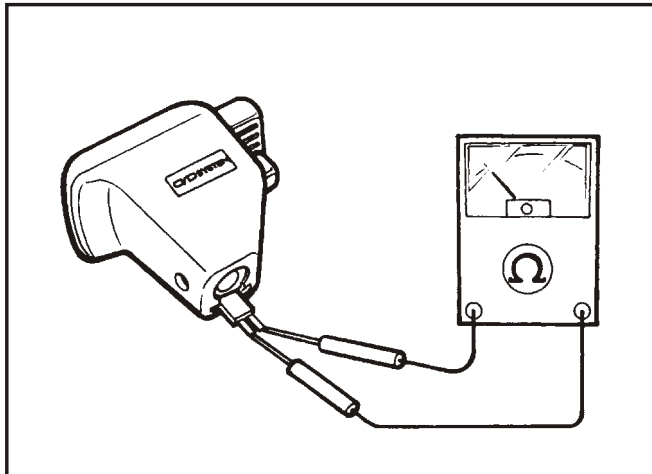
Figure 4

## OD CANCEL SWITCH Inspection of Continuity

1. Remove the selector lever knob.
2. Check the continuity of the terminals using an ohmmeter.
3. Continuity should be seen when the switch is released and an open should be seen when it is depressed.
4. If not correct, replace the switch.

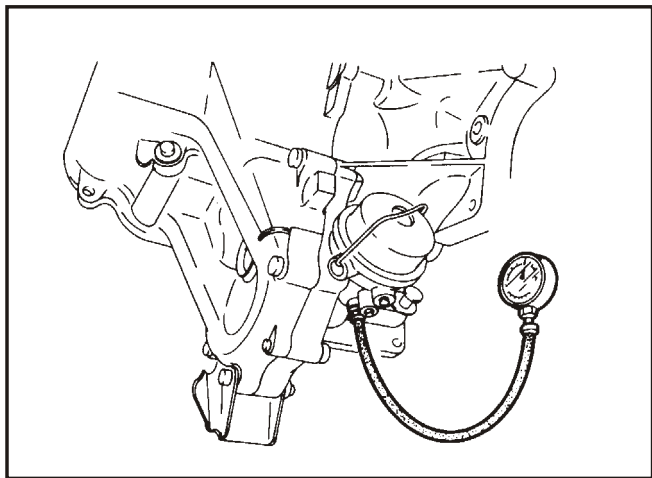
Figure 5

2. Place a pressure gauge on the governor pressure tap (See Figure 5). Drive the vehicle on the road or on the rack and view governor pressure. Governor pressure should be relatively close to road speed. If governor pressure is not correct, replace the governor. If changing the governor does not correct the condition, the governor pressure circuit will need to be investigated. If governor pressure is good, go to the next step.

## GOVERNOR PRESSURE TEST

1. Install a pressure gauge onto the governor pressure fitting.
2. Drive the vehicle on the road or on the rack and view governor pressure. Governor pressure should be relatively close to road speed..
3. If governor pressure is not correct, replace the governor.
4. If changing the governor does not correct the condition, the governor pressure circuit will need to be investigated.

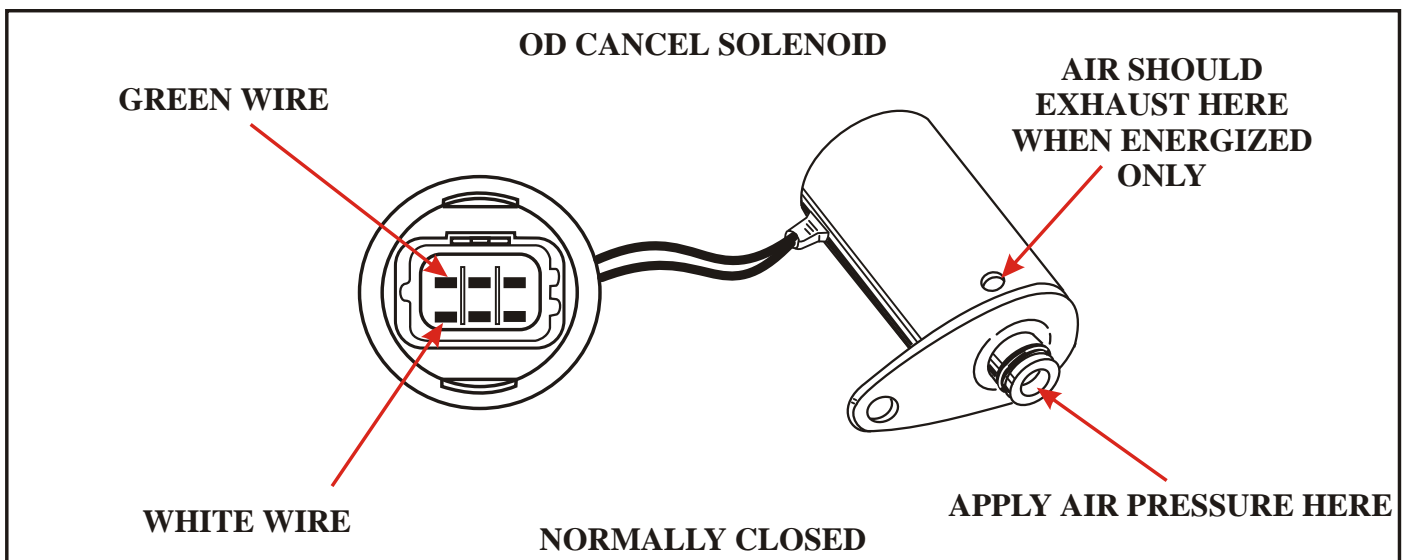
Figure 6

3. Remove the valve body and inspect the OD cancel solenoid with air (See Figure 6). This solenoid is a normally closed solenoid. When it is not energized, it blocks or holds pressure. When energized, it allows pressure to be vented away through the exhaust hole on the side of the solenoid. Replace the solenoid if necessary. If the solenoid checks good, go to the last step.

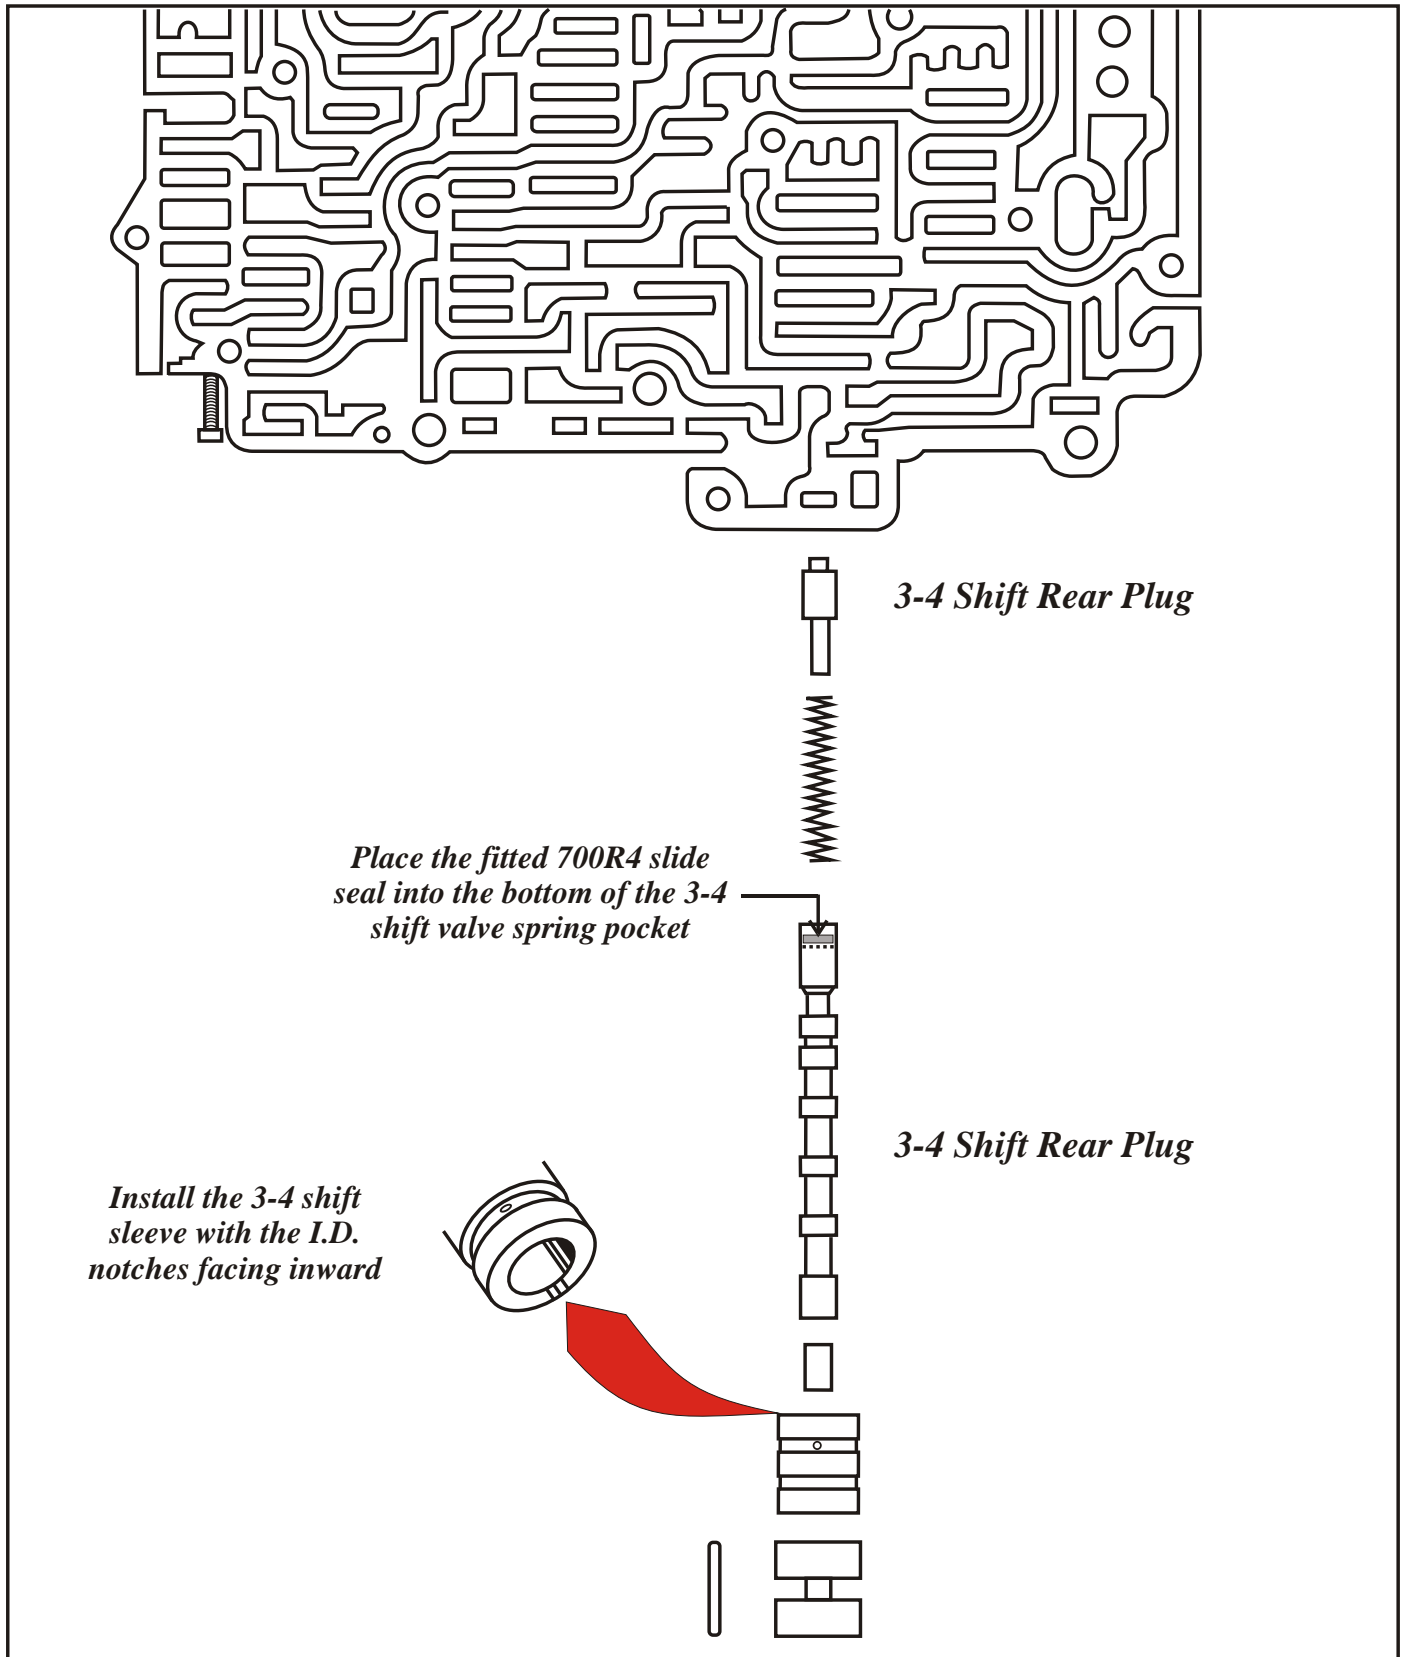
Figure 7

4. Locate the 3-4 shift valve line-up in the main valve body as shown in Figure 7. It is common for the 3-4 shift plug to over travel and get stuck in the bore. This prevents the 3-4 shift valve from fully stroking causing the no 3-4 shift complaint. To fix this concern, acquire a slide seal (**not the O ring**) from a 700R4 or 2004R pump. Cut a piece off that will fit into the 3-4 shift valve spring pocket as shown in Figure 7. This added shim which is approximately .093" thick will prevent the 3-4 shift plug from over traveling causing the no 3-4 shift complaint. Nor will it increase spring tension to cause a later 3-4 shift.

5. On assembly of the 3-4 shift valve, be sure to place the I.D. markings inwards on the 3-4 shift sleeve as shown in Figure 7.
