Technical Service Information

THM 3T40 (125C) TCC ENGAGEMENT

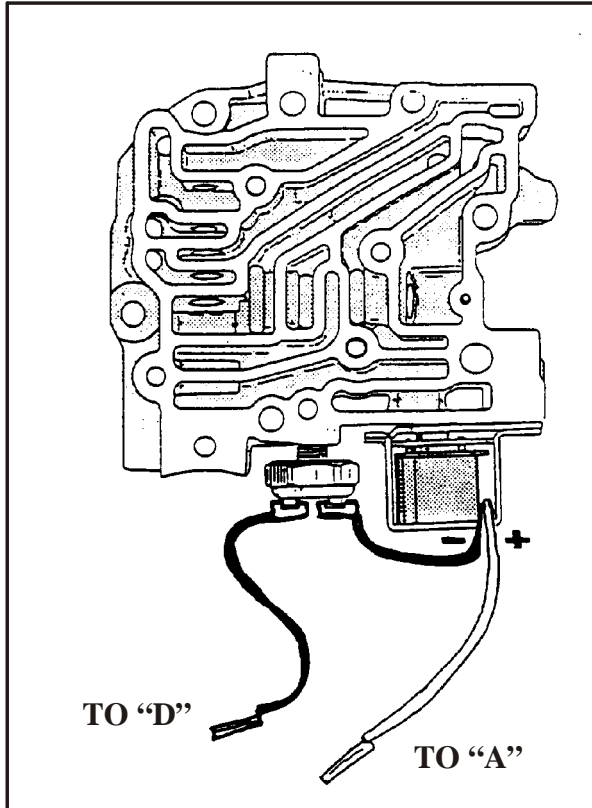
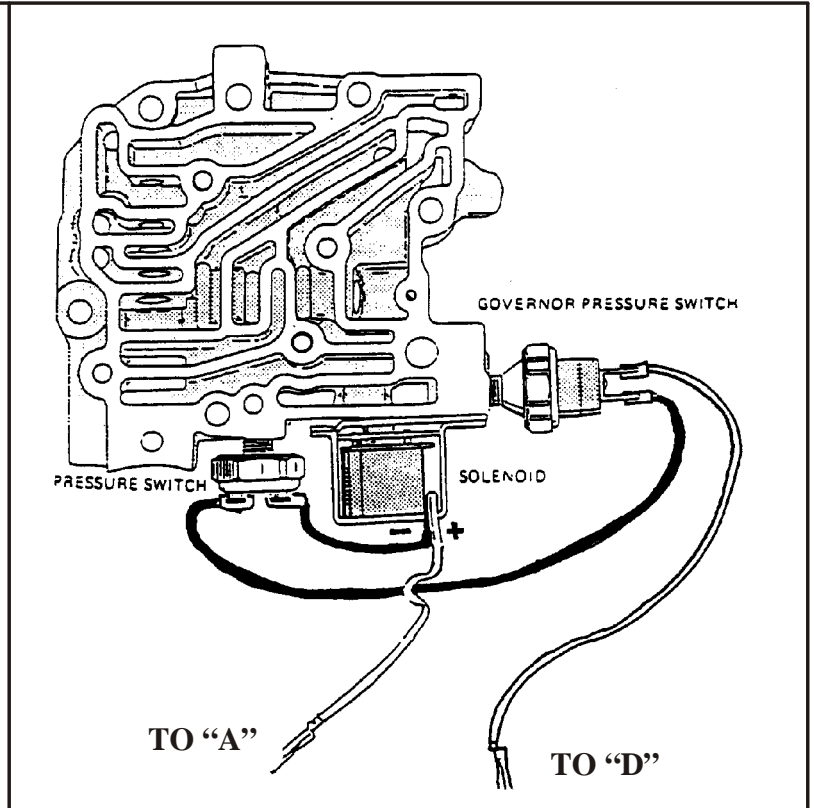
The vehicles that come equipped with the 3C system have a two wire connector. Figure 1 shows the internal connection in the transmission. The "A" lead is the plus or hot lead and the "D" lead is the ground signal sent to the transmission by the computer. Figure 2 shows the internal connections in the transmission with the vehicles, however the "D" lead DOES NOT have an external connection on the vehicles that have a Diesel engine or vehicles that are not equipped with the 3C system.
