Technical Service Information

ISUZU 4L30E

SOLENOID CODES STORED WITH FAILSAFE

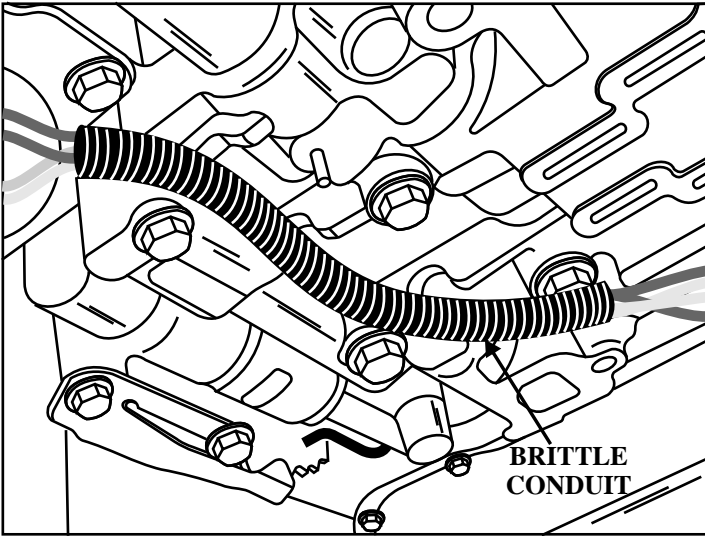
Figure 1

CAUSE: The internal wire harness in the main valve body area, where the filter is located, is encased in a plastic conduit which hardens over a period of time, (Refer to Figure 1).
When the filter is replaced, it can be pushed up against the wire harness, See Figure 2, causing the conduit to break up in sections. This can expose a wire splice in the internal harness causing it to come into contact with the valve body resulting in a short to power or ground, See Figure 3, causing the above complaints.
The type of failure that will occur depends on the year of the vehicle. 1990 to 1993 Isuzu vehicles were equipped with a Bosch TCM which controlled the solenoids on the power side. A short causes solenoid codes or a "Ground Control Relay fault, to store and a failsafe condition.
1994 and later vehicles are equipped with a Delco TCM which control the solenoids on the ground side. In addition to solenoid codes and failsafe, a short here will more than likely destroy the TCM because of a short to power.

CORRECTION: Verify the internal harness splice is covered with heat shrink or conduit that can be "zip tied" to the harness.
As a side note, this transmission is also in Cadillac Catera. The solenoids in these vehicles are controlled on the ground side. Therefore it is possible to have the same TCM failure and or a P1625 indicating a TCM fault. Note: there have been many instances that by unplugging the rear harness connector the P1625 code would go away which would indicate that the TCM may be functional after the short in the harness is covered.
