# "SIMPLE SOLUTIONS FOR '98"

## INTRODUCTION

***AUTOMATIC TRANSMISSION SERVICE GROUP***  
9200 S. DADELAND BLVD.  
SUITE 720  
MIAMI, FL 33156  
(305) 670-4161

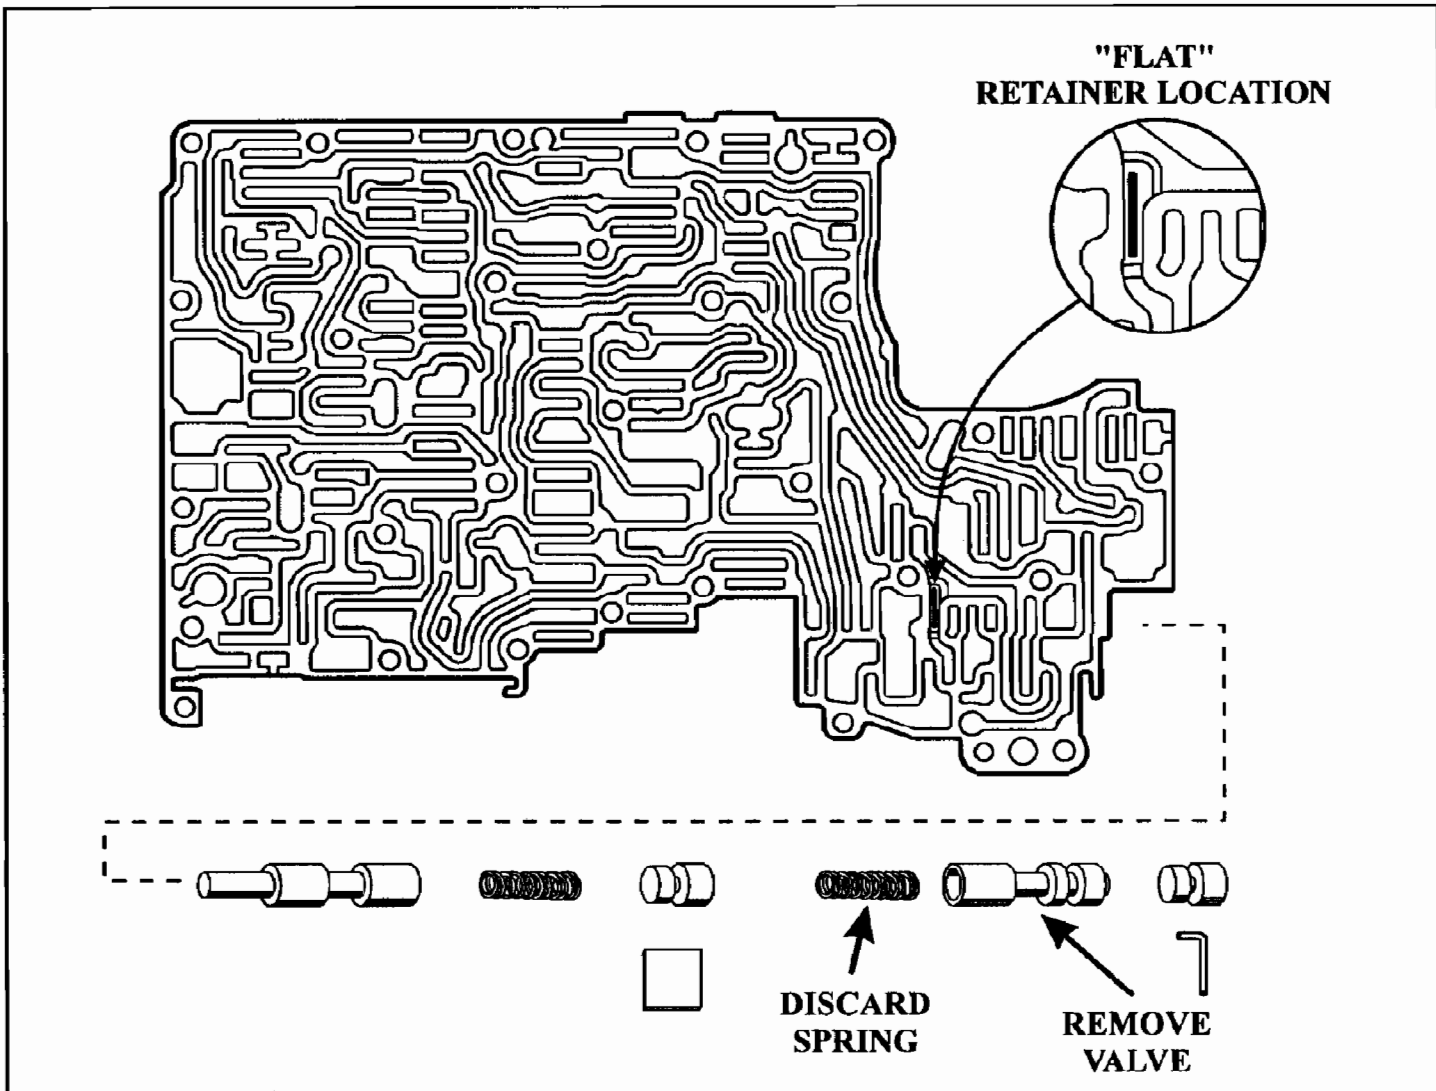
Figure 1

**COMPLAINT:** Before and/or after rebuild, the vehicle exhibits a delay to reverse, or possibly a no reverse at all condition, on later model vehicles equipped with the reverse engagement valve in the valve body.

**CAUSE:** The cause may be, a stuck or damaged reverse engagement valve.

**CORRECTION:** The reverse engagement valve can be bypassed entirely using the following procedure:

- (1) Remove the "L" shaped retainer, bore plug, reverse engagement control valve and reverse engagement control valve spring (See Figure 1).
- (2) Discard the reverse engagement control valve spring (See Figure 1).
- (3) Ensure that the "Flat" retainer and bore plug are installed in their proper positions, as shown in the inset in Figure 1.
- (4) Install 1/4" steel checkball against the bore plug (See Figure 2).
- (5) Reinstall the reverse engagement control valve **backwards** as shown in Figure 2, against the steel checkball.
- (6) Install AXOD checkball against the reverse engagement control valve, as shown in Figure 2.
- (7) Reinstall the bore plug and "L" shaped retainer (See Figure 2).
- (8) Grind the tip of the reverse engagement control valve as necessary to get the bore plug and the "L" shaped retainer installed correctly (See Figure 3).

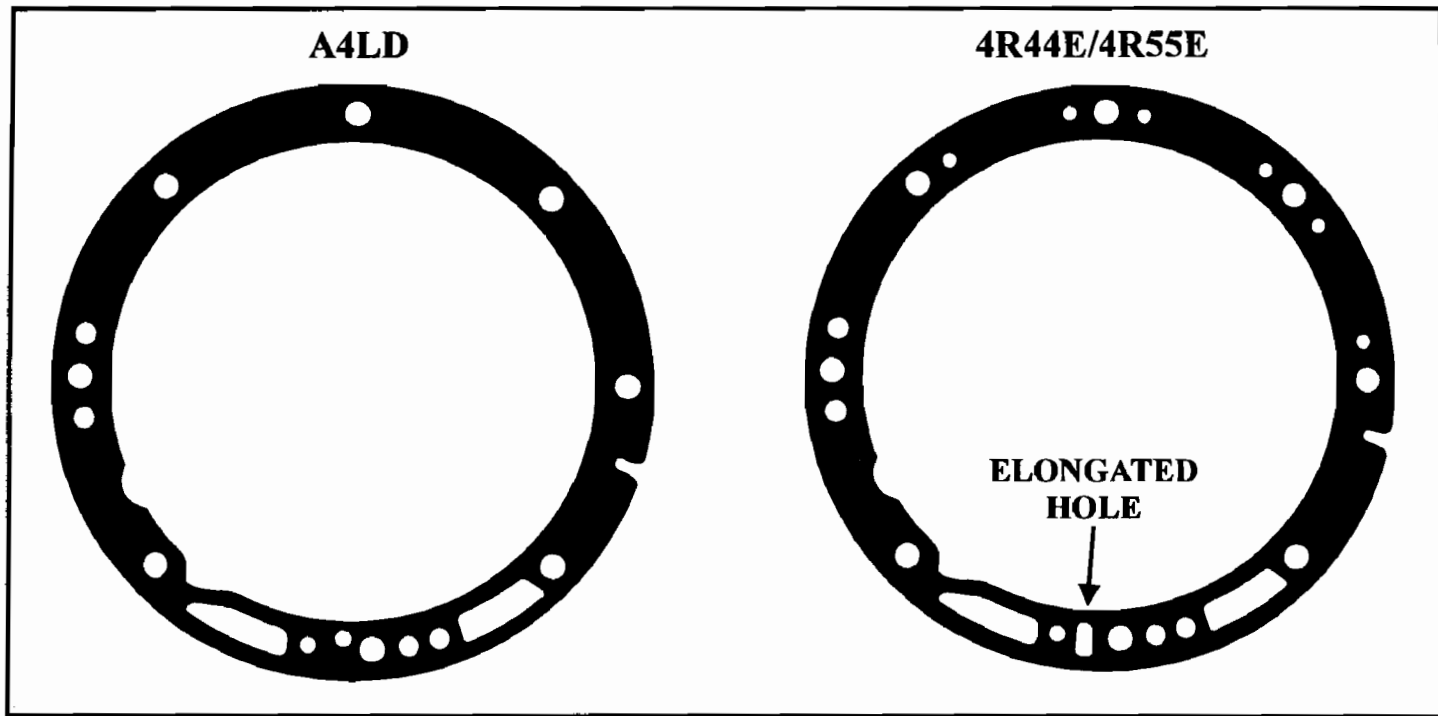
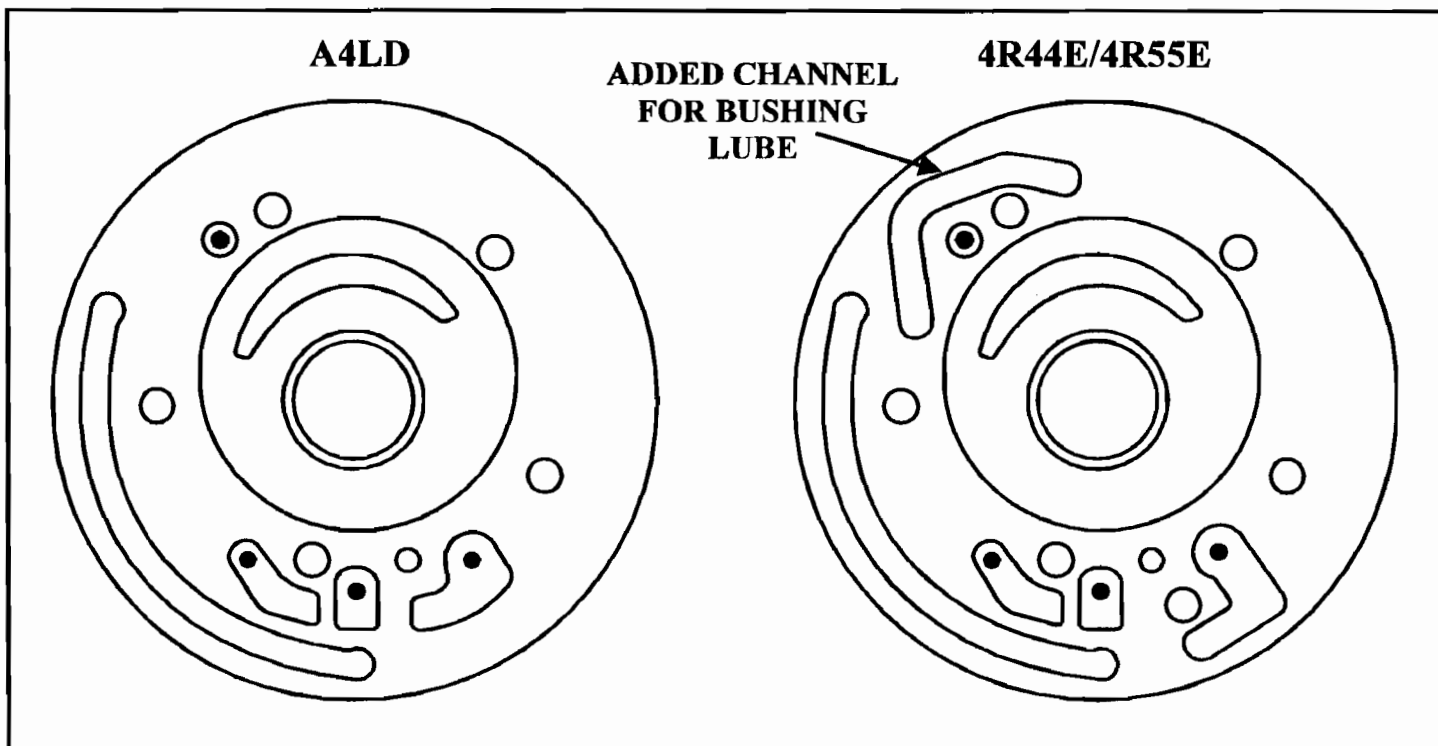
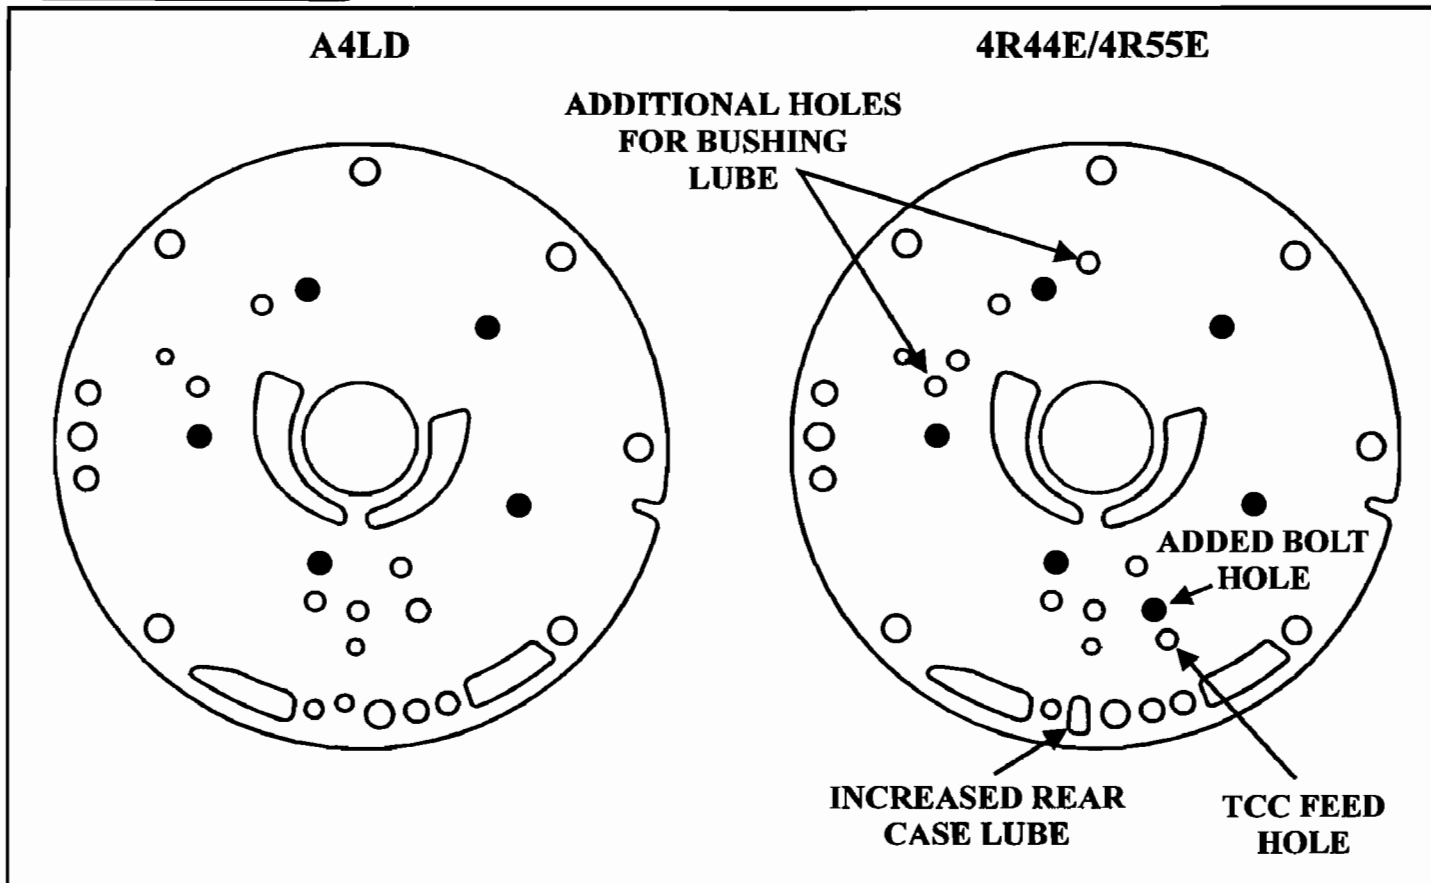
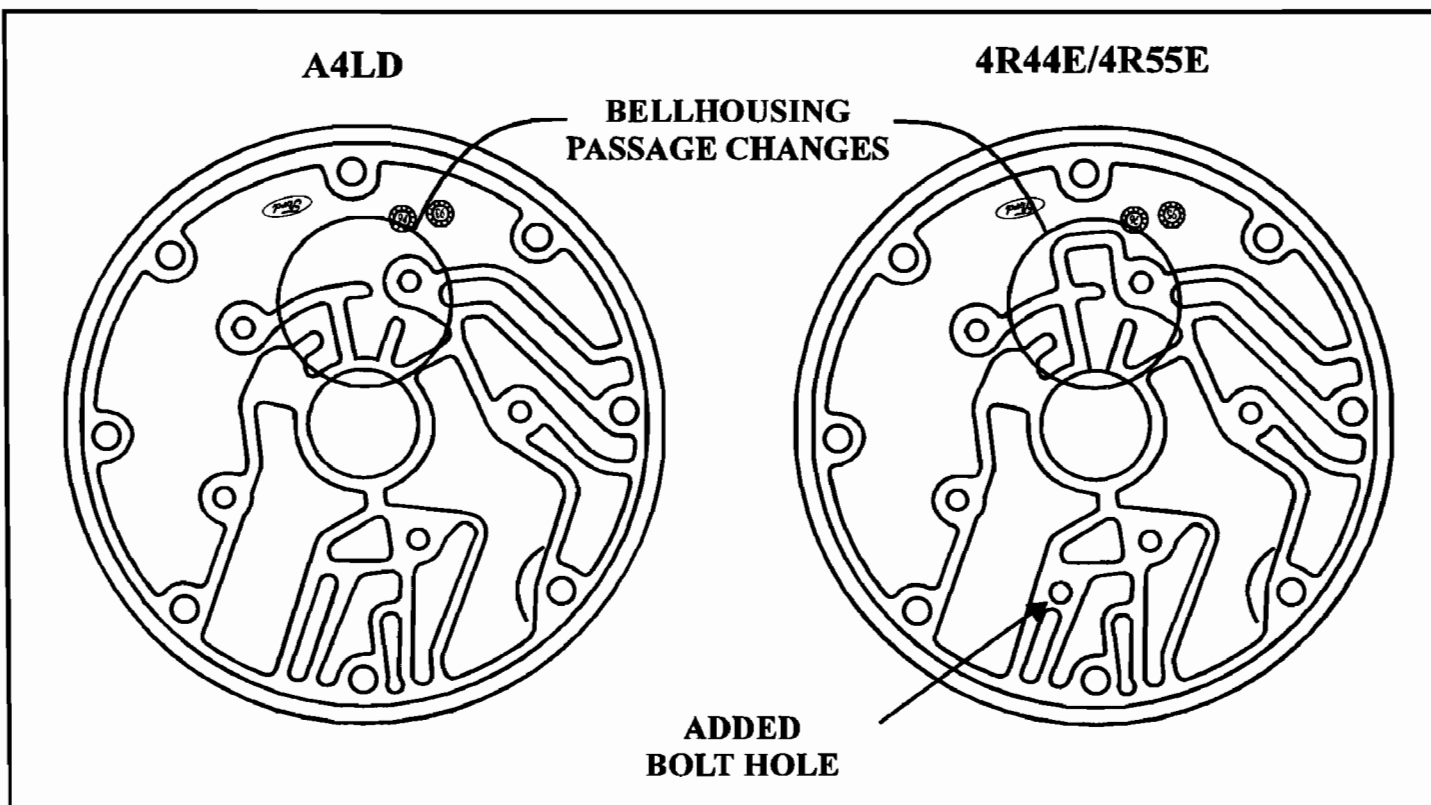
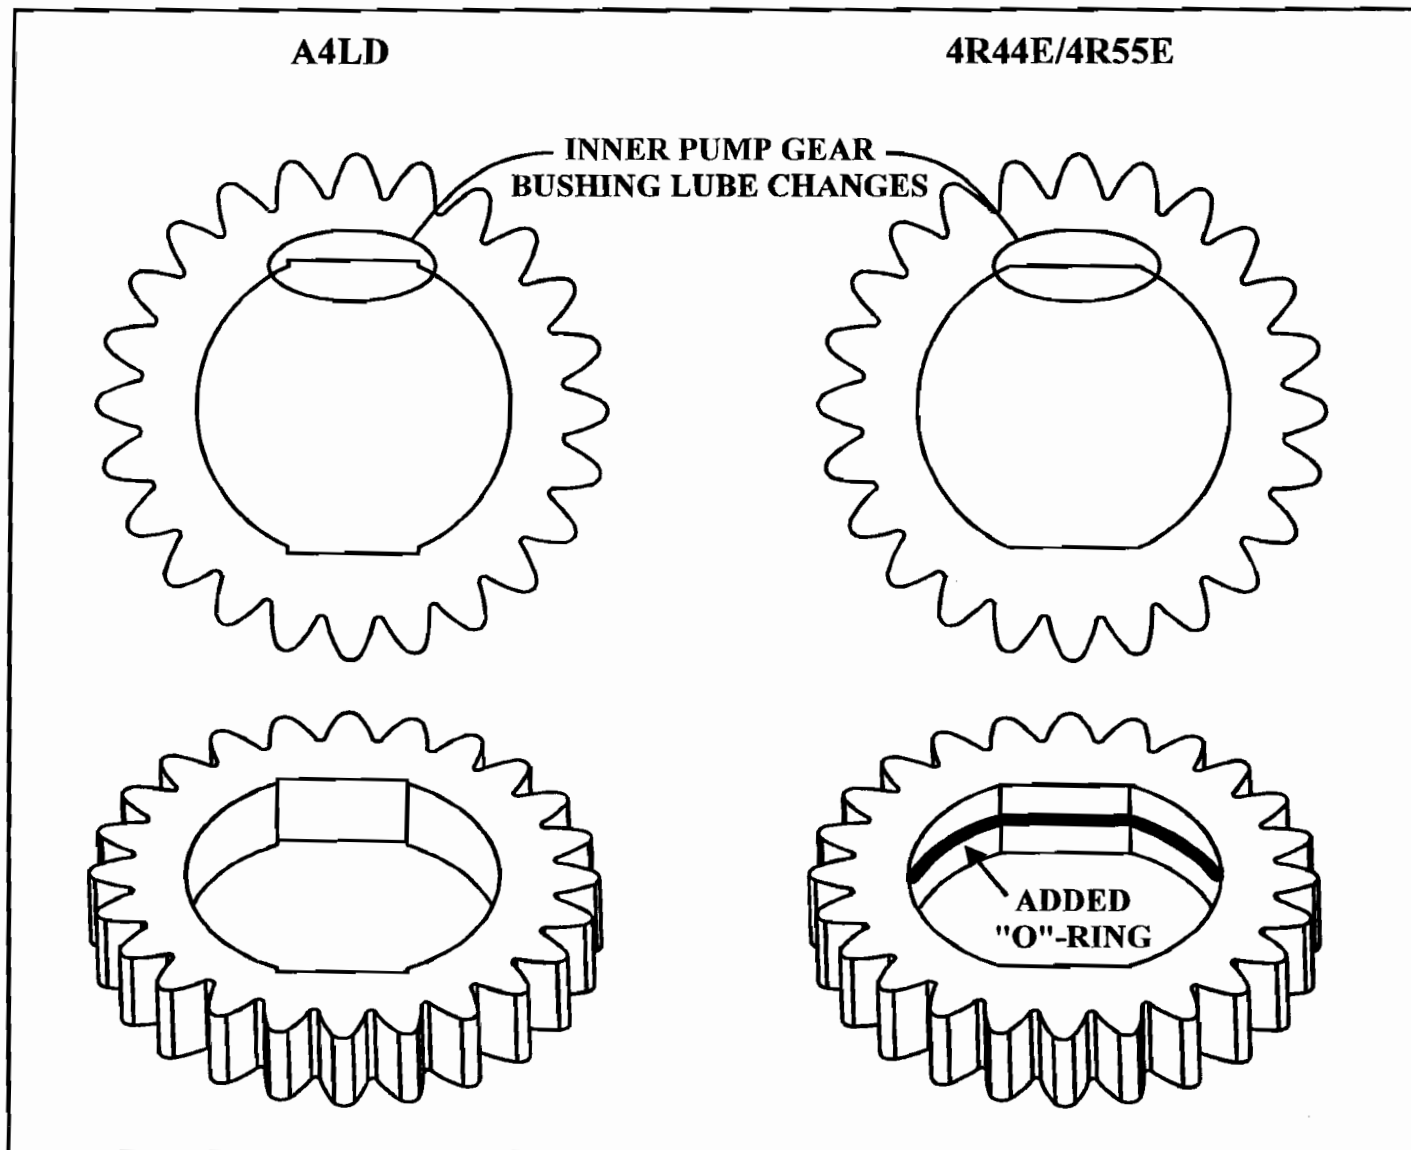
**COMPLAINT:** Premature transmission failure due to lack of lubrication and/or no cooler flow until the converter clutch is applied.

**CAUSE:** The cause may be, a mis-match of A4LD and 4R44E/4R55E bellhousing/oil pump components. The 4R44E/4R55E transmission no longer lubricates the converter hub bushing through the inner pump gear. The 4R44E/4R55E bellhousing, oil pump, oil pump plate, inner pump gear, and pump to case gasket were redesigned to improve converter hub bushing and rear case lubrication. Listed below are the parts that changed on the 4R44E/4R55E components, and how to identify them.

**CORRECTION:** During rebuild, if any oil pump/bellhousing components are damaged and require replacement, you must verify that the proper components are being used.

**Special Note:** The 4R44E/4R55E pump and bell housing components can be used on the A4LD transmission, *when all parts listed above are used as a package*. It is not recommended to install A4LD parts onto a 4R44E/4R55E transmission. Refer to Figures 1 through 5.

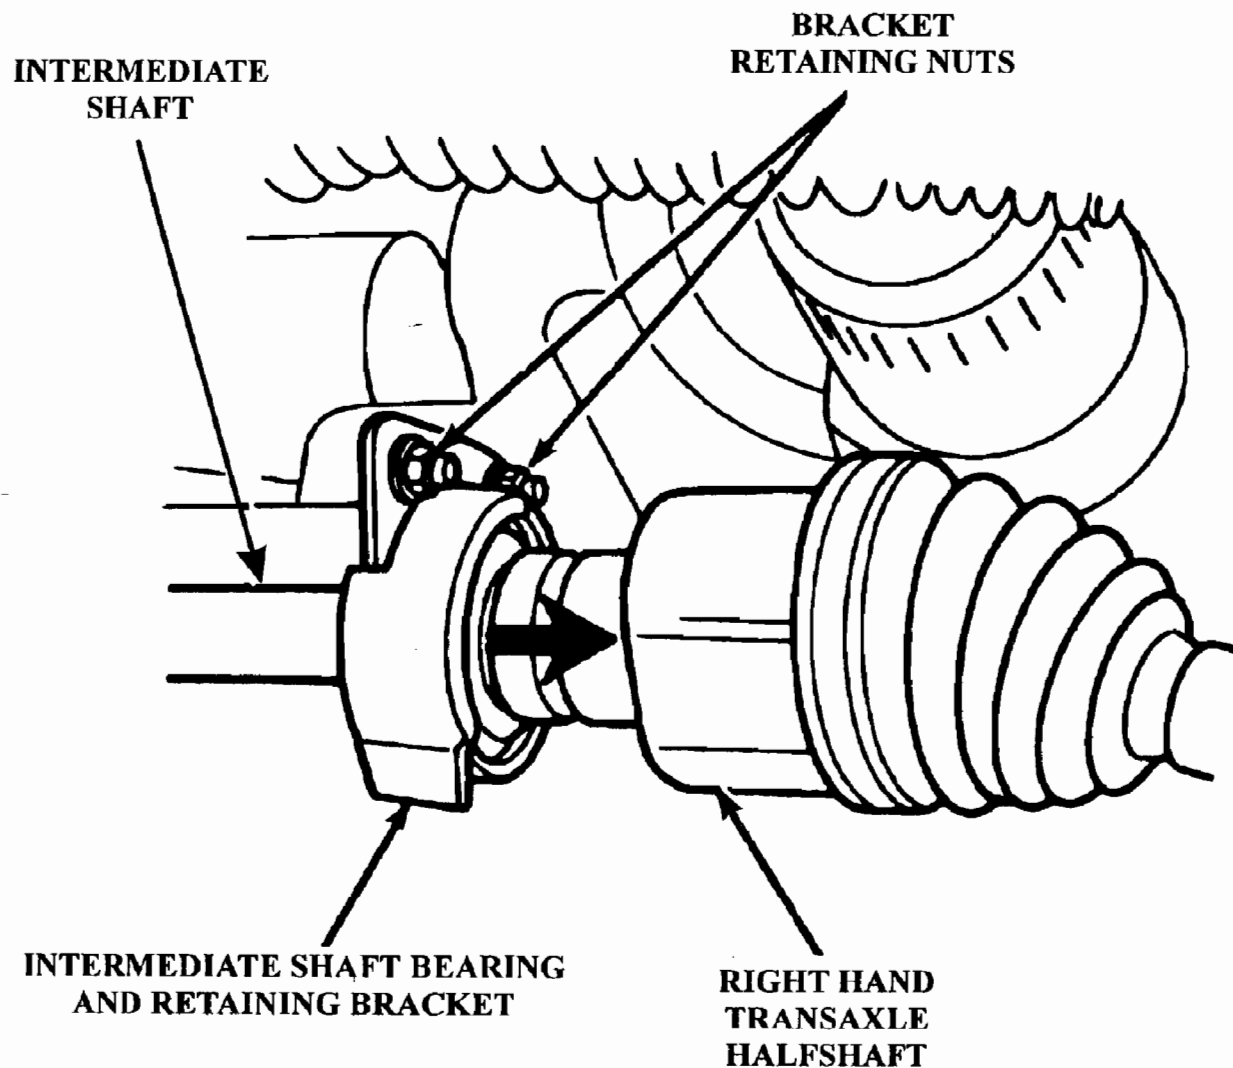
Figure 1

**COMPLAINT:** After overhaul, vehicle exhibits a leak from the right hand differential seal, noise or vibration concerns, or engine oil filter damage and subsequent engine issues.

**CAUSE:** The cause may be, inadvertently using the wrong set of mounting holes when remounting the intermediate shaft bearing and bracket assembly. For location refer to Figure 1. The original 1st design style of intermediate shaft bracket had two sets of mounting holes, one for CD4E applications, and the other set for MTX-75 (Standard Shift) applications, as shown in Figure 2.

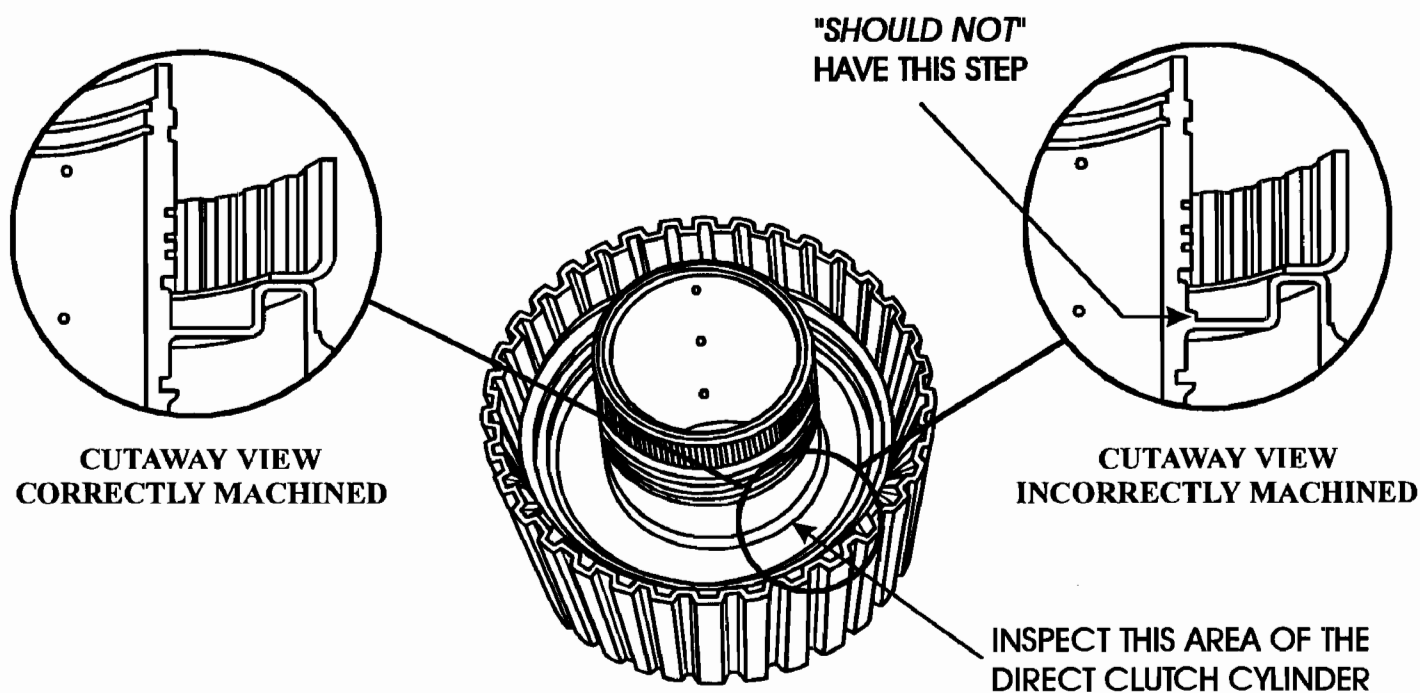
Figure 1

**COMPLAINT:** Before and/or after overhaul, the vehicle exhibits a flare or slipping condition on the 2-3 shift, or a no 2-3 shift at all, on some 96-97 Taurus, 96-97 Sable, 96-97 Windstars.

**CAUSE:** The cause may be, a mis-machined direct/intermediate clutch cylinder, as shown in Figure 1, or the direct clutch steel plates binding in the clutch cylinder due to cylinder being out of round.

**CORRECTION:** Inspect the direct clutch cylinder hub machining in the area shown in Figure 1, and replace clutch cylinder as necessary. Check for free movement of the steel clutch plates in the direct clutch cylinder by installing and removing the plates, and turning the plates 2-3 splines each time. Replace direct clutch cylinder as necessary. Also the 3 tabs on the servo spring retainer must fit on the outside edge of the spring as shown in Figure 2. Replace the servo spring retainer if it is bent or damaged from an incorrect installation.

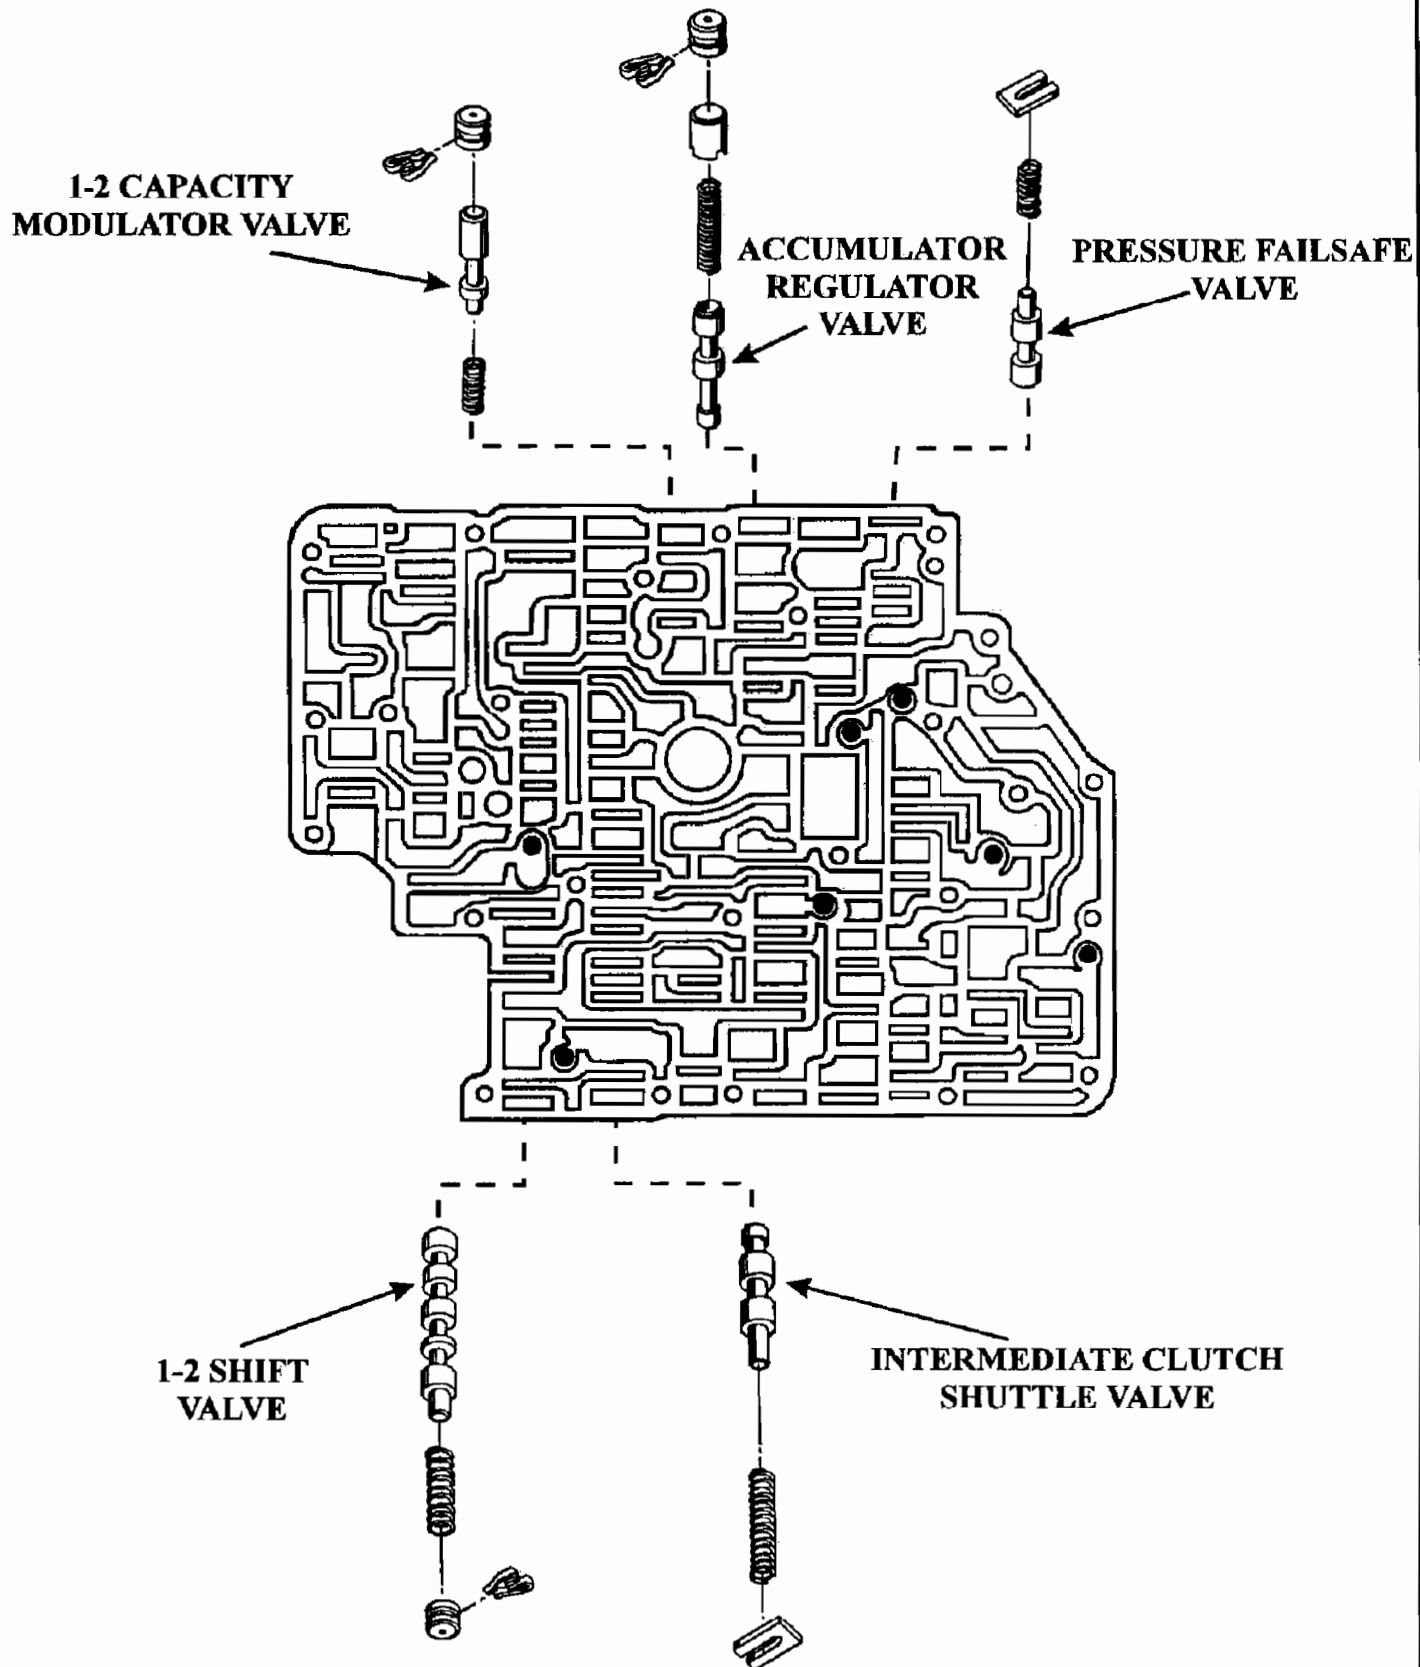
Figure 1

**CAUSE:** The cause may be, one or more of the following valves may be sticking:

- 1-2 Shift valve
- Intermediate Clutch Shuttle Valve
- 1-2 Capacity Modulator Valve
- Accumulator Regulator Valve
- Pressure Failsafe Valve

**CORRECTION:** Locate the the valve or valves in question shown in Figure 1. Remove them from the valve body and inspect the valve for scratches or scoring. Inspect the valve bore for scratches or scoring. Install the valve back into its bore without the spring and ensure that each valve falls in and out of its bore on its own weight. If the valve will not fall on its own weight it may be necessary to clean or polish the bore in the valve body. ***Do not polish the valve it may make the problem even worse.*** If the valve or valve bore shows heavy scratches or scoring, valve body replacement may be necessary.

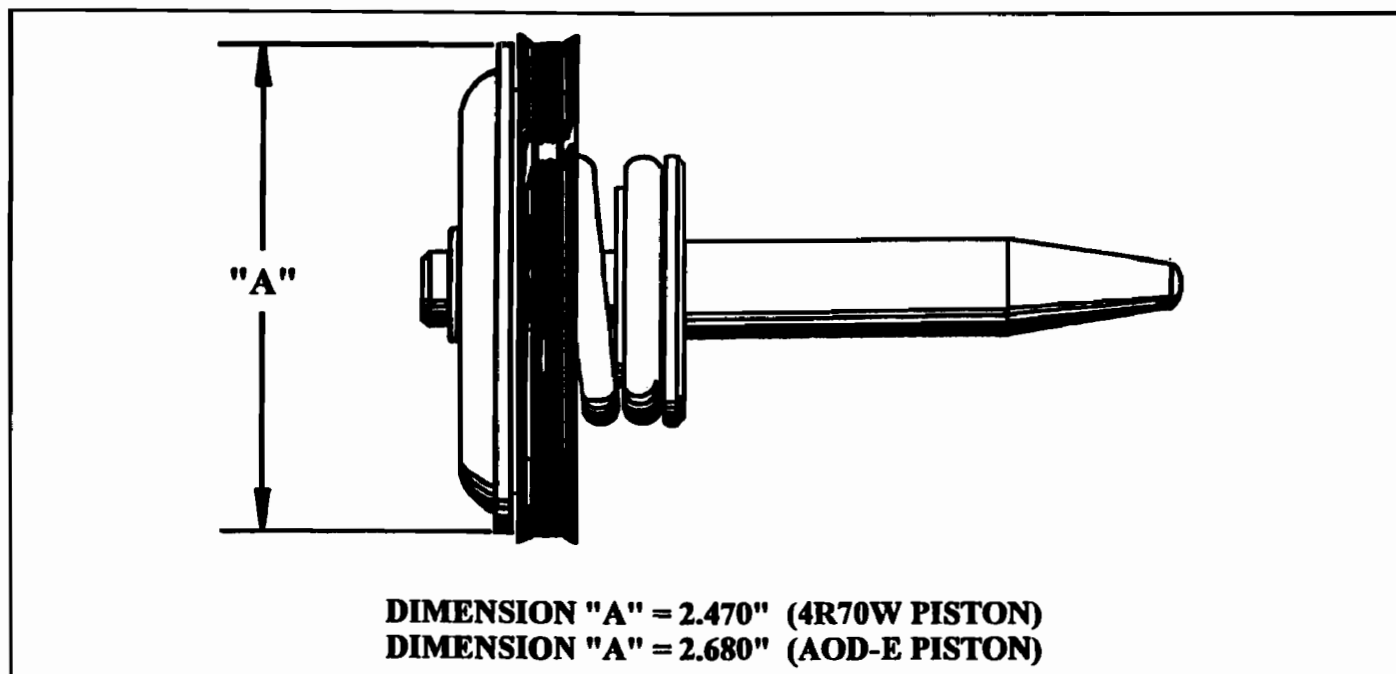
Figure 5

**COMPLAINT:** After overhaul, the 4R70W transmission displays a 3-neutral upshift, and upon disassembly you find the forward clutches burnt.

**CAUSE:** The cause may be a mis-assembled Overdrive Servo Assembly, with the "Rubber Coated Sleeve" omitted. The 4R70W transmission is calibrated with a smaller diameter overdrive servo piston than is the AOD-E transmission. To retain a common case between the two transmissions, an additional "Rubber Coated Sleeve" is required on the 4R70W Overdrive Servo Assembly, as shown in Figure 6.

**CORRECTION:** Install the "Rubber Coated Sleeve" in the Overdrive Servo Assembly, as shown in Figure 6. If your rubber coated sleeve is missing or lost, you **MUST** buy the complete Overdrive Servo Assembly, available under OEM part number F3LY-7H188-A. It is not available individually. Overdrive servo piston dimensions are shown in Figure 5, to identify the two different overdrive pistons.
