# TRANSMISSION SEMINAR 1991

## TRANSMISSION SEMINAR

# 1991

*This years seminar brings the latest information on transmission changes and complaints to you the field technicians in both a video and slide format along with this printed back-up material to help you in the shop. We cover the most often asked questions on the Mitsubishi, Honda, and Toyota transmissions coming in our hot line. This information will help you when the same type problems arise on the vehicles coming into your shop. We have put together information on the Ford E4OD transmission along with other Ford units with tech hints that will speed up the process when you go through the rebuilding procedure. The Chrysler overdrive units both the A-500/518 and the A-604 units are starting to appear in our shops, both under factory warranty and customer pay. We have listed many of the parts changes and updates that will be facing you during repairs.*

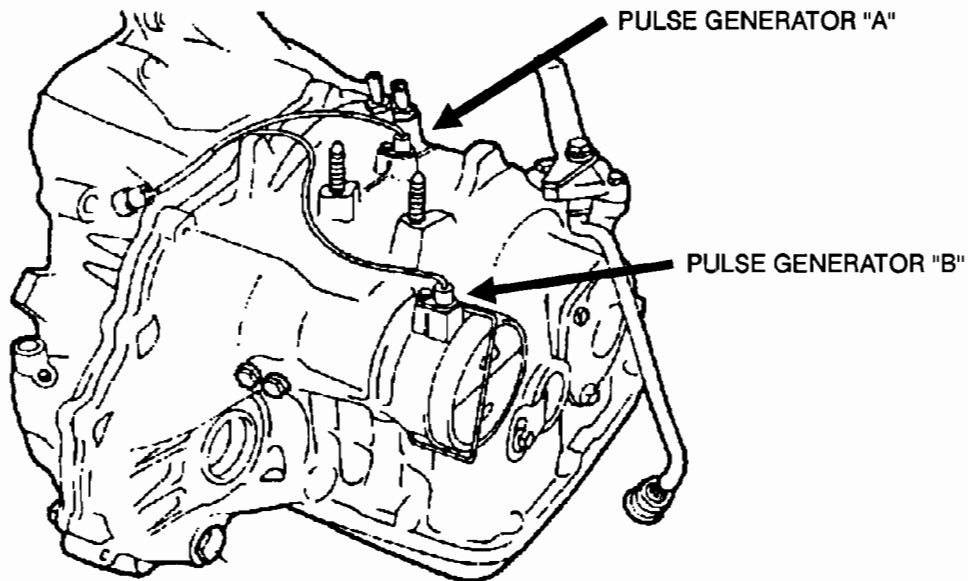
## MITSUBISHI KM-175

- COMPLAINT: LOCKED IN FAIL SAFE MODE SHOWING CODE 3 PULSE GENERATOR "B". CAN BE INTERMITTENT.
- CAUSE: FLUCTUATING OHMS READING, SOME AS HIGH AS 3000 OHMS. PAY PARTICULAR ATTENTION TO PULSE GENERATORS NUMBERED 8201 TO 8619.
- CORRECTION: REPLACED **BOTH** PULSE GENERATORS.

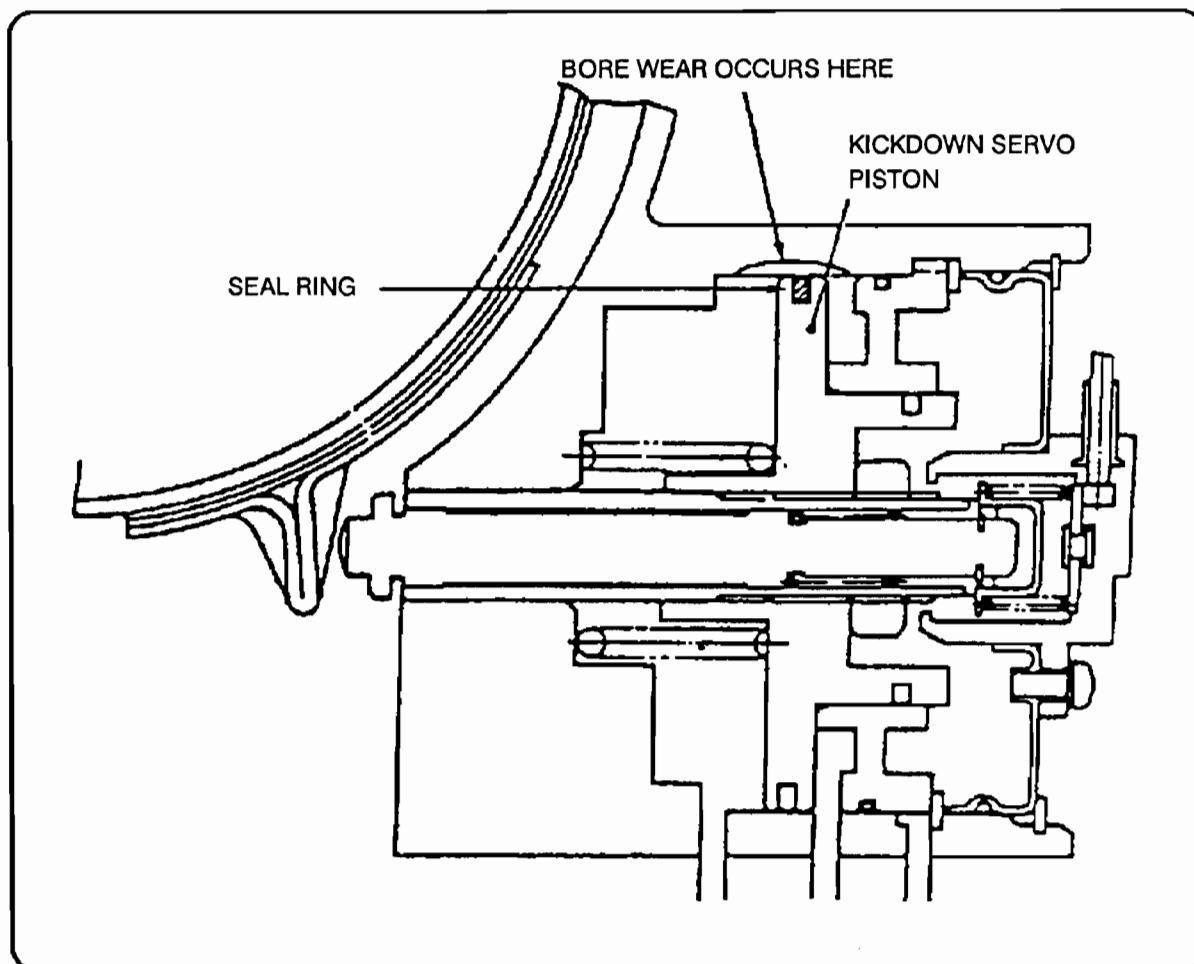
Figure 1

The KM 175 Automatic Transaxle in 1985-1987 Galant vehicles may exhibit one or more of the following hard shift symptoms.

- Harsh or hard 2-3 upshifts and/or 4-3 downshifts
- Harsh or hard 1-2 upshifts and/or 2-3 slipshifts.

These symptoms may be due to the kickdown servo piston not releasing properly. This is caused by hydraulic fluid leaking past the seal rings of the servo piston as a result of wear in the piston bore (figure 1). Because wear of the piston bore varies between vehicles, the severity of the symptoms will also vary.

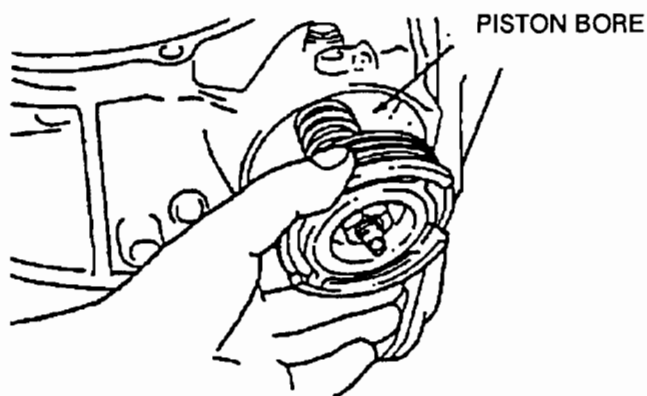
Figure 2

If hard shifts are still exhibited, remove the servo piston assembly from the transaxle and check the piston bore for wear (figure 2). If the bore wear is less than .023 in. the hard shift symptoms can be improved by installing a D-RING repair kit (P/N MD728-665). This kit contains a rubber piston seal ring instead of the carbon material seal ring installed at the factory (figure 3).

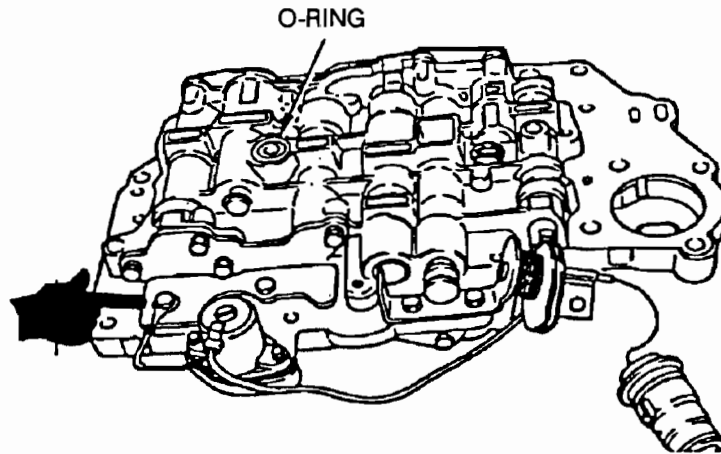
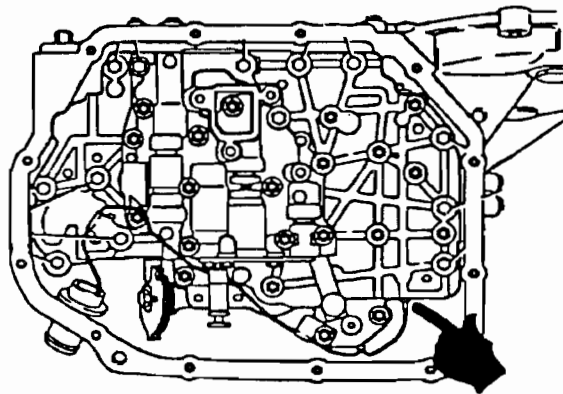
CAUSE: THE CAUSE MAY BE LOOSE GROUND WIRE TO VALVE BODY, OR LOOSE SOLENOID BOLTS.

CORRECTION: INSURE TIGHT CONNECTION OF GROUND WIRE FROM SOLENOID AND SOLENOID BOLTS ARE TIGHTENED PROPERLY.

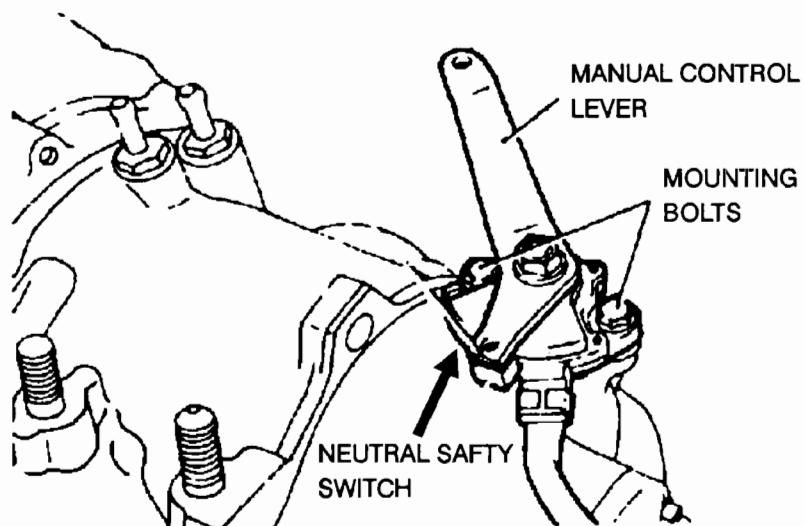
## MITSUBISHI KM-171

CAUSE: FAULTY OR WATER CONTAMINATED NEUTRAL SAFETY SWITCH.

CORRECTION: IN MOST CASES INHIBITOR SWITCH IS REPAIRABLE OTHERWISE, REPLACE THE SWITCH.

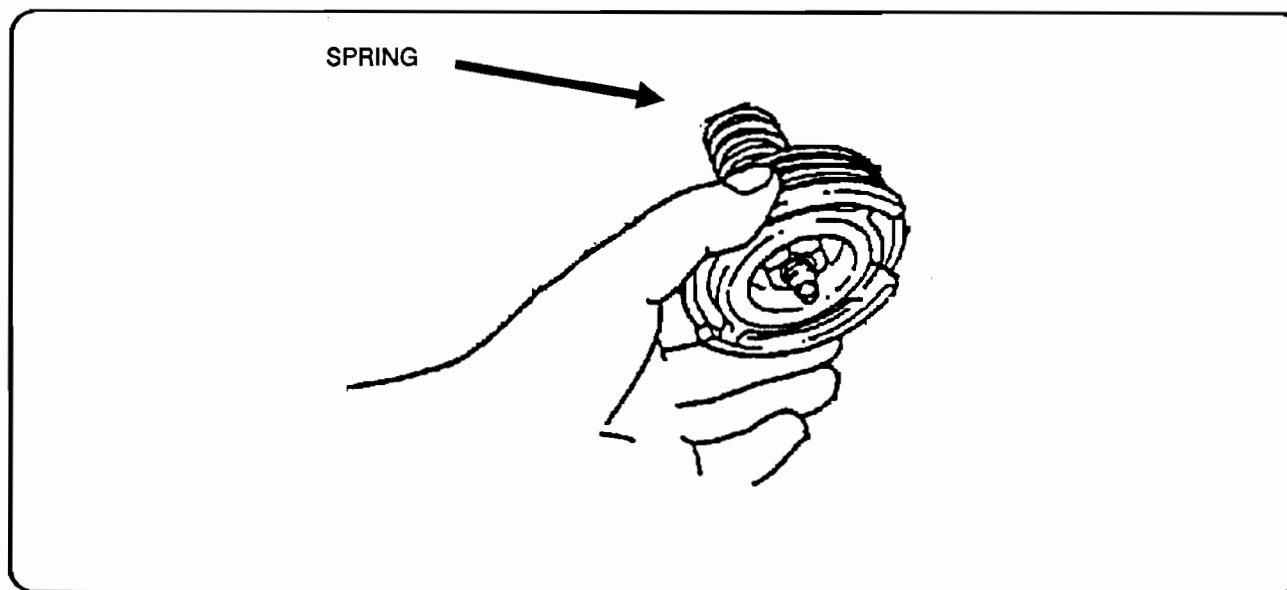
## MITSUBISHI KM-175

COMPLAINT:      SOFT OR DRAWN OUT 1-2 & 2-3 SHIFT.

CAUSE:            ORIGINAL SERVO SPRING TOO STRONG.

CORRECTION      OBTAIN ORIGINAL F3A JATCO SERVO SPRING. CUT IT DOWN TO EXACTLY THE SAME HEIGHT AS THE KM-175 SPRING, FIT NEW SERVO SEALS AND REASSEMBLE.  
TO ADJUST THE BAND CORRECTLY:  
TORQUE TO 7.5 ft. lb., BACK OFF TO ZERO, REPEAT, THEN TORQUE TO 3.5 ft. lb. AND BACK OFF 2 TURNS.

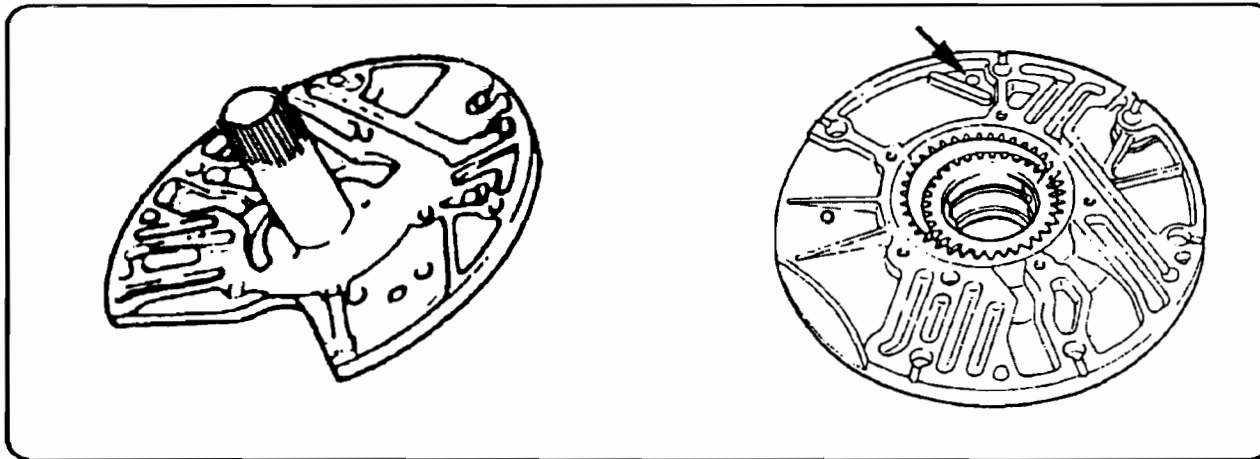
PUMP STATOR WITH HOLE MUST GO WITH PUMP BODY WITHOUT CORRESPONDING BREATHER HOLE.

PUMP STATOR WITHOUT HOLE MUST GO WITH PUMP BODY WITH HOLE.

MIS-MATCH OF THESE PARTS CAN CAUSE EITHER HOLE LEAKING DIRECTLY OUT FRONT PUMP AREA  
OR BLOWING OIL OUT FILLER CAP.

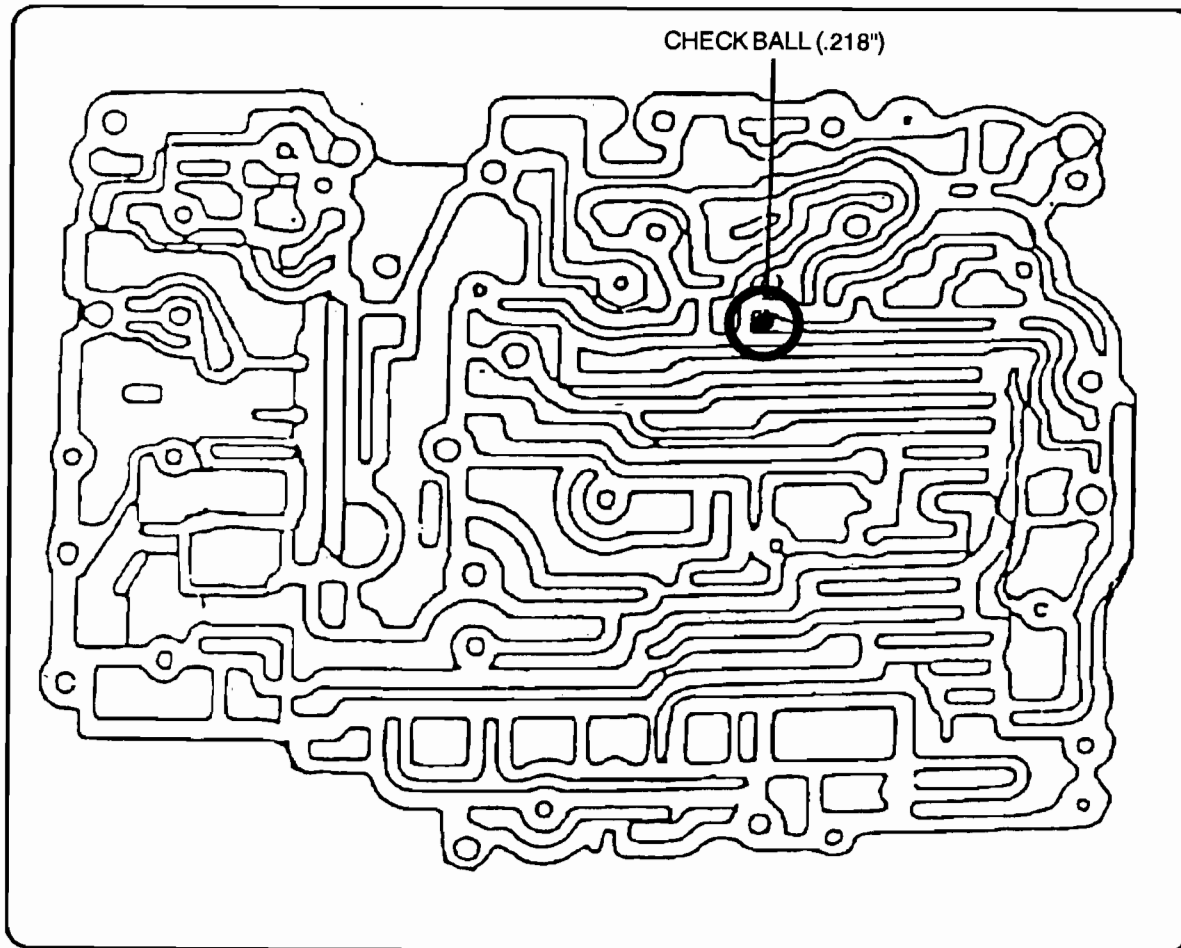
CAUSE: VITON CHECK BALL MISSING, OR OFF LOCATION.

CORRECTION: INSTALL CHECK BALL IN PROPER LOCATION.

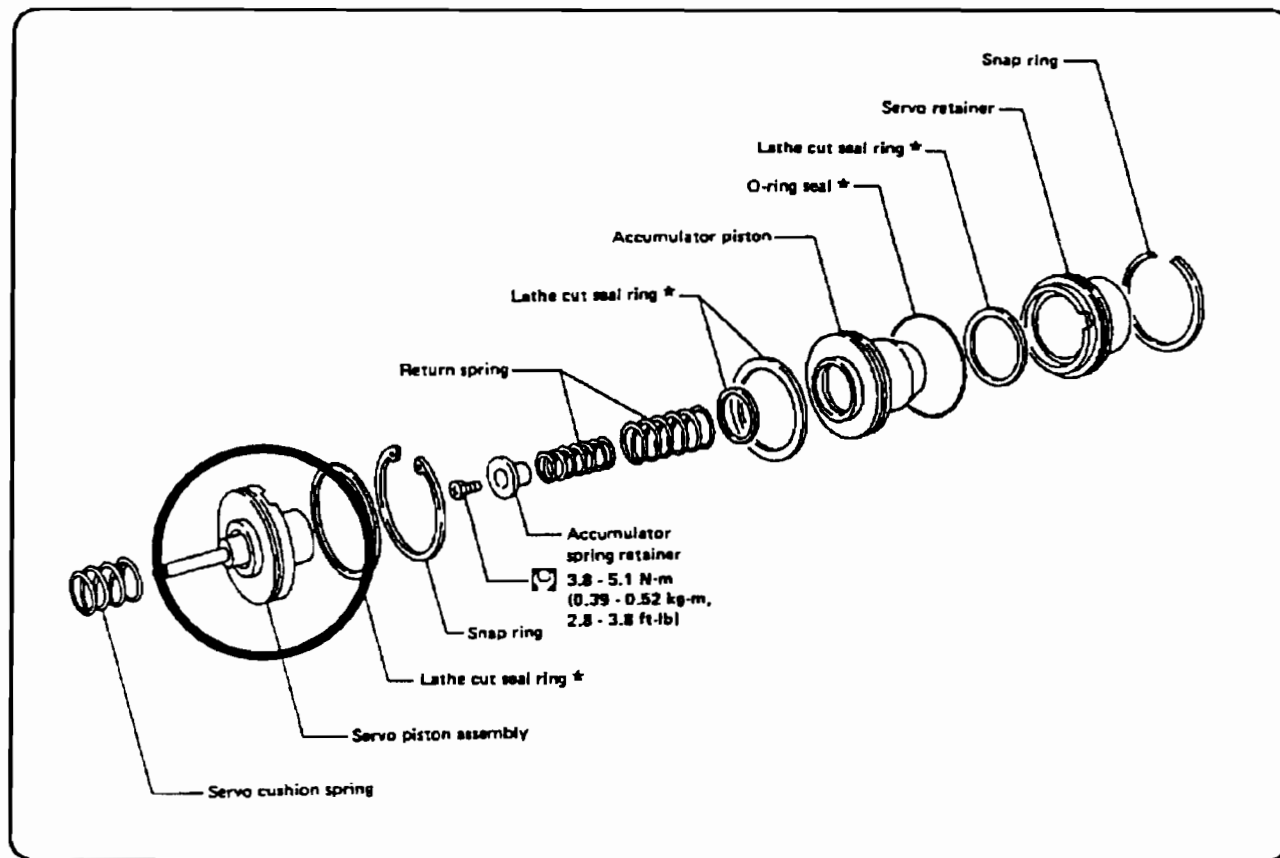
CAUSE: SERVO PISTON PIN INSTALLED UPSIDE DOWN.

CORRECTION: INSTALL PISTON PIN AS SHOWN.

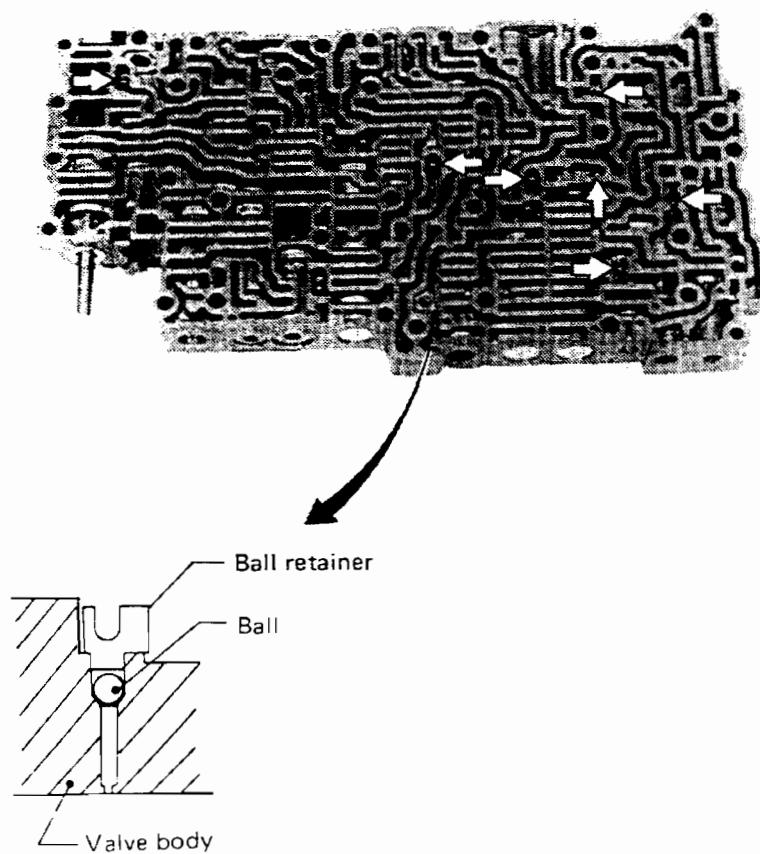
## NISSAN RL4FO2A

COMPLAINT: No forward movement.

CAUSE: The cause may be check ball and retainer off location or left out.

CORRECTION: Install check ball & retainer in proper location.

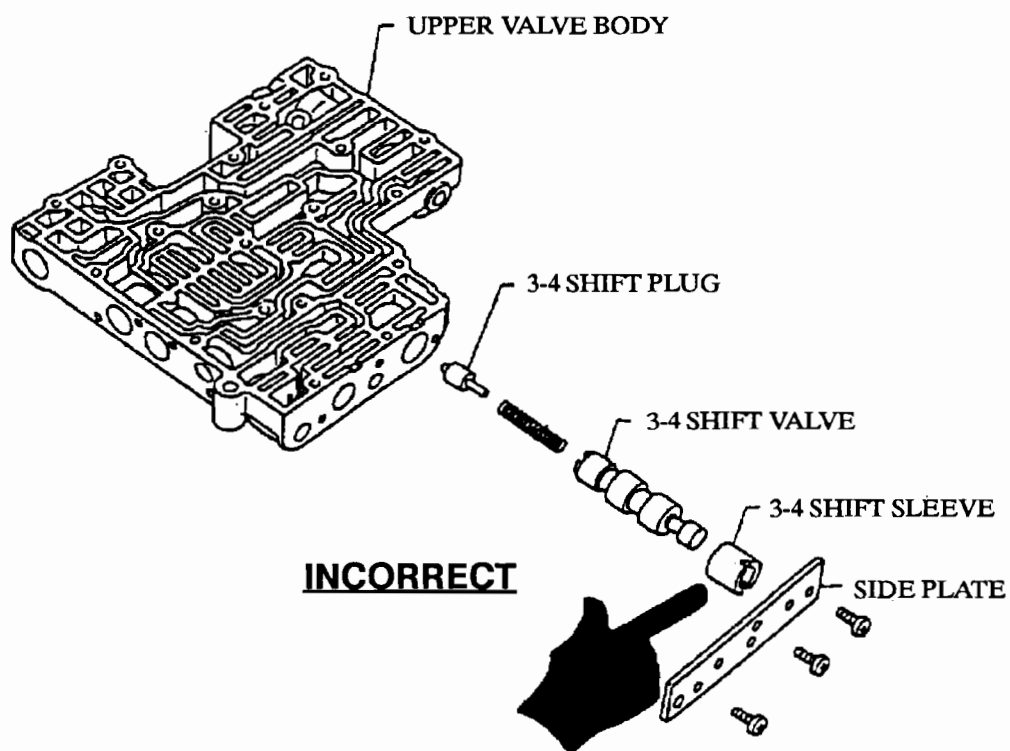
CAUSE: 3-4 SHIFT SLEEVE INSTALLED AS SHOWN IS INCORRECT. NOTCHES SHOULD FACE VALVE.

CORRECTION: INSTALL 3-4 SHIFT SLEEVE WITH NOTCHES FACING 3-4 SHIFT VALVE.

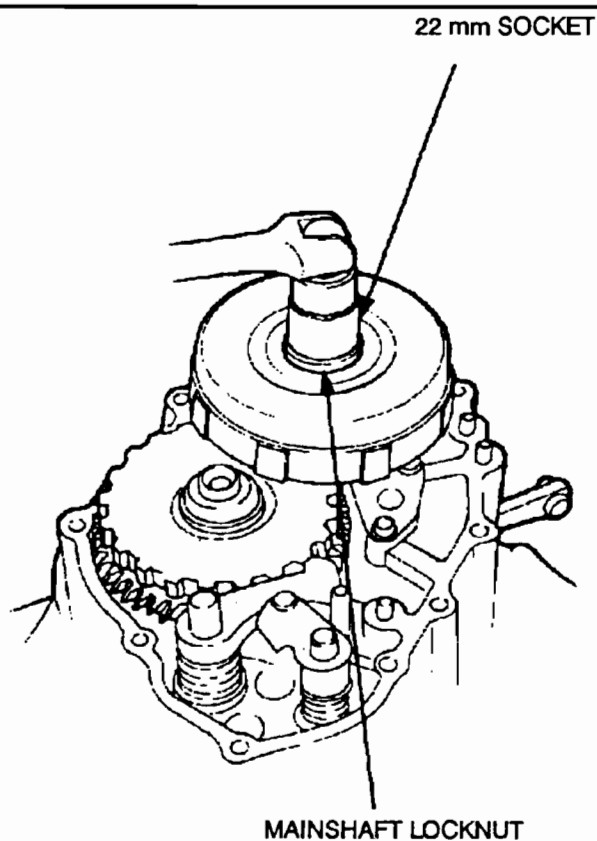
CAUSE: MAINSHAFT LOCK NUT LOOSE.

NOTE: THE MAINSHAFT LOCKNUT HAS LEFT HAND THREDS

CORRECTION REPLACE LOCK NUT USING LOCKTITE.

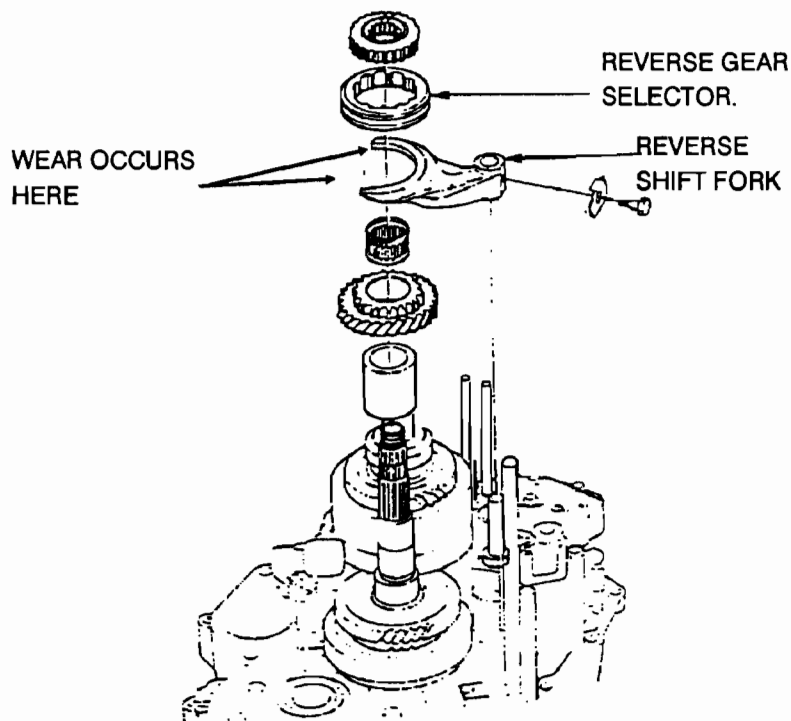
CAUSE: WORN REVERSE GEAR SELECTOR/WORN OR BENT FORK.

When the inner teeth on the reverse selector gear wear down (**EVEN SLIGHTLY**) they won't mesh perfectly with the teeth on either the reverse hub gear, or the counter reverse gear, and will cause a harsh clanging-type noise when the reverse selector gear is moved between these two gears.

This is often overlooked when rebuilding the transmission because the wear is so slight, but is **EXTREMELY CRITICAL** to smooth drive engagement.

CORRECTION: REPLACE REVERSE GEAR SELECTOR AND/OR FORK.

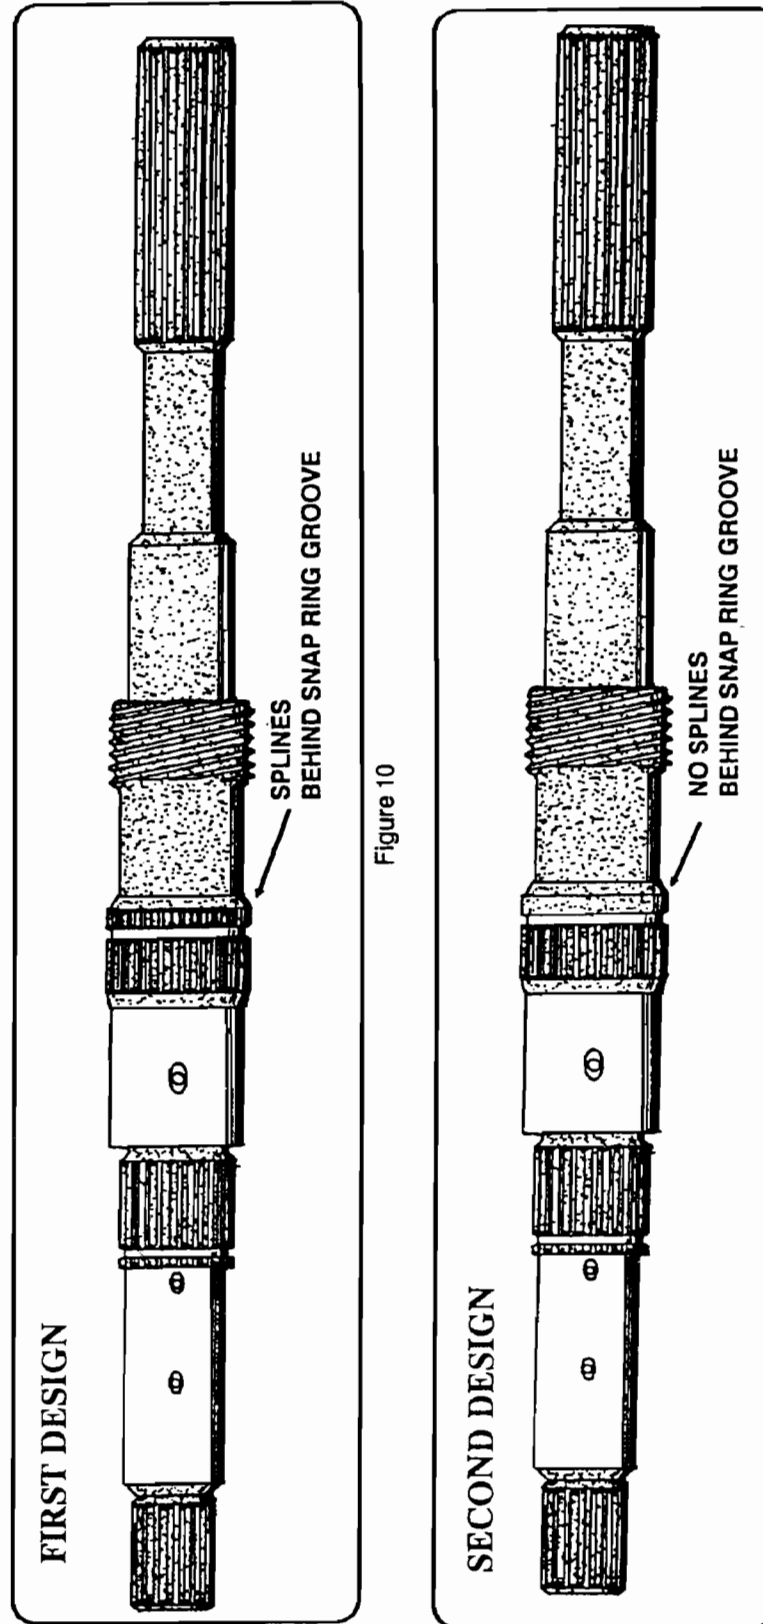
Figure 10

- CHANGE:** Portion of spline area on output shaft, behind park gear snap ring, was eliminated (see Figure 10).
- REASON:** To prevent park gear from moving rearward in case snap ring breaks, and provides more support for snap ring, to prevent snap ring breakage.
- INTERCHANGABILITY:** Will retro-fit to all previous models and is highly recommended.
- SPECIAL NOTES:** In mid-year 1989, a boss was added inside the extension housing, to act as a stop for the parking gear to eliminate the possibility of the parking gear disengaging from the splines in the event that the parking gear to shaft snap ring breaks.

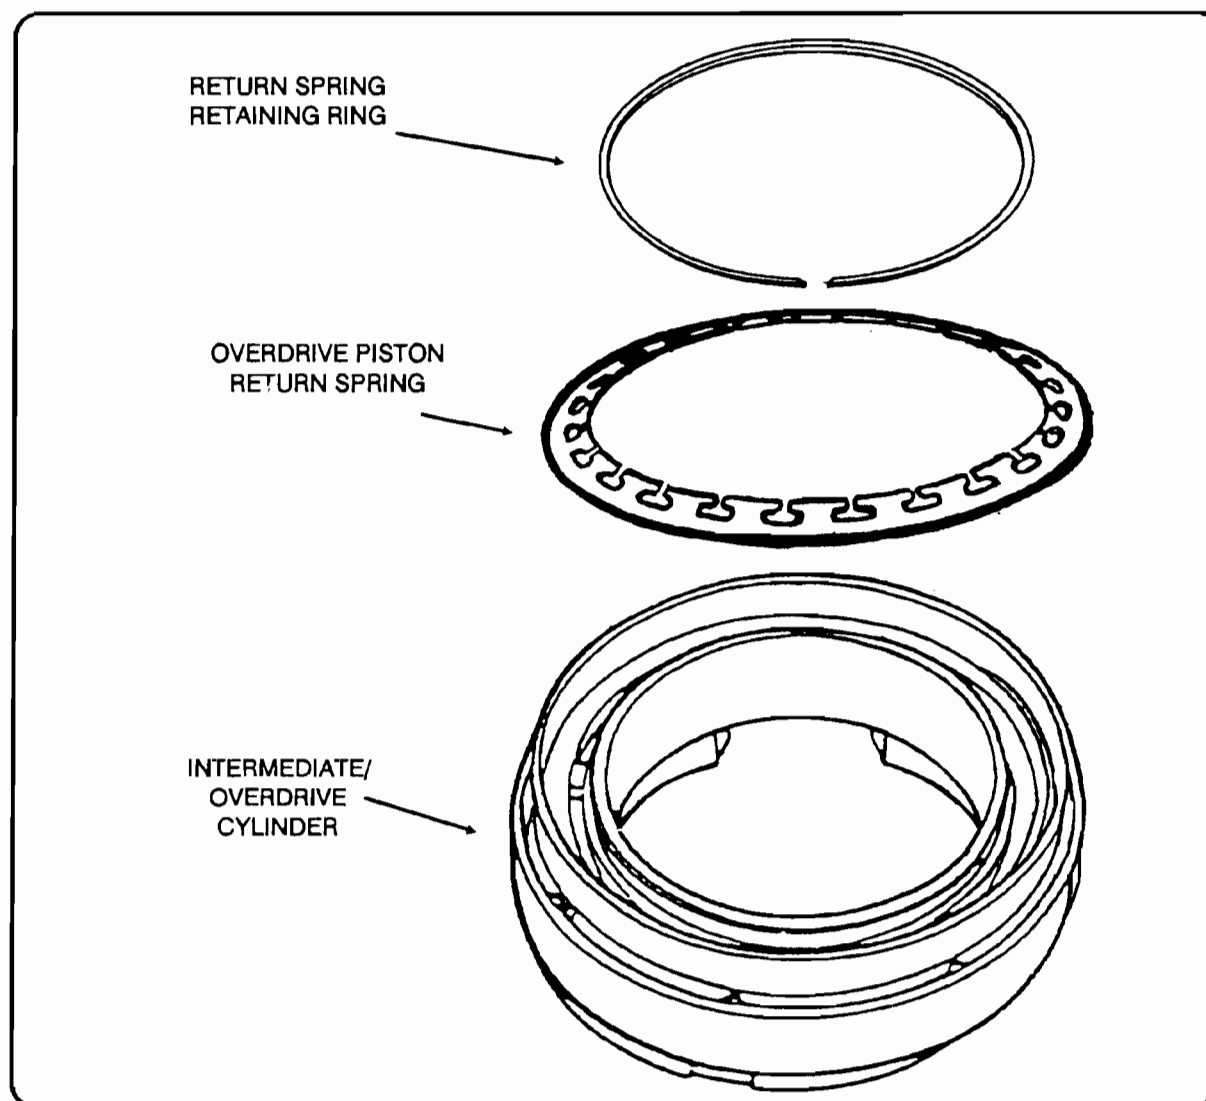
Figure 14

- COMPLAINT:** Harsh 3-4 shift, or upon transmission dis-assembly the o/d piston return spring retaining ring (see figure 14) is dislodged from groove.
- CAUSE:** The cause may be insufficient ring tension.
- CORRECTION:** Replace ring with part number FOTZ-7A527-A.

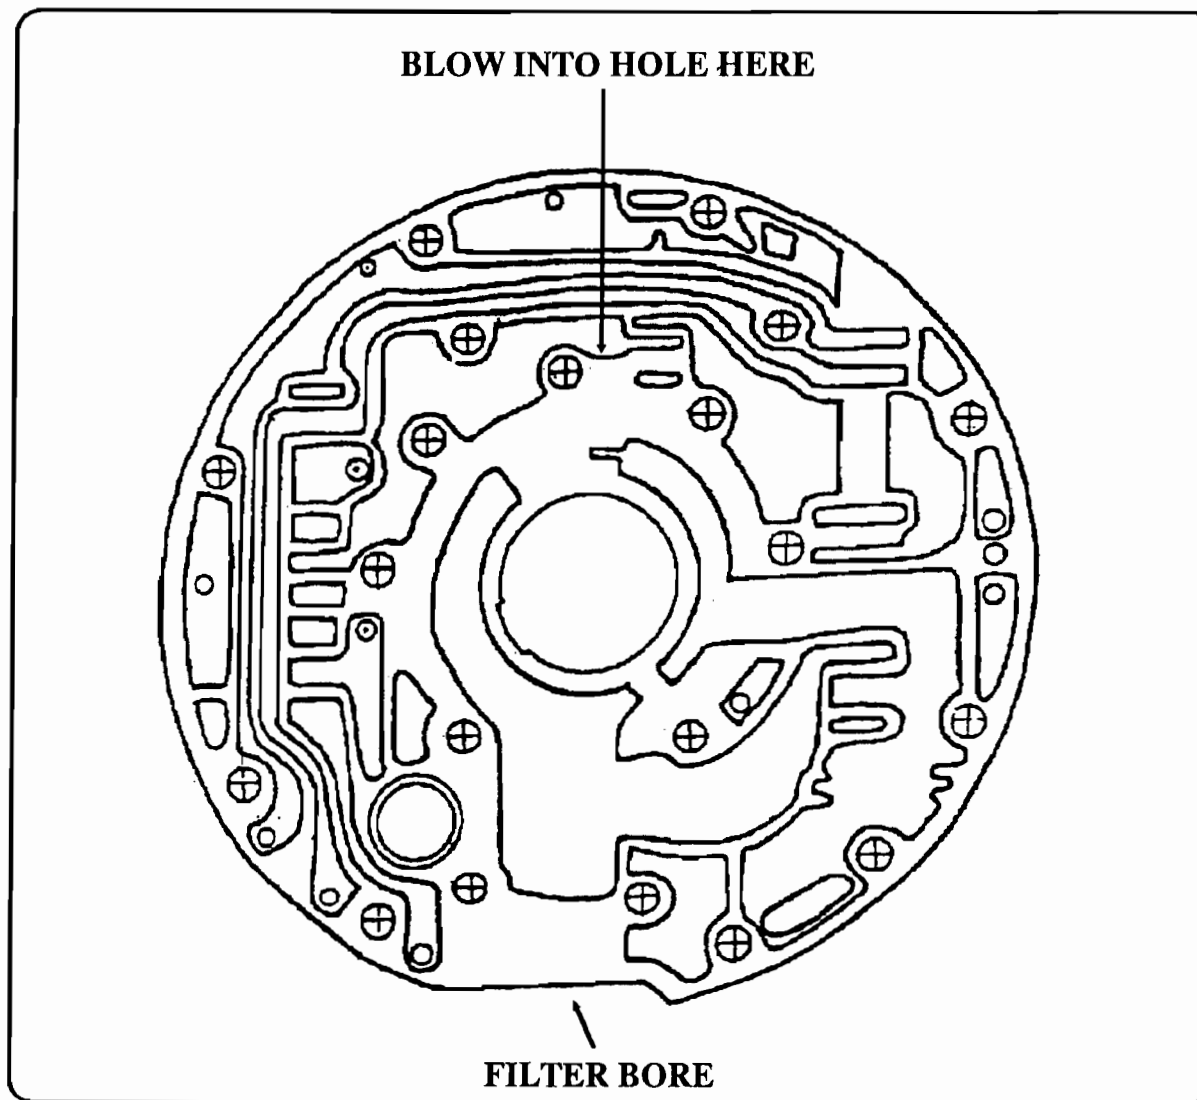
Figure 15

**COMPLAINT :** Overdrive planetary and overdrive sprag failure due to lack of lube.

**CAUSE :** The cause may be a plugged or restricted lube passage in pump cover. There is a ball and spring under the orificed cup plug making this passage prone to clogging up.

To check for restriction blow into hole in pump cover (See Figure 15). Air should exit from hole in rear of stator shaft as shown in (Figure 16).

**CORRECTION:** Clean out the lube passage.

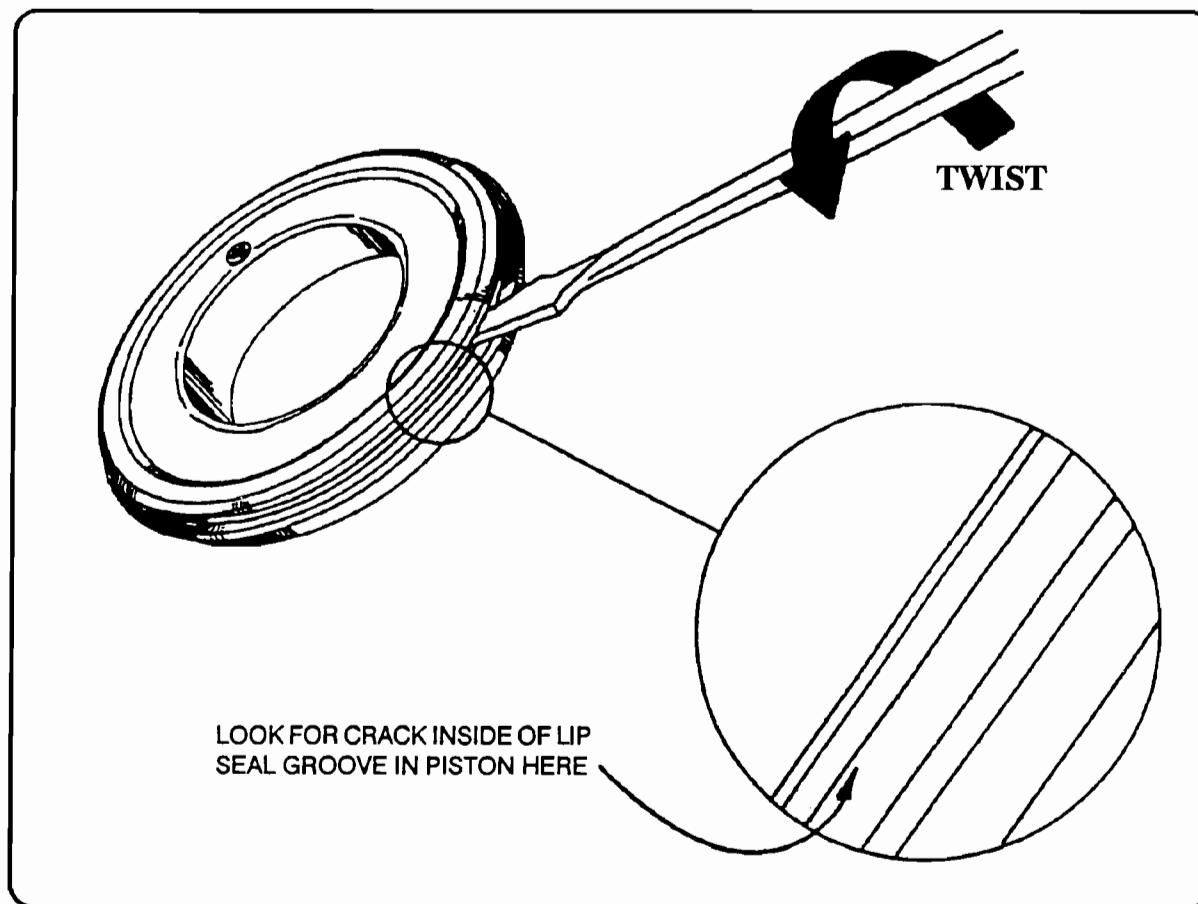
Figure 33

**COMPLAINT:** Flare or slip on 2-3 shift, or premature failure of direct clutches.

**CAUSE:** The cause may be cracked direct clutch piston. For procedure to check the piston, (see figure 33).

**CORRECTION:** Replaced the direct clutch piston.

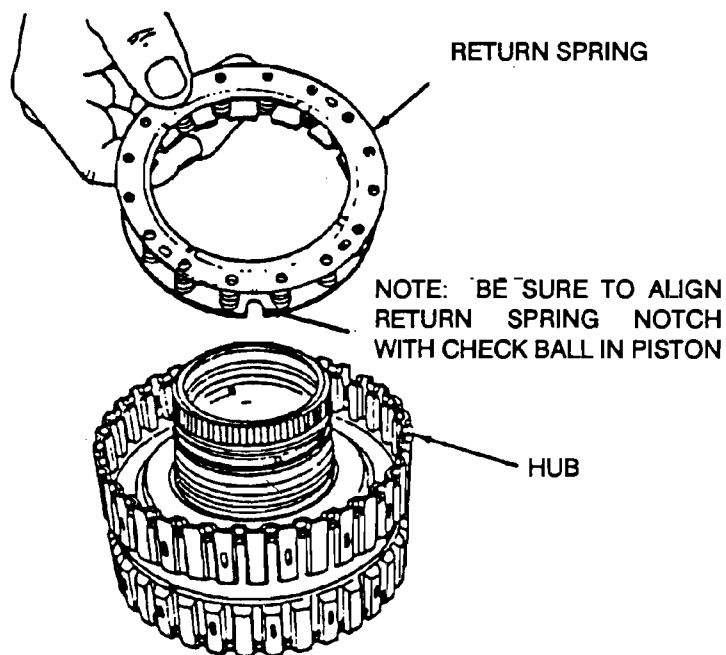
Figure 35

- COMPLAINT:** An extended 3-4 shift with possible direct clutch failure or a NO 3-4 shift condition.
- CAUSE:** This condition may be caused by a partially or fully blocked oil flow of direct clutch piston check ball.
- CORRECTION:** Special care must be taken during the overhaul operation when re-assembling the direct clutch return spring over the direct clutch piston. Make sure that the notch in the spring bottom retainer (See Figure 35) is positioned properly over the check ball so it will not block or restrict oil flow of the piston check ball assembly.

**INSTALL RETURN SPRING IN CYLINDER ALIGNING RETURN SPRING NOTCH WITH CHECK BALL IN PISTON.**

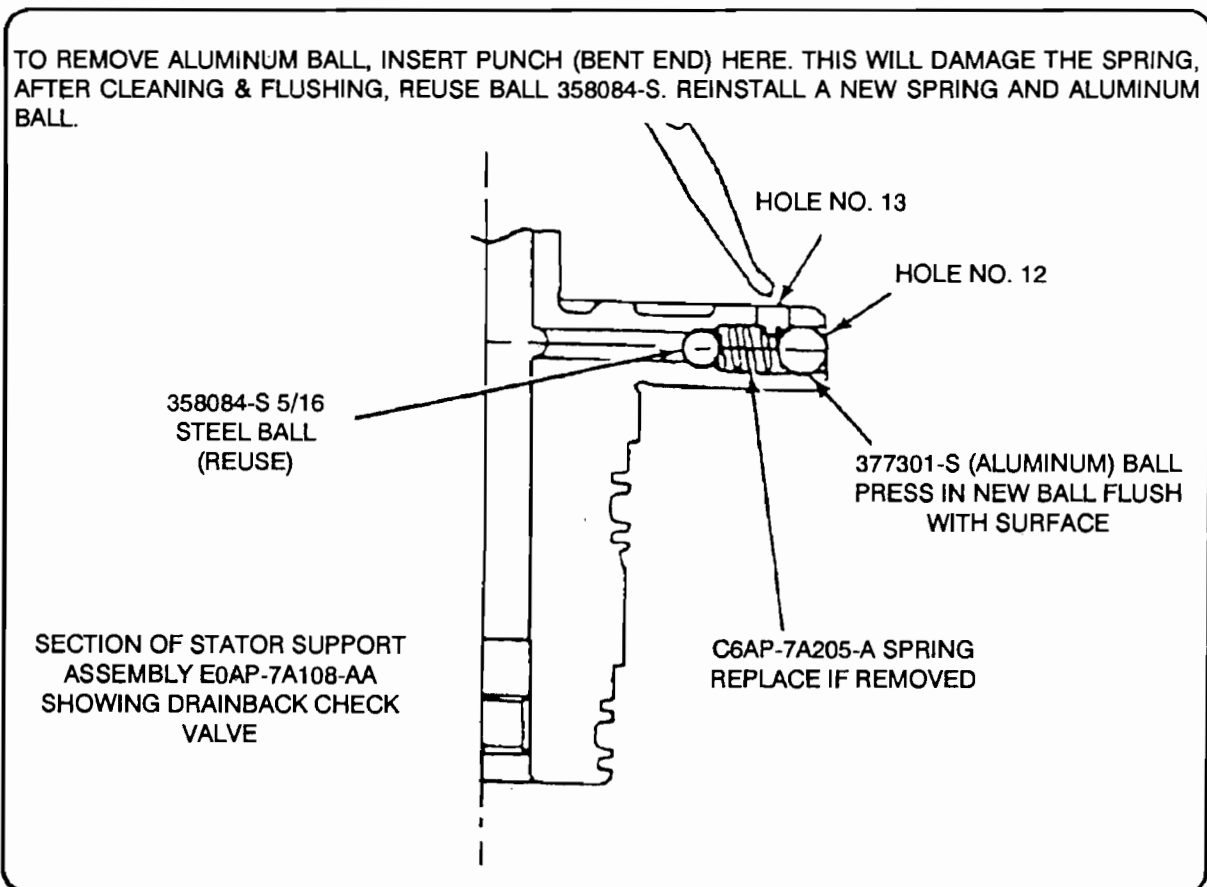
**COMPLAINT:** Repeated burning of the planetary carrier, reverse sun gear & drive shell and forward sun gear. At times this will occur in less than 100 miles after rebuild.

**CAUSE:** The cause may be the converter drain back cross hole passage in the pump stator support blocked with debris, or the checkball stuck (See Figure 39 ).

Spring and ball kit ..... E5AZ-7A205-A

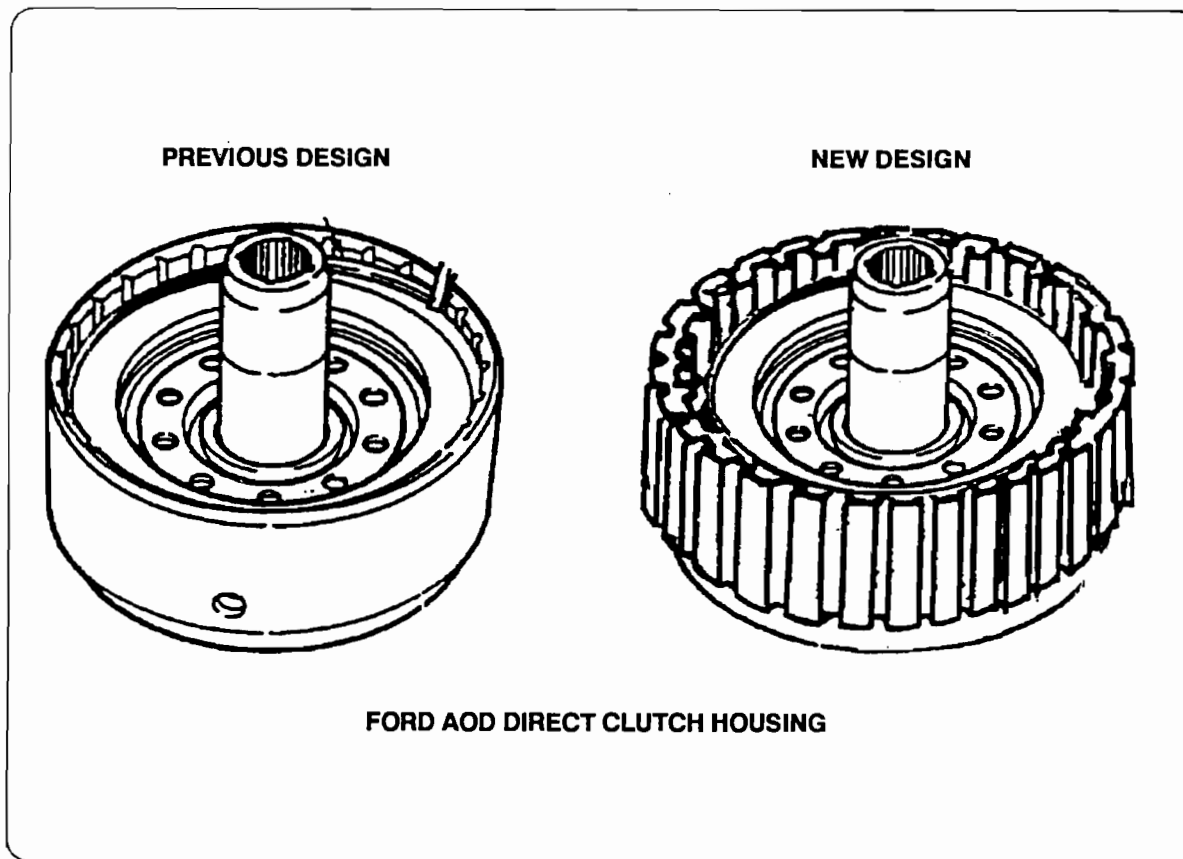
**CAUSE:** In 1989 there was a new design stamped steel direct clutch housing (See Figure 42 ) introduced, that creates the noise.

**CORRECTION:** Install the previous design cast steel direct clutch housing.

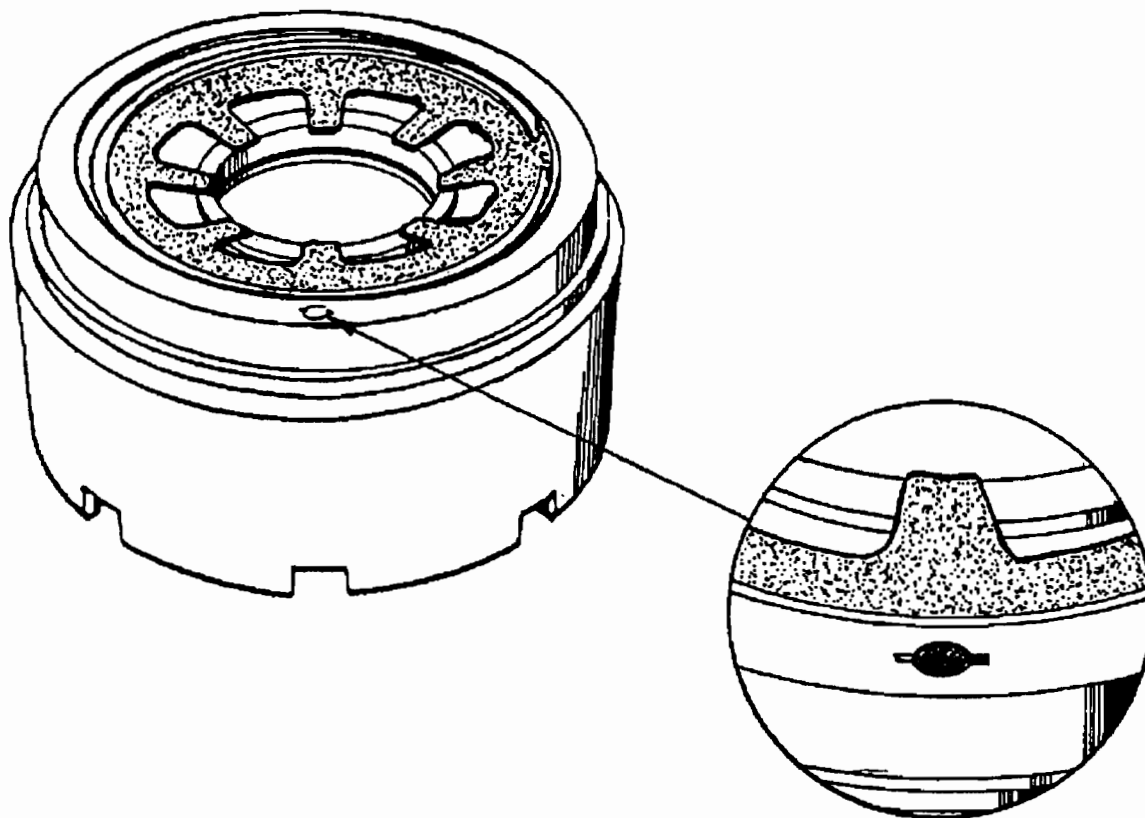
**CHRYSLER A604**  
**PREMATURE FAILURE OF O.D. AND REVERSE CLUTCHES**

**COMPLAINT:** Premature failure of the overdrive and reverse clutch plates, and all lip seals and "O" rings are good.

**CAUSE:** The cause may be an orifice and screen assembly blown out of the overdrive/reverse piston.

**CORRECTION:** Replace the orifice/screen assembly with a new one, available under OEM part number 4531903, and stake the new assembly in place. They were not all staked in place at the factory.

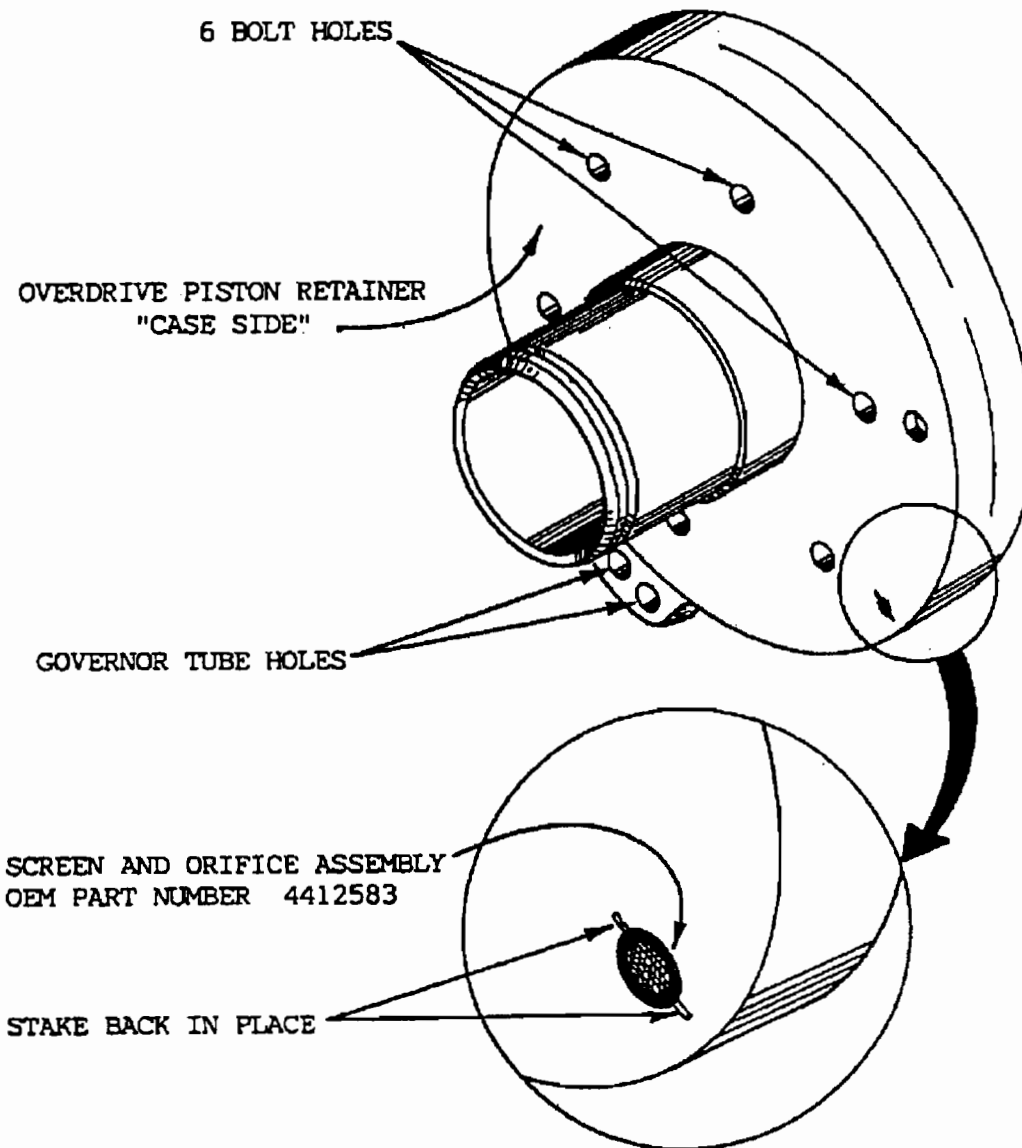
## A500 OVERDRIVE PISTON RETAINER

**CAUSE:** The cause may be the Screen and Orifice Assembly blown out of the overdrive piston retainer (see figure on next page).

**CORRECTION:** Replace the Screen and Orifice Assembly with a new one, available under OEM part number 4412583, and make sure that you "STAKE" it in place after installation.

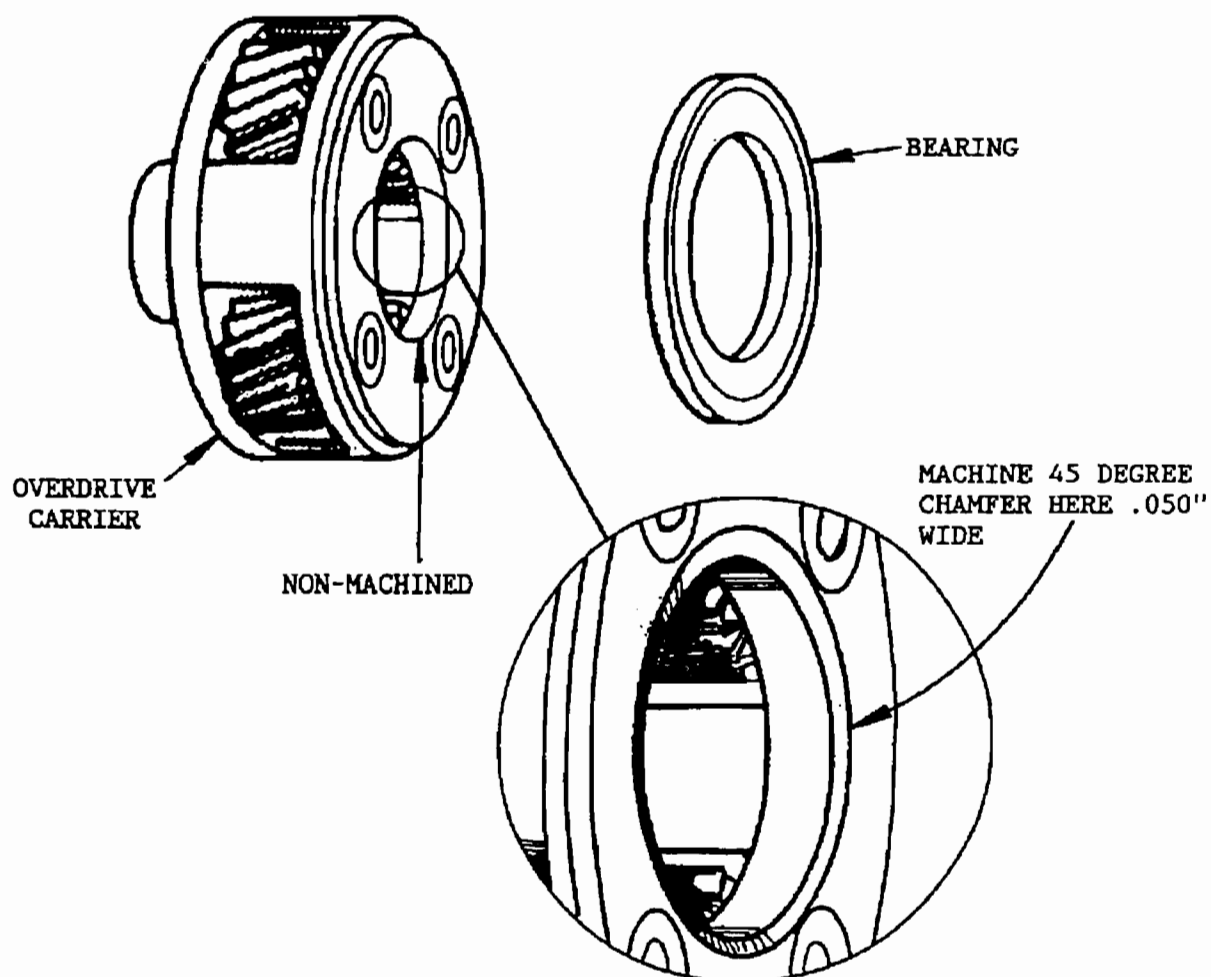
### **CHRYSLER A500 PREMATURE O.D. CARRIER FAILURE**

- COMPLAINT:** Premature failure of the overdrive carrier and bearing. The bearing is actually destroyed first and the bearing takes out the overdrive carrier.
- CAUSE:** The cause is lack of lube to the overdrive carrier bearing.
- CORRECTION:** Replace the bearing and carrier. **BEFORE** installing the new carrier, machine a chamfer on the inside diameter that is .050" wide as shown in figure below. This will provide more lube oil for the carrier bearing.
