CHRYSLER A518 TIE-UP IN PARK AND REVERSE MOVES FORWARD IN NEUTRAL

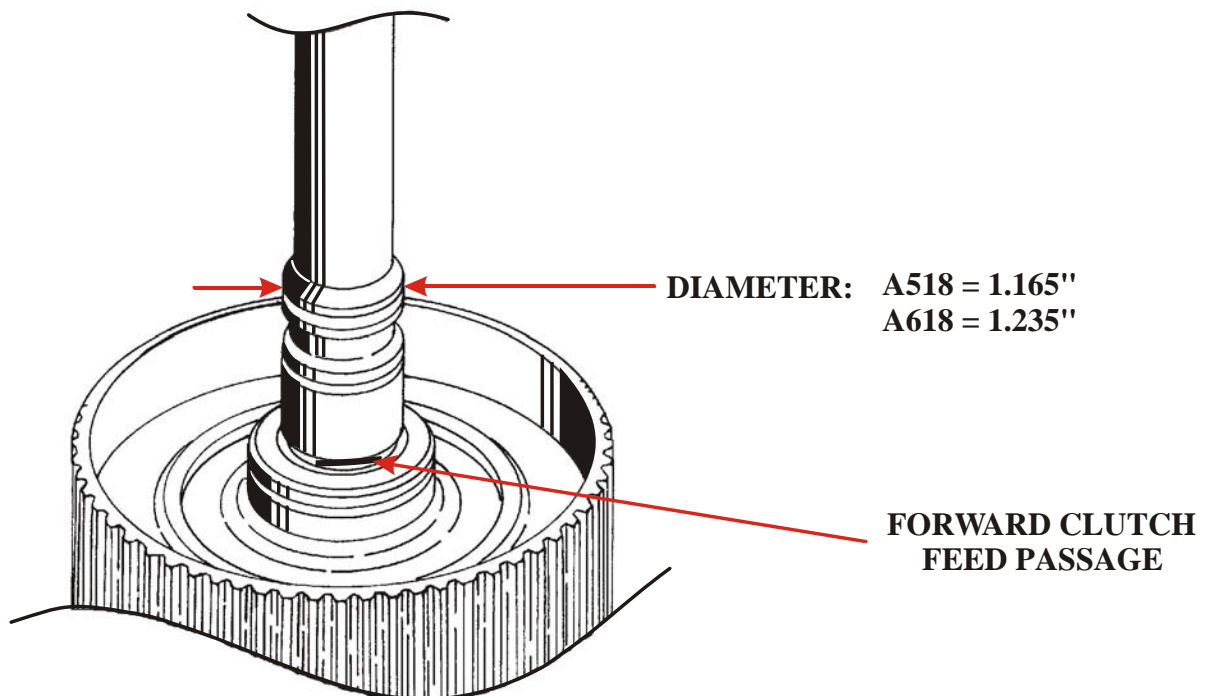
Figure 1

CAUSE: The cause may be, an A618 stator assembly installed into an A518.

TURBINE SHAFT AND FORWARD DRUM ASSEMBLY

CORRECTION: Install the proper A518 stator into the unit. The biggest problem is identification of these two very similar parts. The diameter in the sealing ring area on the turbine shaft on the A518 is 1.165", and the A618 diameter in the same area is 1.235", as shown in Figure 1. Obviously the diameter on the inside of the stator where the sealing rings ride must correspond with these dimensions. When the larger diameter A618 stator is installed on the A518 turbine shaft, converter release oil goes past the sealing ring and applies the forward clutch, as long as the engine is running. Refer to Figures 1 and 2.

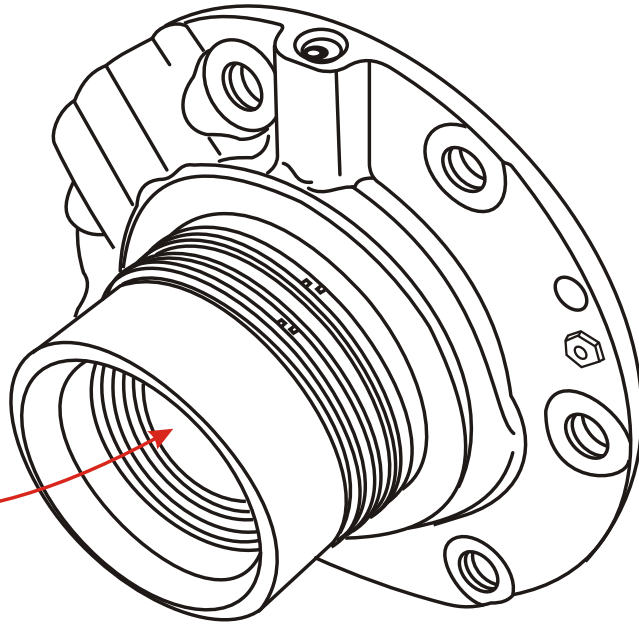
Figure 2

STATOR ASSEMBLY

**DIAMETER IN SEAL RING AREA:
A518 = APPROXIMATELY 1.170"
A618 - APPROXIMATELY 1.240"**
