Technical Service Information

FORD AXOD-E 3-NEUTRAL KICKDOWN

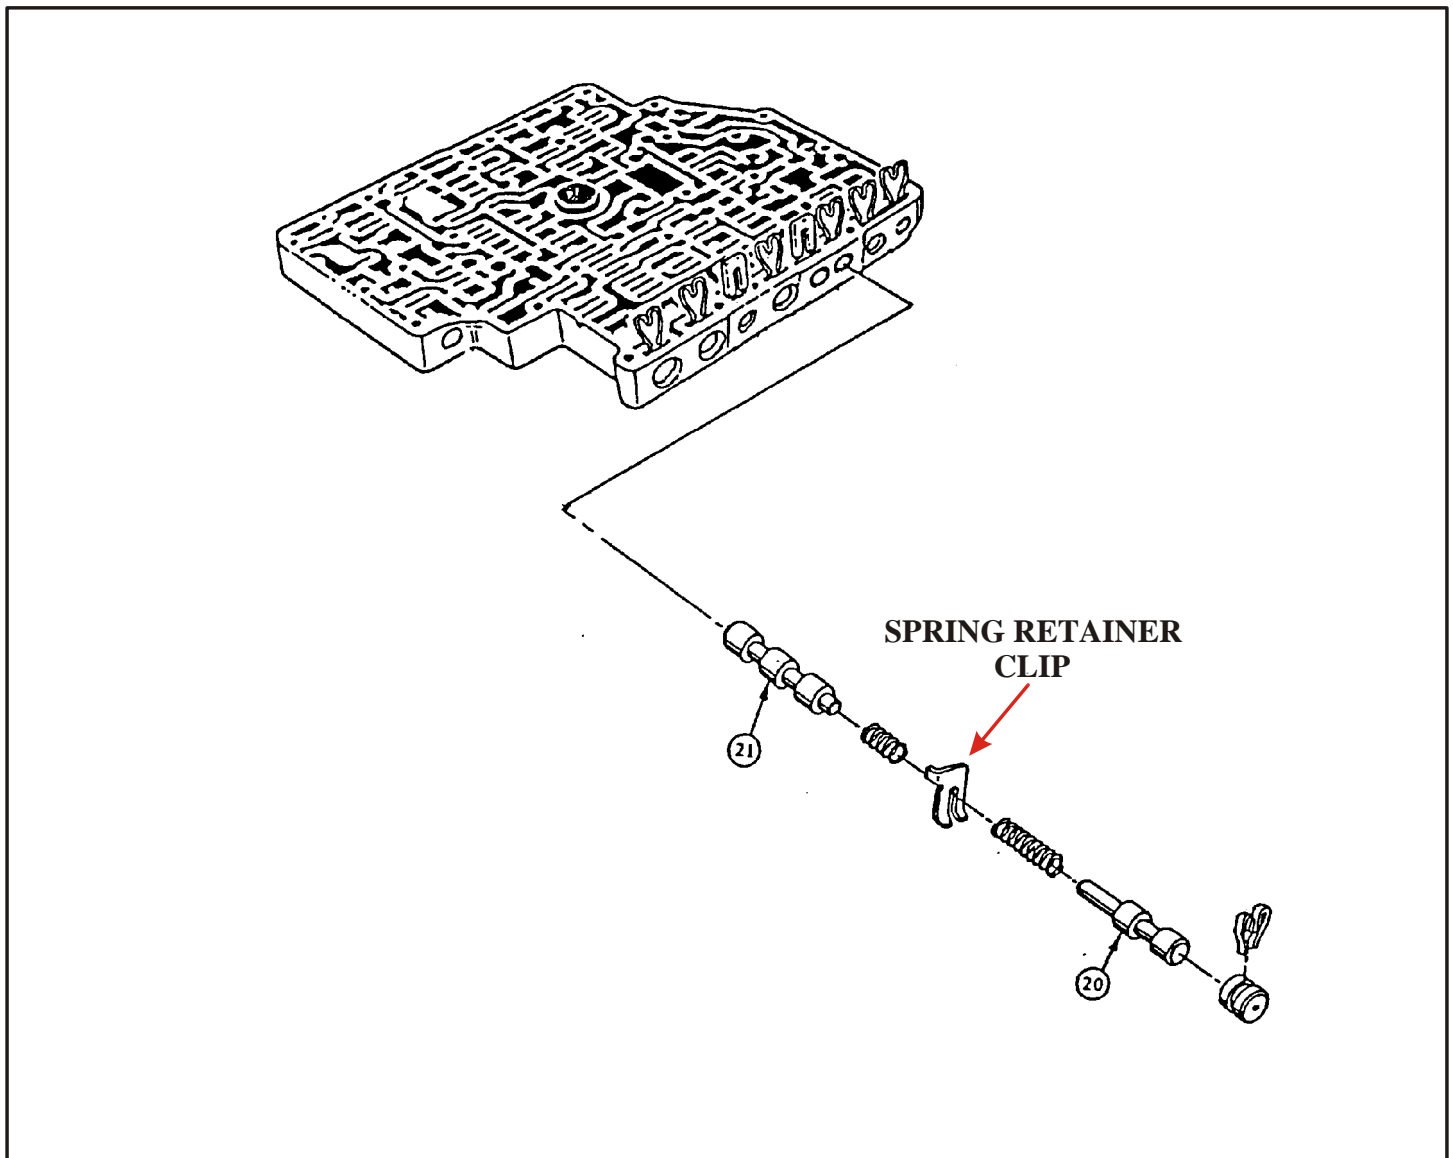
Figure 1

COMPLAINT: A delayed shift may occur during 3-2 forced downshifts, or "Kickdown".

CAUSE: The cause may be, a broken spring retainer clip between the pull-in control valve spring and the 3-2 control valve spring, as shown in Figure 1.

CORRECTION: Replace the spring retainer clip with OEM part number F1DZ-7F194-A.
