Technical Service Information

KM 175-177 **HARSH 2-3 UPSHIFT AND 4-3 DOWNSHIFTS**

87-42
Page 1 of 1

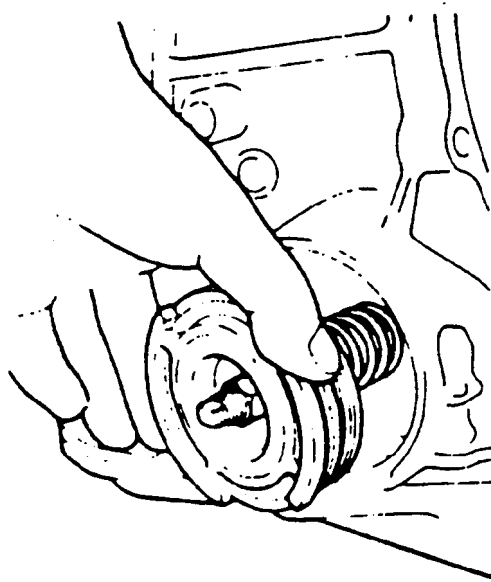
COMPLAINT: Harsh 2-3 upshift and 3-4 downshift, sometimes worse when hot.

CAUSE: Worn servo bore, usually caused by metal contamination of teflon servo seal.

CORRECTION: Repair or replace case.
