Technical Service Information

CHRYSLER A500/518 OVERDRIVE SUN GEAR

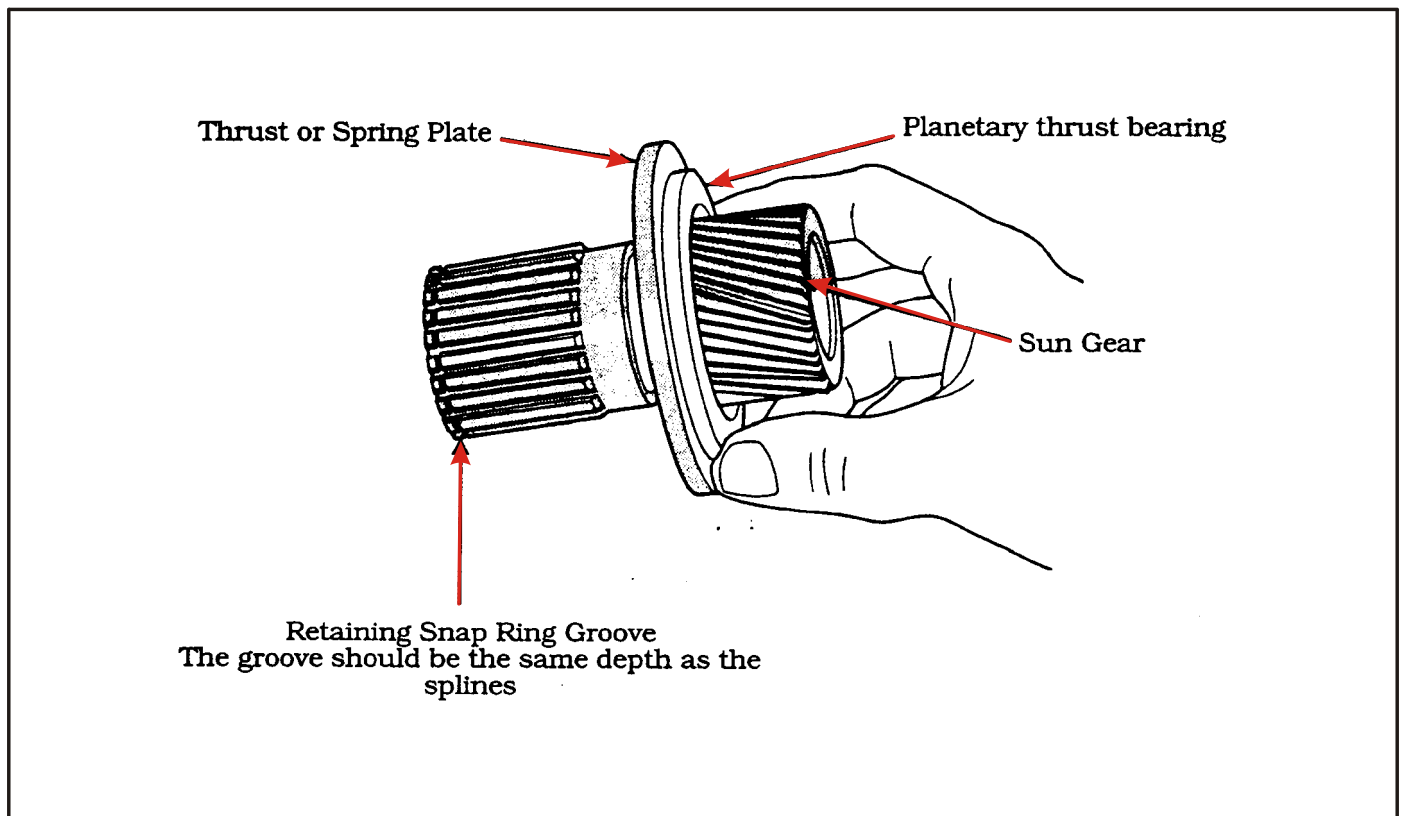
Figure 1

- COMPLAINT:** The retaining ring snap ring groove in a newly purchased sun gear does not seem to retain the retaining ring properly.
- CAUSE:** The retaining ring snap ring groove is not machined deep enough to accommodate the snap ring.
- CORRECTION:** The snap ring groove should be machined the same depth as the splines. You can machine the groove down all the way yourself or reorder a new sungear.
