# THE SEMINAR WITH MORE IN '94

AUTOMATIC TRANSMISSION SERVICE GROUP  
9200 S. DADELAND BLVD. STE 720  
MIAMI, FLORIDA 33156  
(305) 670-4161

## **INTRODUCTION**

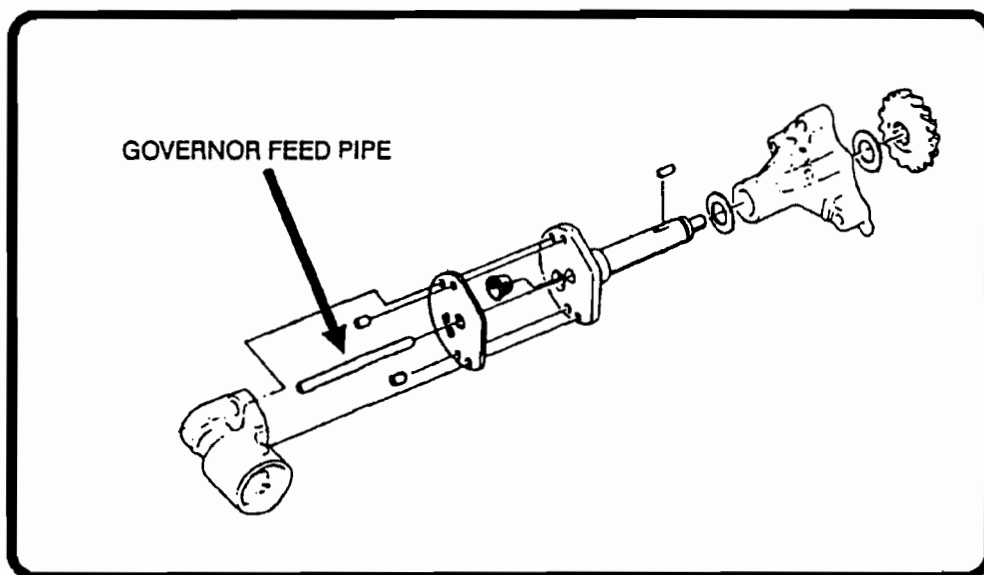
CAUSE: Missing governor feed pipe.

CORRECTION: Replace feed pipe.

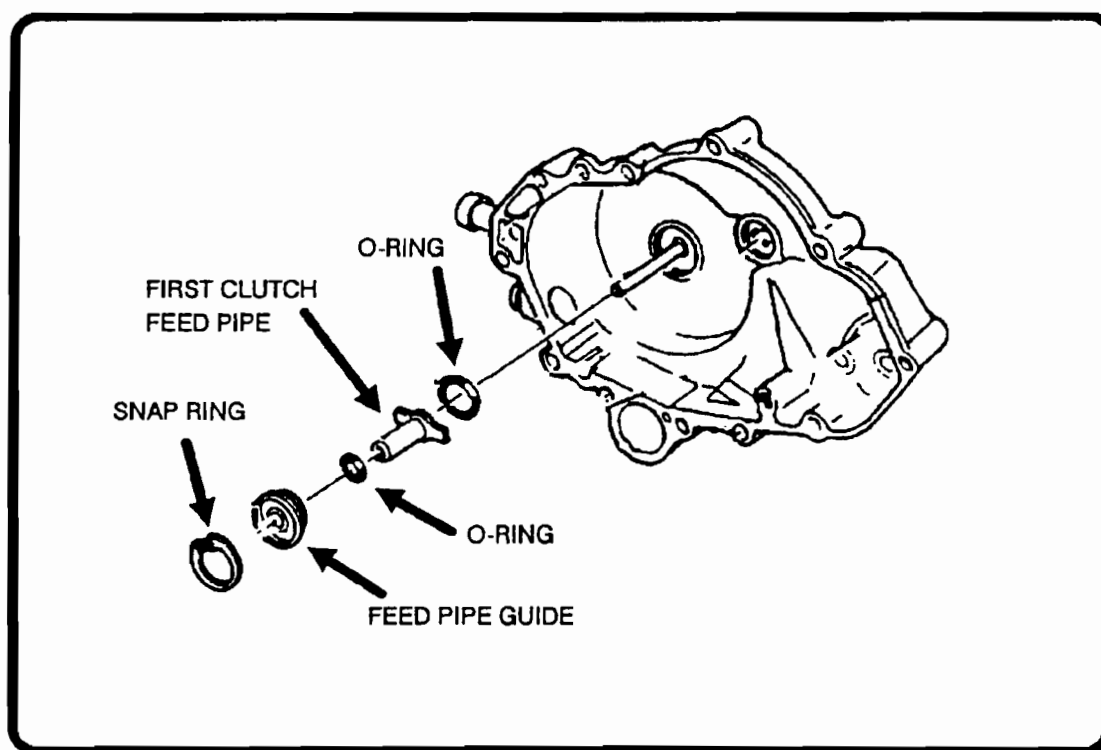
CAUSE: Snap ring is not fully seated causing a sever leak at the first clutch feed pipe.

CORRECTION: Replace the o-ring and reinstall the snap ring pressing down all the way around the snap ring to make sure it is properly seated.

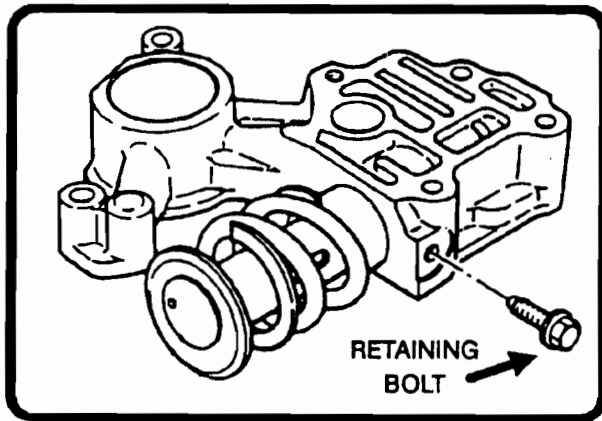
FIGURE 1

## HONDA - ACURA 4 SPEED HIGH LINE PRESSURE

- COMPLAINT:** Harsh engagement, harsh shifts, high line pressure.
- CAUSE:** Pressure regulator retaining bolt jamming spring retainer (figure 1).
- CORRECTION:** When installing retainer and bolt make sure that the slot on the retainer lines up with the bolt hole before installing the bolt (figure 2).

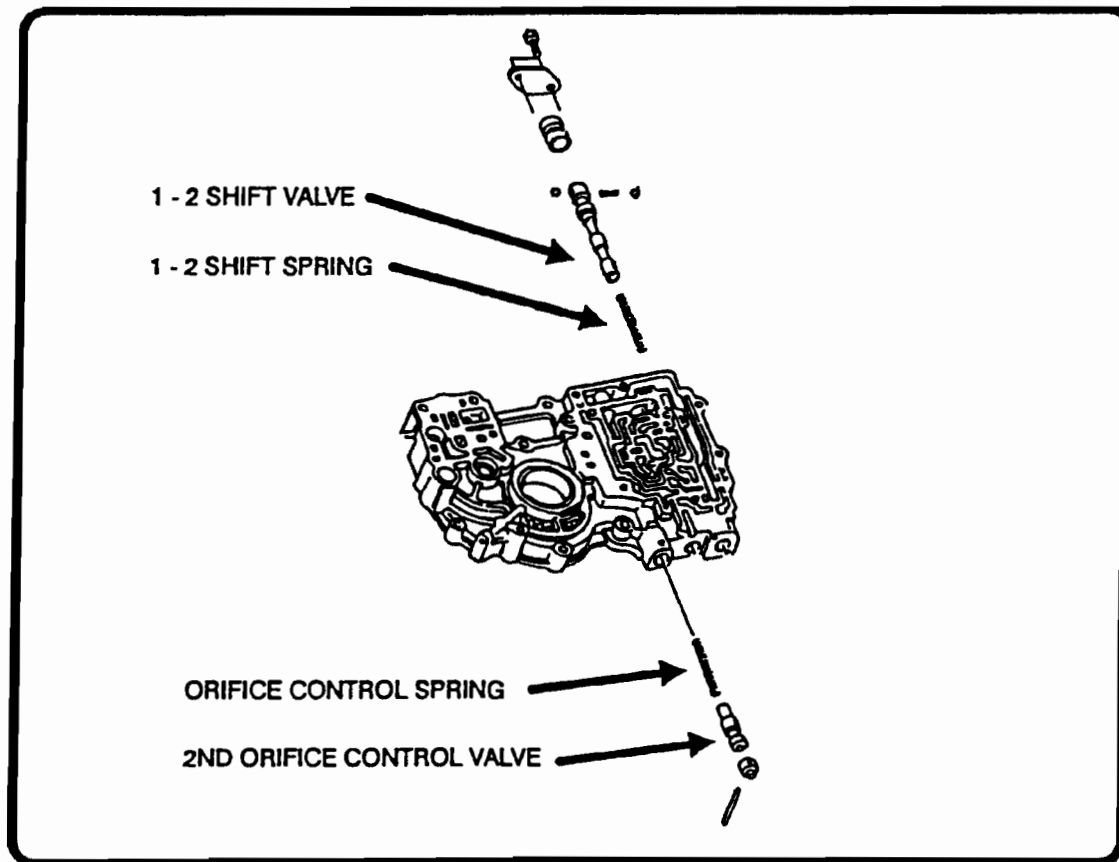
CAUSE: The second gear orifice control valve spring installed improperly into the 1 - 2 shift valve train.

CORRECTION: Remove the springs and reinstall them into their proper locations.

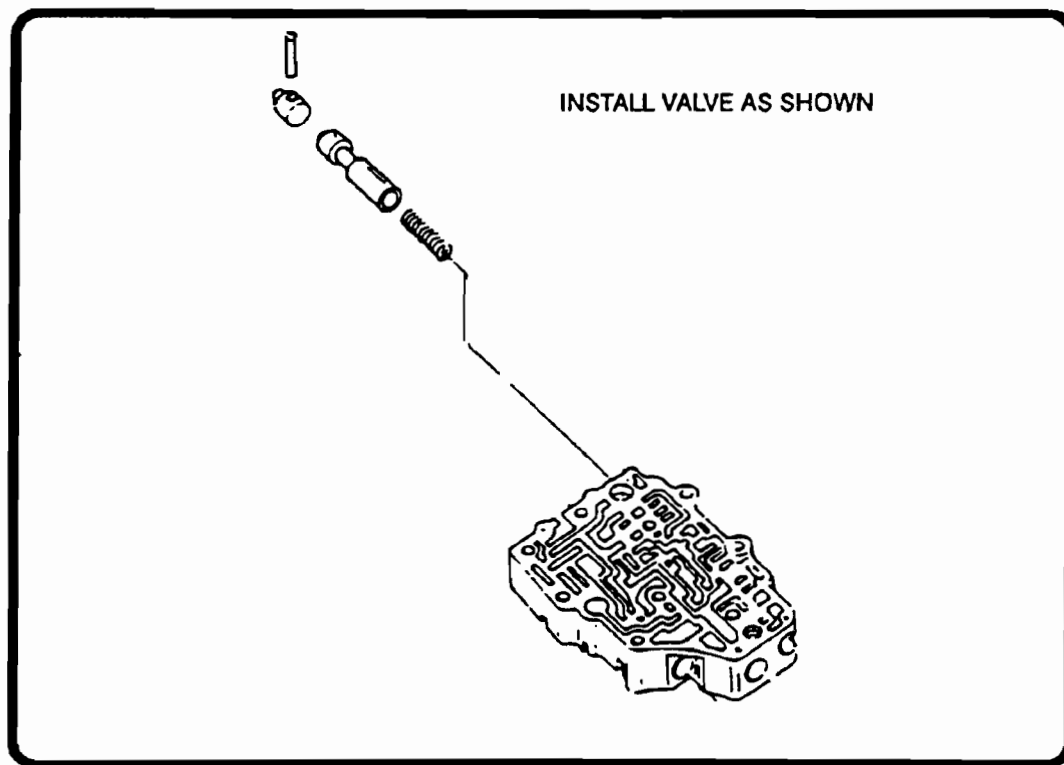
CAUSE: Misassembly of the CPV valve and spring.

CORRECTION: Remove and install correctly.

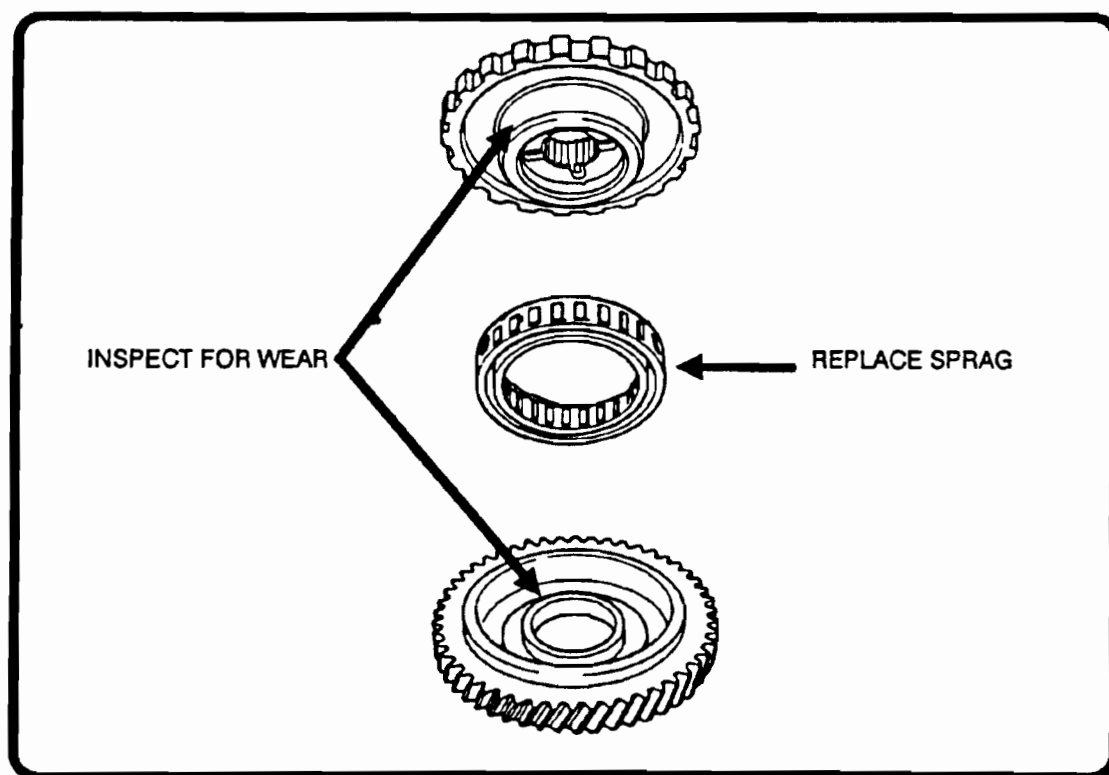
## HONDA - ACURA 4 SPEED SQUAWKING NOISE GOING INTO 1st

**CAUSE:** Sprag is slipping.

**CORRECTION:** Replace sprag, also check inner and outer races for any wear and replace if necessary.

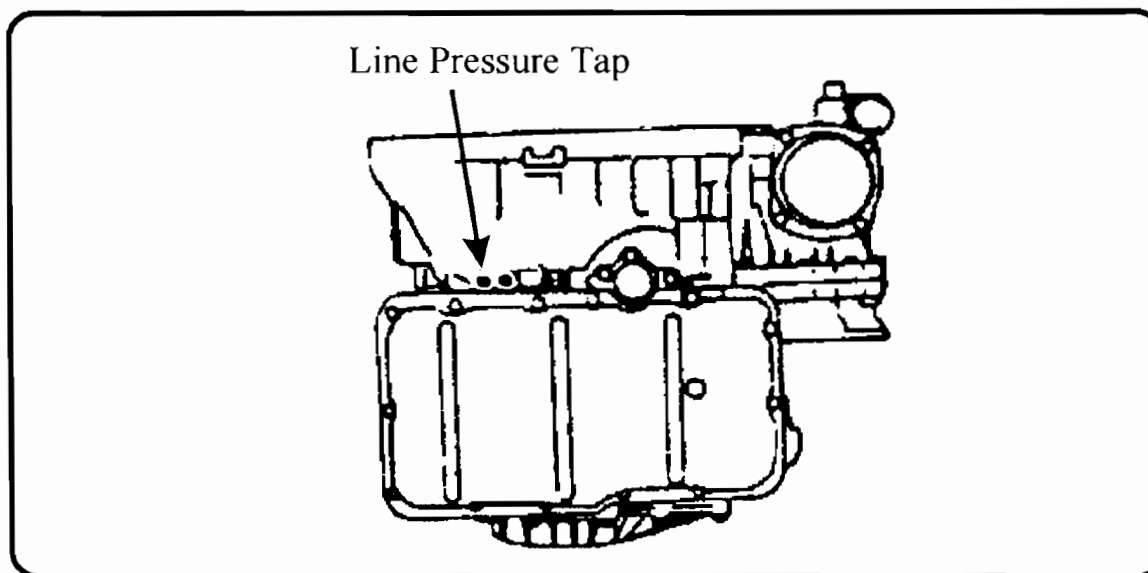
Figure 1.

## POOR SHIFTS AND FRICTION MATERIAL FAILURE

**COMPLAINT:** Poor shift quality, especially after rebuild. The transaxle may shift okay at light throttle but gets increasingly softer with acceleration. If it is released to the customer, it comes back burn't up in a relatively short time. This unit may have been thoroughly air tested and put together with high quality parts and still have the same results.

**CAUSE:** No line pressure rise with throttle opening. This can be easily checked by connecting a pressure gauge to the line pressure tap on top of the case, near the front of the transaxle. See figure 1. Test the line pressure in drive at idle. It should be around **60 psi**. At increased throttle opening, pressures should smoothly increase to a maximum of around **180 psi**. at stall. If the line pressure stays at or near idle pressure, the cause is a weak or clogged pressure control solenoid.

**CORRECTION:** Remove the valve body and replace the 4-Unit Solenoid Assembly which contains the pressure control solenoid. See figure 2. The pressure control solenoid is not serviced separately. A new solenoid assembly is available from the Nissan dealer. The part number for the solenoid pack is **31940-27X66**.

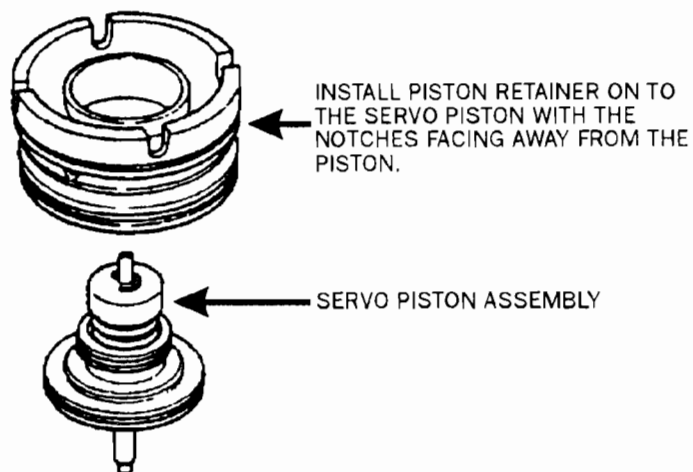
Figure 1

CAUSE: The reverse servo piston may have been installed upside down allowing 2nd apply oil to dump to exhaust.

CORRECTION: Install the servo piston retainer with the notches facing away from the servo piston. Refer to Figure 1.

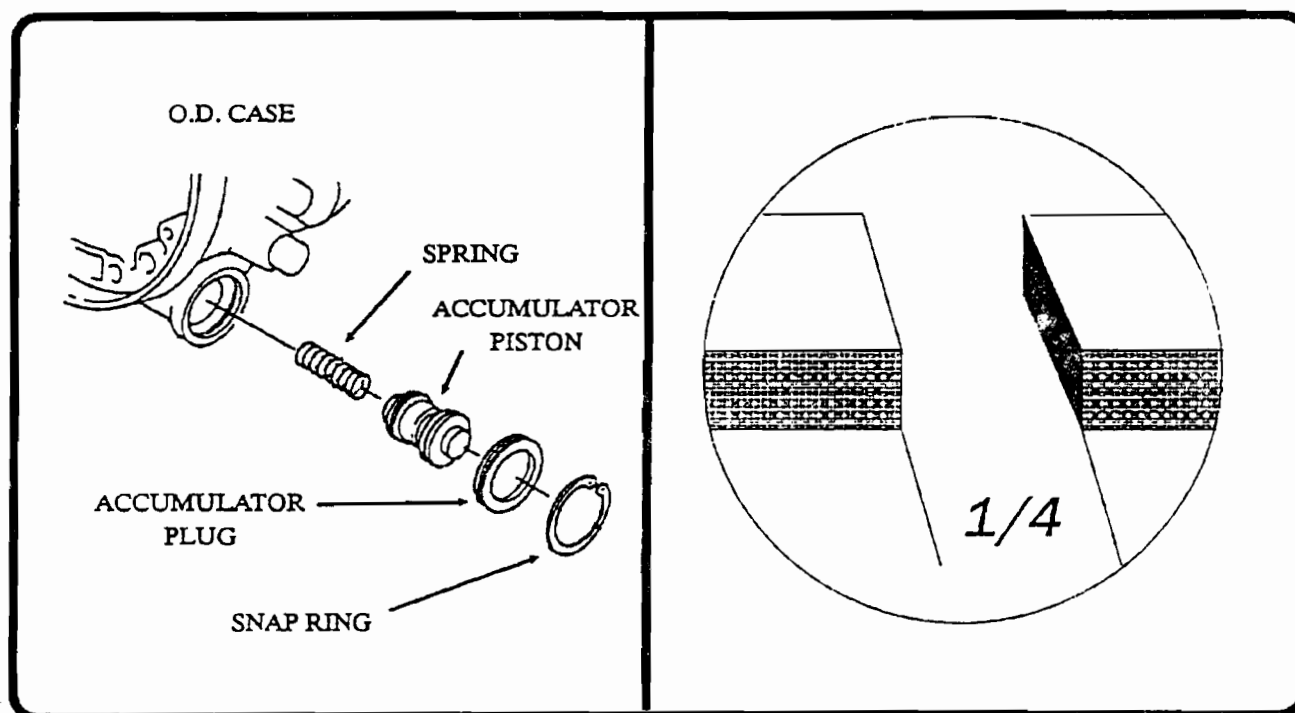
FIGURE 1

**CAUSE:** The overdrive accumulator ring is cutting off lube flow to the O.D. case (Figure 1).

**CORRECTION:** The O.D. accumulator ring should have a 1/4" gap when fitted in the accumulator bore. This 1/4" gap allows lube oil to flow into the O.D. case (Figure 2).

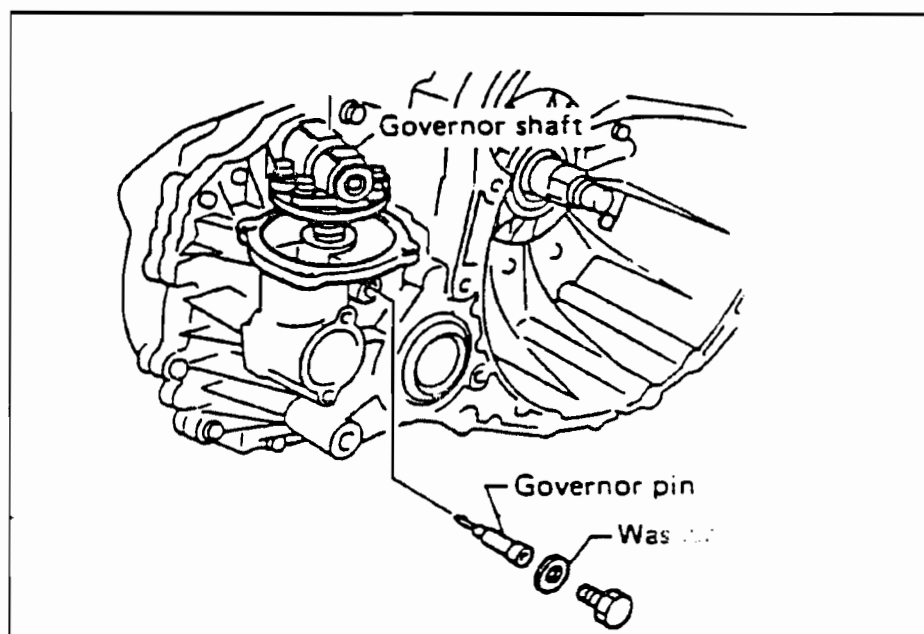
## NISSAN RL4F02A FALLS OUT OF OVERDRIVE AT TIMES

- COMPLAINT:** TRANSAXLE UPSHIFTS OK, BUT DOWNSHIFTS 4-3 OR 4-2 AT HIGHWAY SPEEDS WHEN YOU LIFT YOUR FOOT OFF OF THE GAS PEDAL.
- CAUSE:** THE PROBLEM CAN BE EXCESSIVE END PLAY IN THE GOVERNOR SHAFT. THIS WILL CAUSE THE SHAFT TO MOVE UPWARD ON THE SPIRAL GEAR WHEN COASTING, AND BLOCK GOVERNOR FEED OIL.
- CORRECTION:** REMOVE THE BOLT AND PIN THAT HOLDS THE GOVERNOR SHAFT INTO THE CASE. INSPECT THE PIN FOR WEAR AND REPLACE IT IF NECESSARY. SEE FIGURE 1.

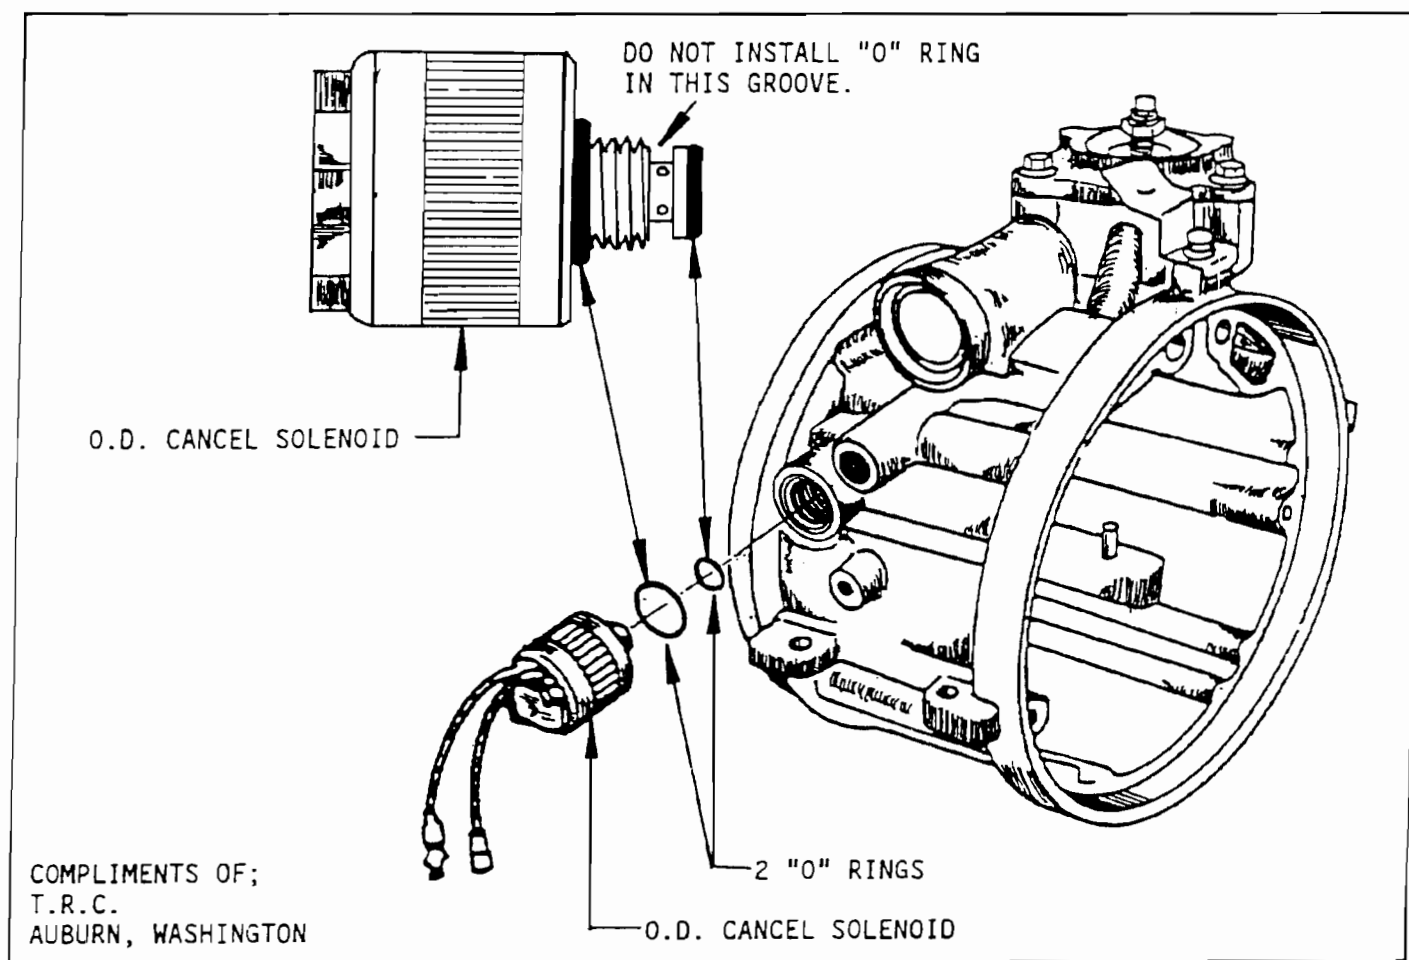
Figure 1

CAUSE: The cause may be the small "O" ring missing, or mis-installed in the groove of the O.D. cancel solenoid. The small "O" ring goes BEHIND the O.D. cancel solenoid, as shown in Figure 1, and seals against the bottom of the case bore (See Figure 1).

CORRECTION: Install "O" ring in proper location as shown in Figure 1.

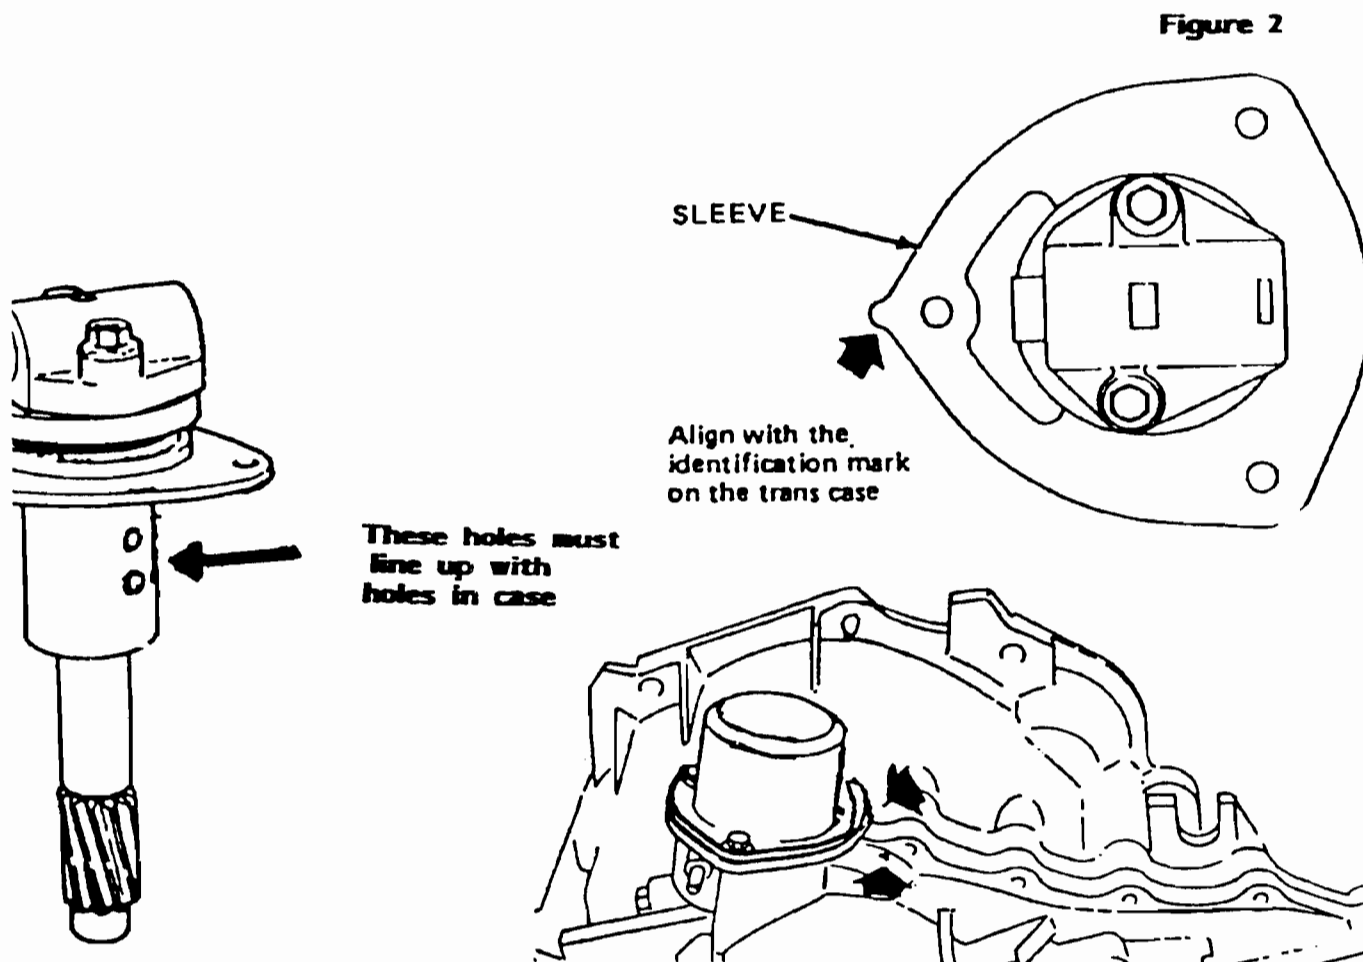
CAUSE: GOVERNOR IS INSTALLED INCORRECTLY.

CORRECTION: THE HOLES IN THE GOVERNOR SLEEVE MUST LINE UP WITH THE HOLES IN THE CASE (FIGURE 1); FIGURE 2 SHOWS THE WAY IT SHOULD BE ON FINAL INSTALLATION.

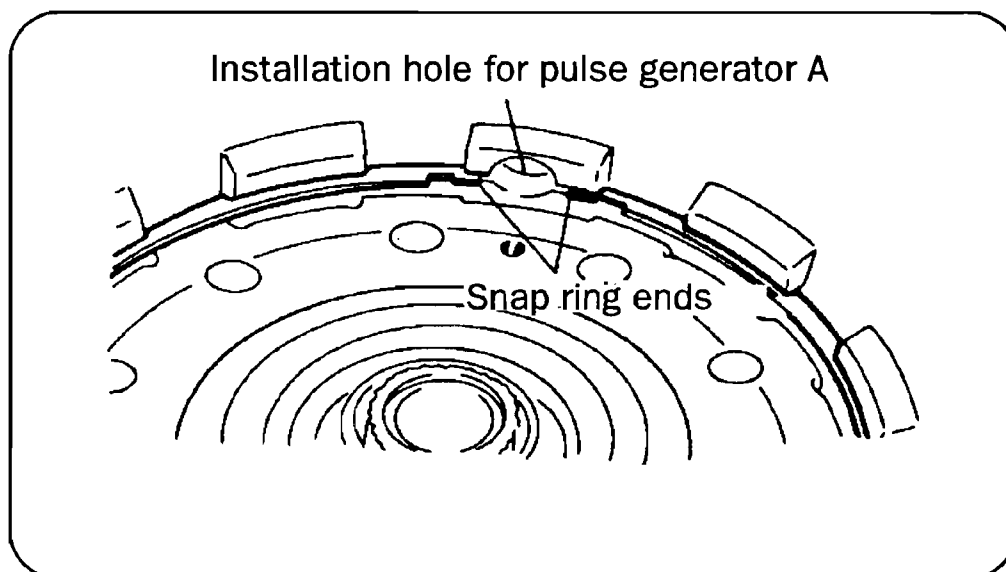
Figure 1

**Cause:** The snap ring that holds the center support into the case may have been mis-positioned and when pulse generator A was installed, one end of the snap-ring came out of its groove and jammed against the sun shell.

**Correction:** Install the snap-ring so that the open end of the snap-ring faces the entrance hole in the case for pulse generator A. See figure 1 below.

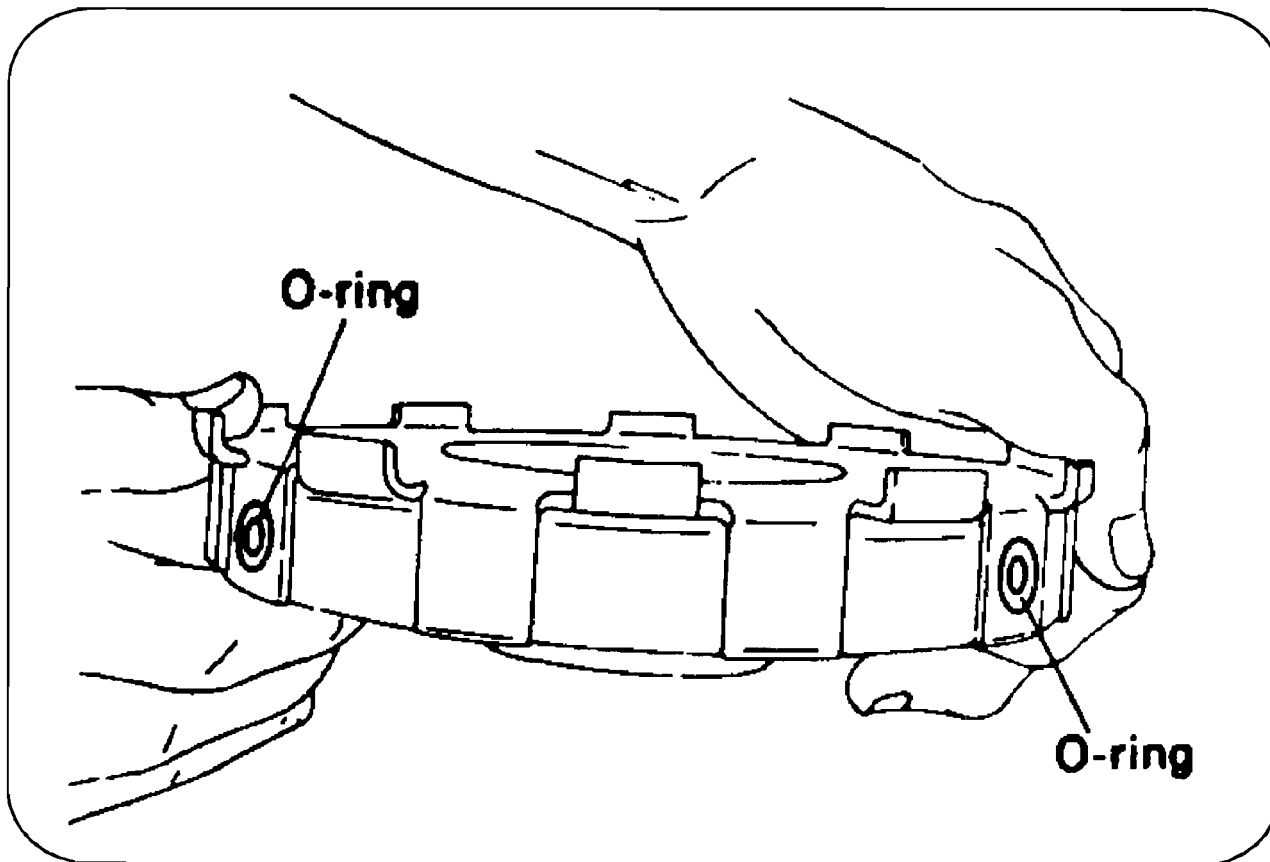
Figure 1

- Complaint:** Slipping or no reverse when hot after overhaul.
- Cause:** Missing or undersized O'rings on the center support causing a loss of low and reverse oil.
- Correction:** Install or replace O'rings with a thicker O'ring. A C4 inner linkage seal O'ring is thicker and fits nicely into the support. This will provide a better compressed seal when the support is placed into the case. See figure 1 below for the O'ring location on the center support.

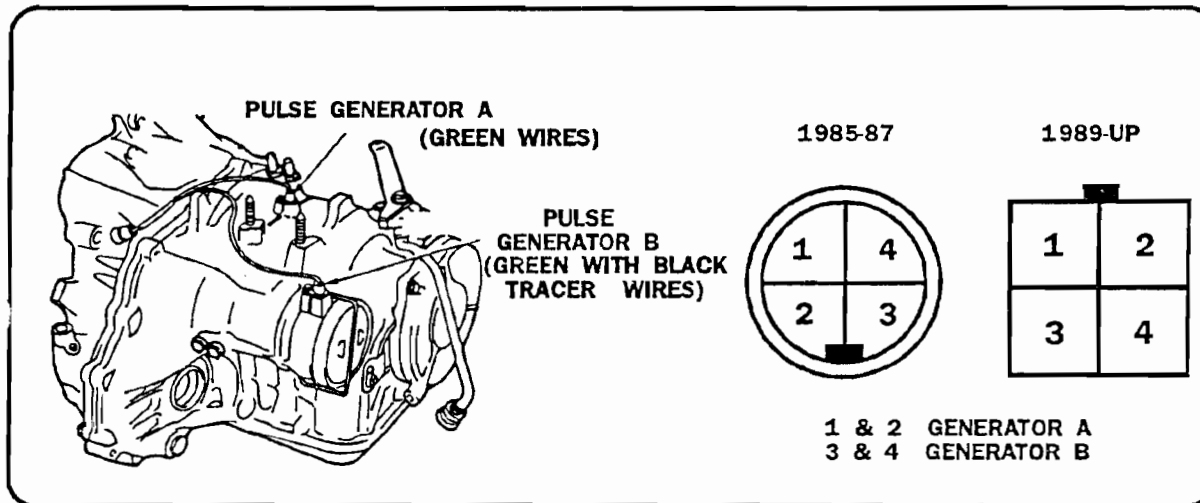
Figure 1.

### SHIFTS TO FAIL-SAFE AFTER OVERHAUL

**COMPLAINT:** After an overhaul, some KM175-177 series transaxles may go to fail-safe after making the first shift. If the key is turned off, the transaxle will start in first gear again until making the first shift.

**CAUSE:** Pulse Generator A and Pulse Generator B may be be switched. Both pulse generators plug in the same way and may be installed backwards.

**CORRECTION:** The pulse generator with the green (solid color) wires must go behind the bell housing. The pulse generator with the green with black tracer (striped color) wires must go to the output shaft (SEE FIGURE 1).

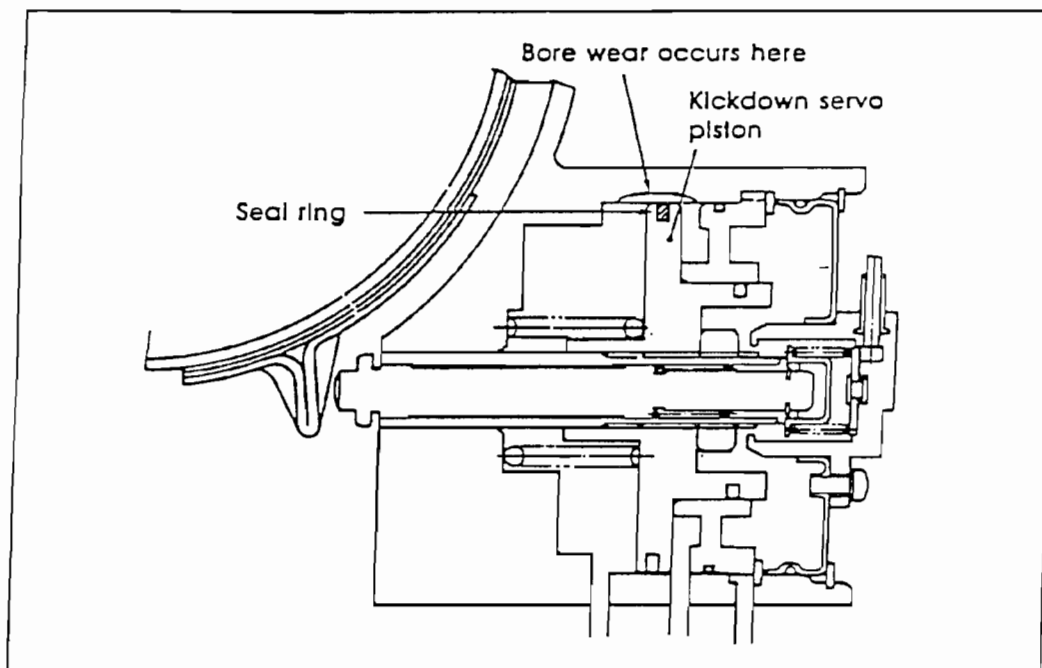
Figure 1

These symptoms may be due to the kickdown servo piston not releasing properly. This is caused by hydraulic fluid leaking past the seal ring of the servo piston as a result of wear in the piston bore (Figure 1). Because wear of the piston bore varies between vehicles, the severity of the symptoms will also vary.

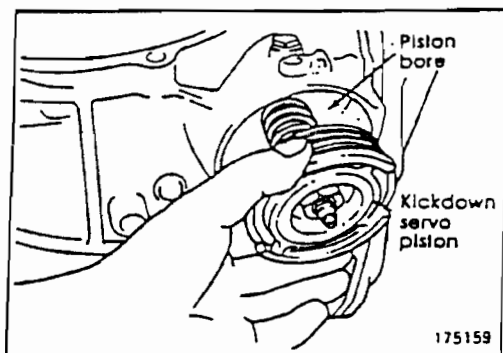
Figure 2

If hard shift symptoms are exhibited, remove the servo piston assembly from the transaxle and check the piston bore (transaxle case) for wear (Figure 2). If the bore wear is less than 0.023 in. (0.5 mm), the hard shift symptoms can be improved by installing a D-ring repair kit (P/N MD728665). This kit contains a rubber piston seal ring instead of the carbon material seal ring installed at the factory (Figure 3).

If the piston bore wear is greater than 0.023 in. (0.5 mm), the transaxle case must be replaced using a new carbon material servo piston seal ring (P/N MD727999).

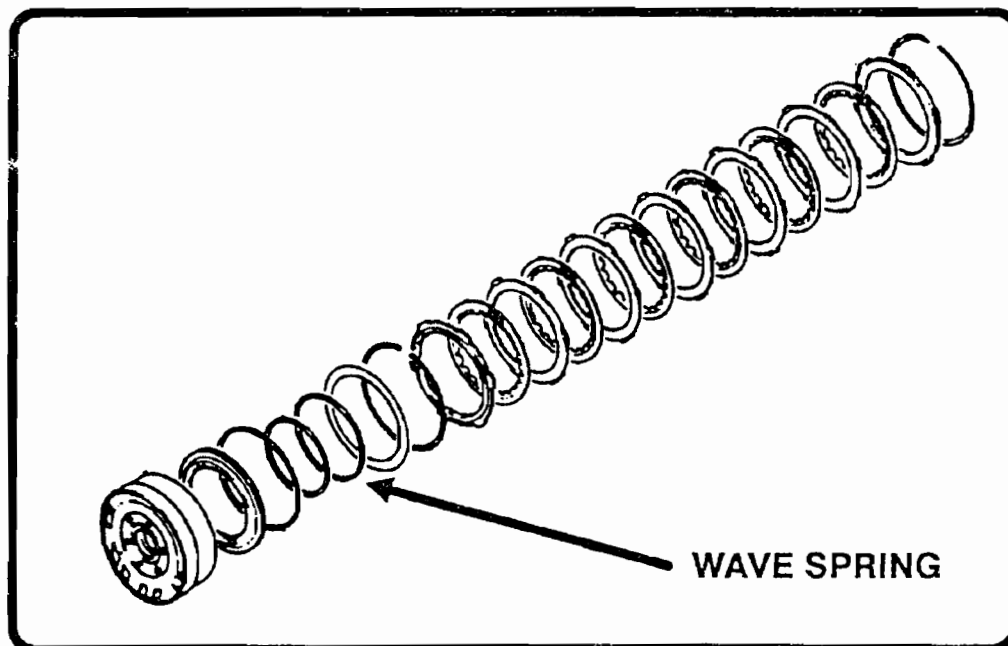
Figure 1

**COMPLAINT:** *Bind up in D: second, third, or overdrive. And the low reverse clutches are burned.*

**CAUSE:** *Broken square cut waved spacer found underneath the diaphragm return spring in the low reverse clutch housing, and will not allow the clutch to release (see figure 1).*

**CORRECTION:** *Replace the wave spacer.*

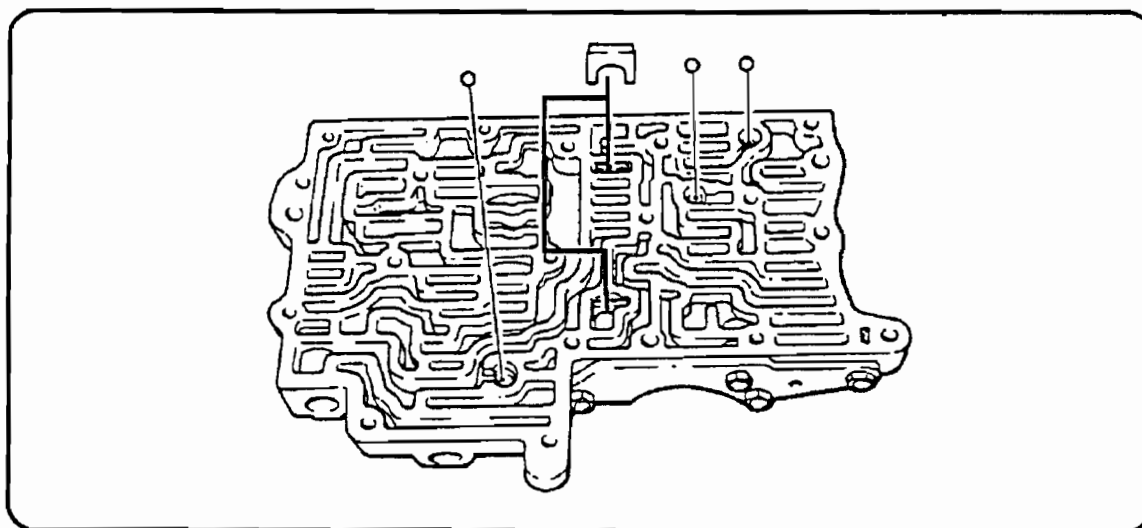
FIGURE 1.

**COMPLAINT:** After an overhaul, the KM175 may have wrong gear starts and possibly only one shift, similar to fail safe, but energizing Shift Solenoids A and B cannot make it start in first gear.

**CAUSE:** If the solenoids are not clogged or damaged, one or both of the stopper plates in the upper valve body may have gotten turned around or installed incorrectly when the valve body was opened for cleaning. The stopper plates can prevent the shift control valve from moving if they are installed incorrectly. See **figure 1** for valve body position.

**CORRECTION:** When installing both stopper plates in the upper valve body, be certain that they go in with the horseshoe end down. See **figure 2**. Next, check to make sure that the shift control valve is free to travel past the stopper plates in both directions, and that the end plugs are not straddled by the stopper plates.

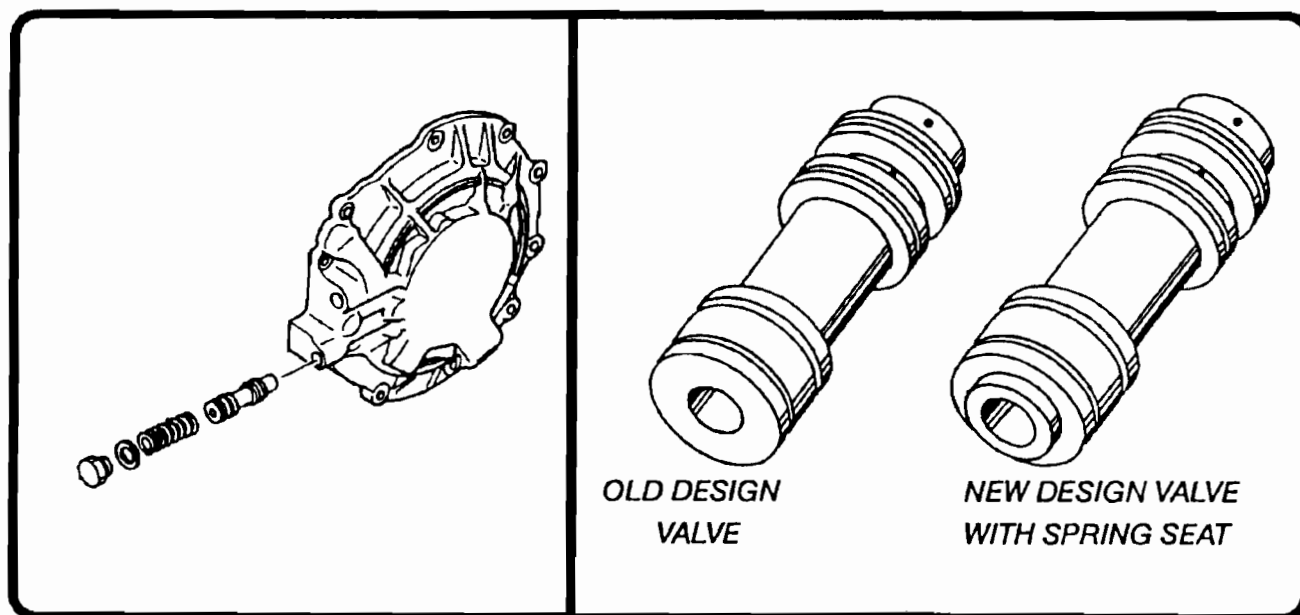
FIGURE 1

**CAUSE:** *The spool valve in the pump did not have a seat for the spring. The spring will hang the valve and cause low line pressure (figure 1).*

**CORRECTION:** *Order updated valve from Ford. It has a seat formed on the valve for the spring and will work on both units (figure 2) part # FO2Z-7Z306-A.*

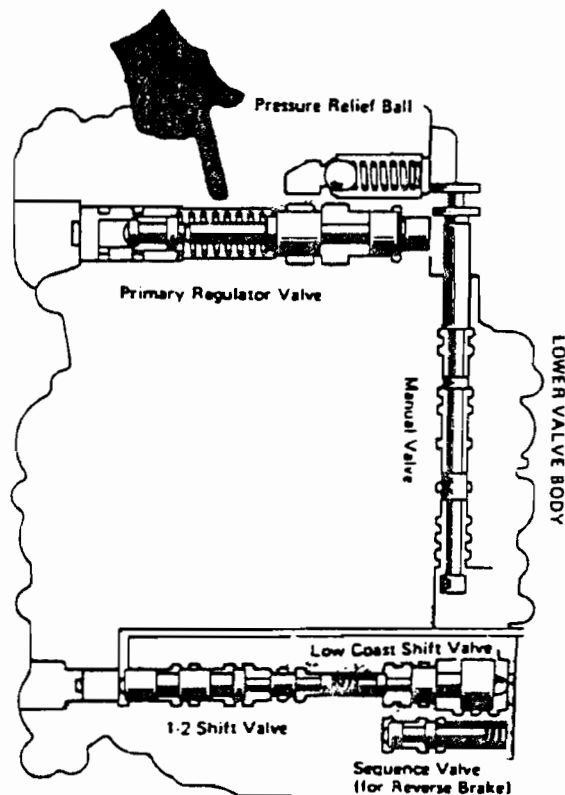
CAUSE: Missing or mis-positioned check ball. High line pressure.

CORRECTION: Install check-ball in proper location or replace Primary Valve Spring with a new spring, part # 90501-18028.

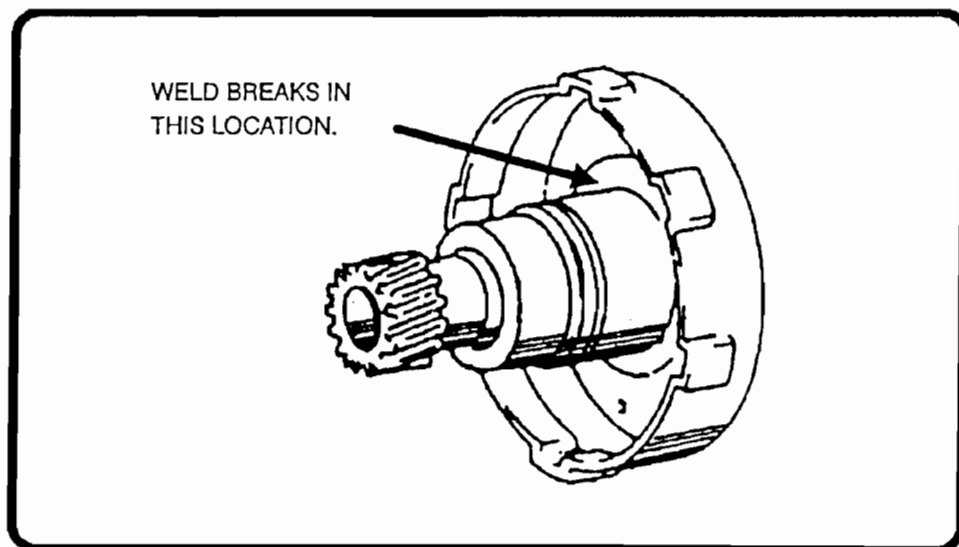
- COMPLAINT:** *Up shifts 1-2, 2-3, 3-4 good but has no reverse.*
- CAUSE:** *Weld for sun gear in overdrive drum broken. Piston must be removed in order to be checked properly .*
- CORRECTION:** *Replace drum.*

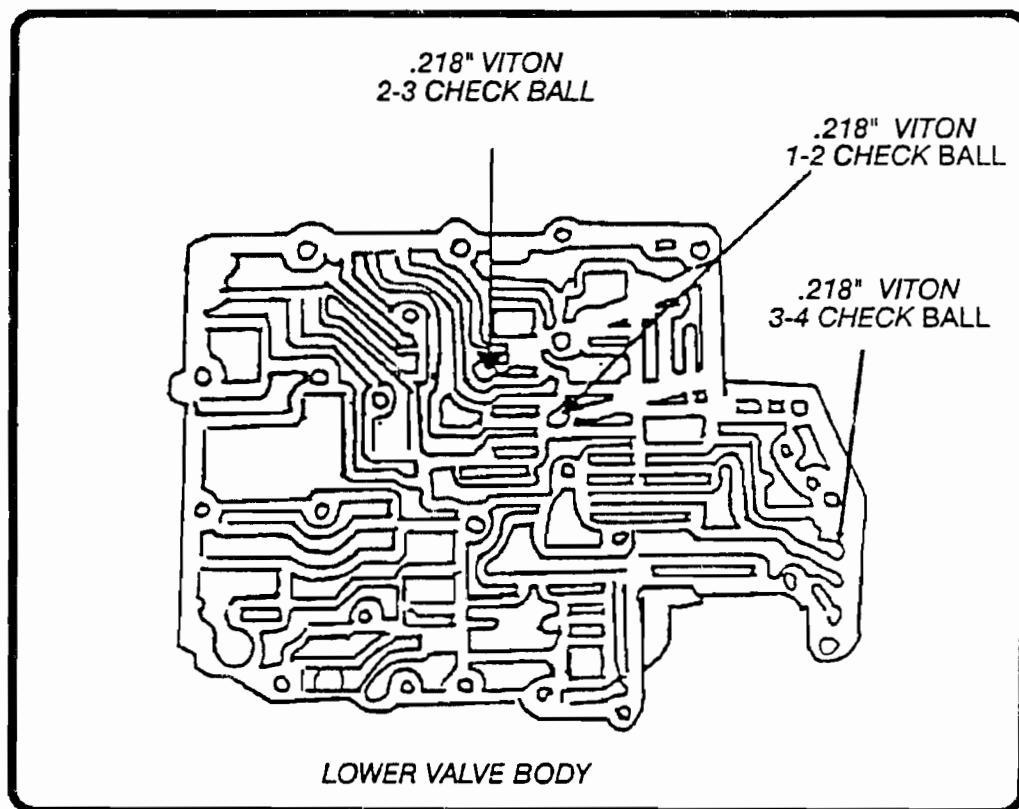
Figure 1

CAUSE: The cause may be a missing or worn check balls.

CORRECTION: Replace check balls in locations shown in Figure 1.

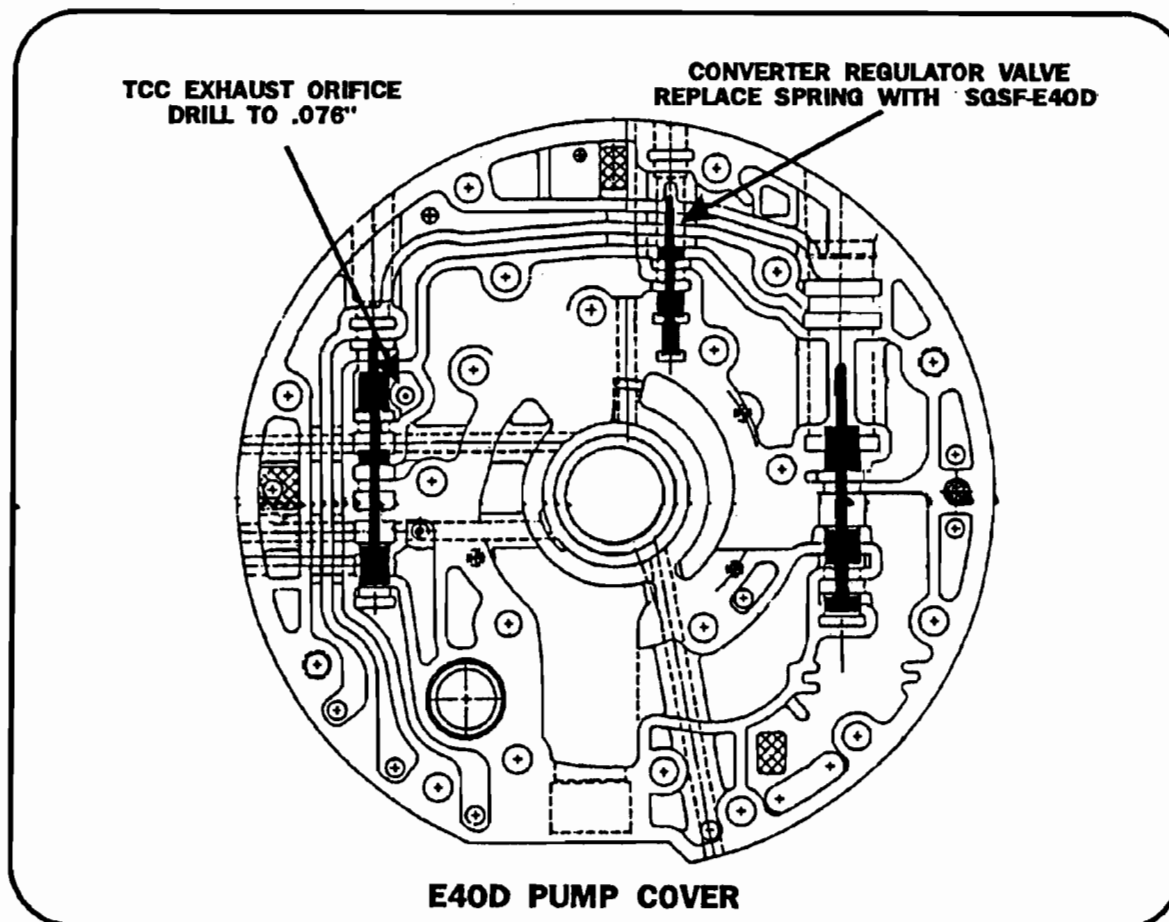
Figure 1

- COMPLAINT:** Soft converter clutch engagement or shudder on hard acceleration
- CAUSE:** Low converter pressure and/or limited ability of the converter exhaust orifice to control converter clutch apply.
- CORRECTION:** Replace the converter regulator valve spring in the pump cover with a "SGSF E4OD" shudder fix spring (see figure 1), Drill the converter clutch exhaust orifice to .076 in. (see figure 1).

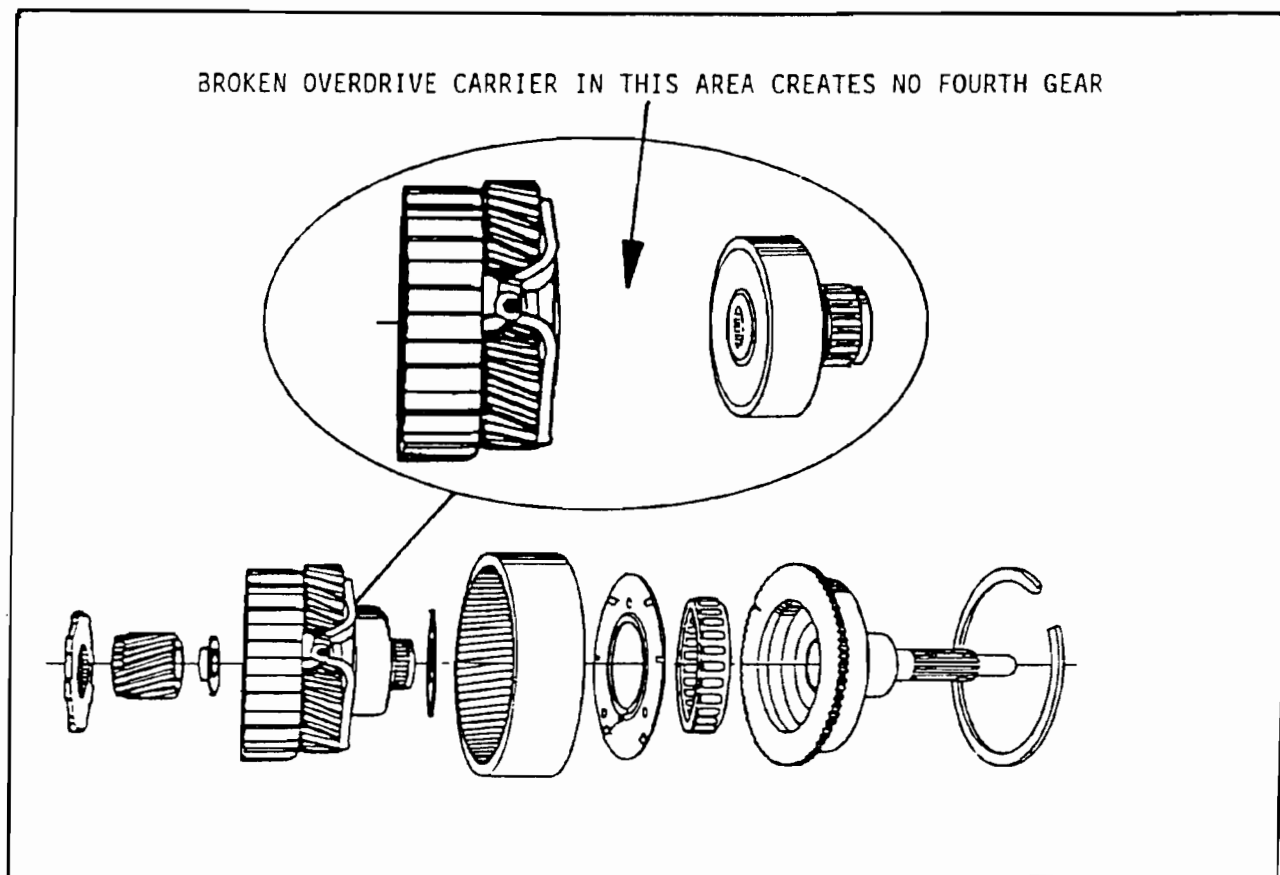
Figure 1

## FORD A4LD NO FOURTH GEAR

CORRECTION: Replace overdrive carrier complete.

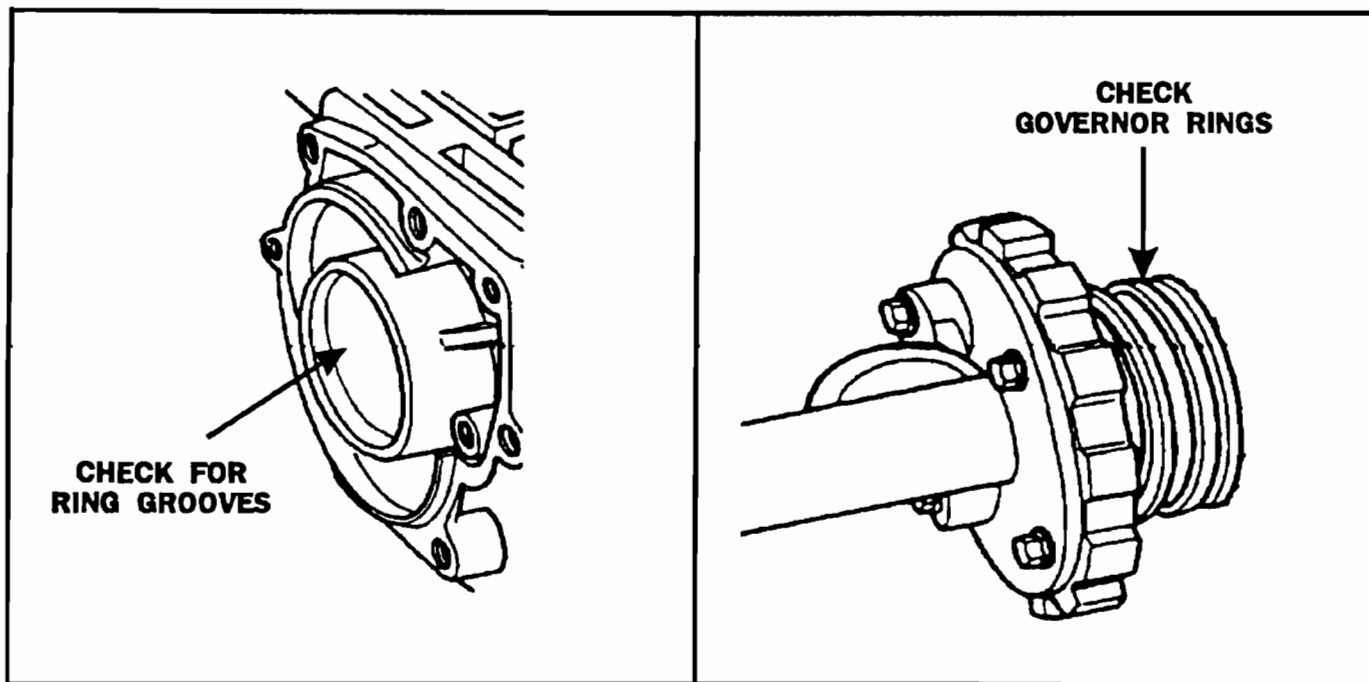
FIGURE 1

- COMPLAINT:** BOLWING FLUID OUT THE BREATHER VENT
- CAUSE:** ONE POSSIBLE CAUSE IS GOVERNOR RINGS LEAKING CAUSING PRESSURE TO BUILD UP IN THE CASE BLOWING FLUID OUT THE VENT.
- CORRECTION:** CHECK GOVERNOR BORE (FIGURE 1) FOR RING GROOVES, IF RING GROOVES ARE PRESENT REPLACE CASE OR INSTALL A SLEEVE KIT. ALSO CHECK GOVERNOR RINGS FOR DAMAGE (FIGURE 2) REPLACE IF NECESSARY.
