Technical Service Information

FORD E4OD DELAYED ENGAGEMENT

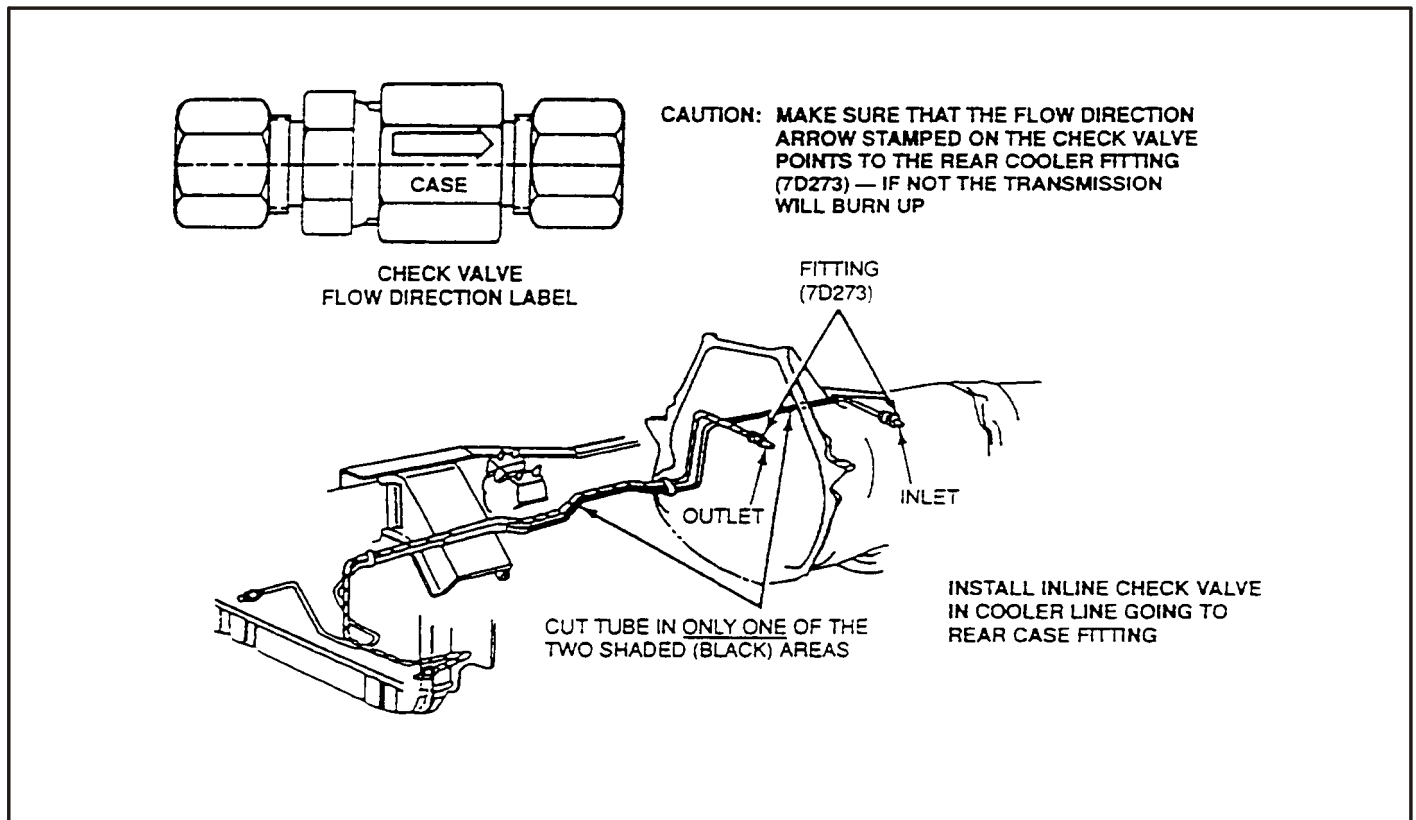
Figure 1

COMPLAINT: A delayed engagement of 10 to 30 seconds, after setting for an extended period of time.

CAUSE: The cause may be, converter drain back through the cooler.

CAUSE: Install an in-line check valve, OEM part number F0TZ-7D174-A, in the "COOLER RETURN LINE" going to the REAR case fitting. (See Figure 1).

NOTE: MAKE SURE THAT THE FLOW DIRECTION ARROW STAMPED ON THE CHECK VALVE POINTS TOWARDS THE REAR COOLER FITTING, OR A TRANSMISSION FAILURE WILL RESULT.
