# Technical Service Information

## MERCEDES 722.6 VARIETY OF SHIFT AND/OR TCC COMPLAINTS

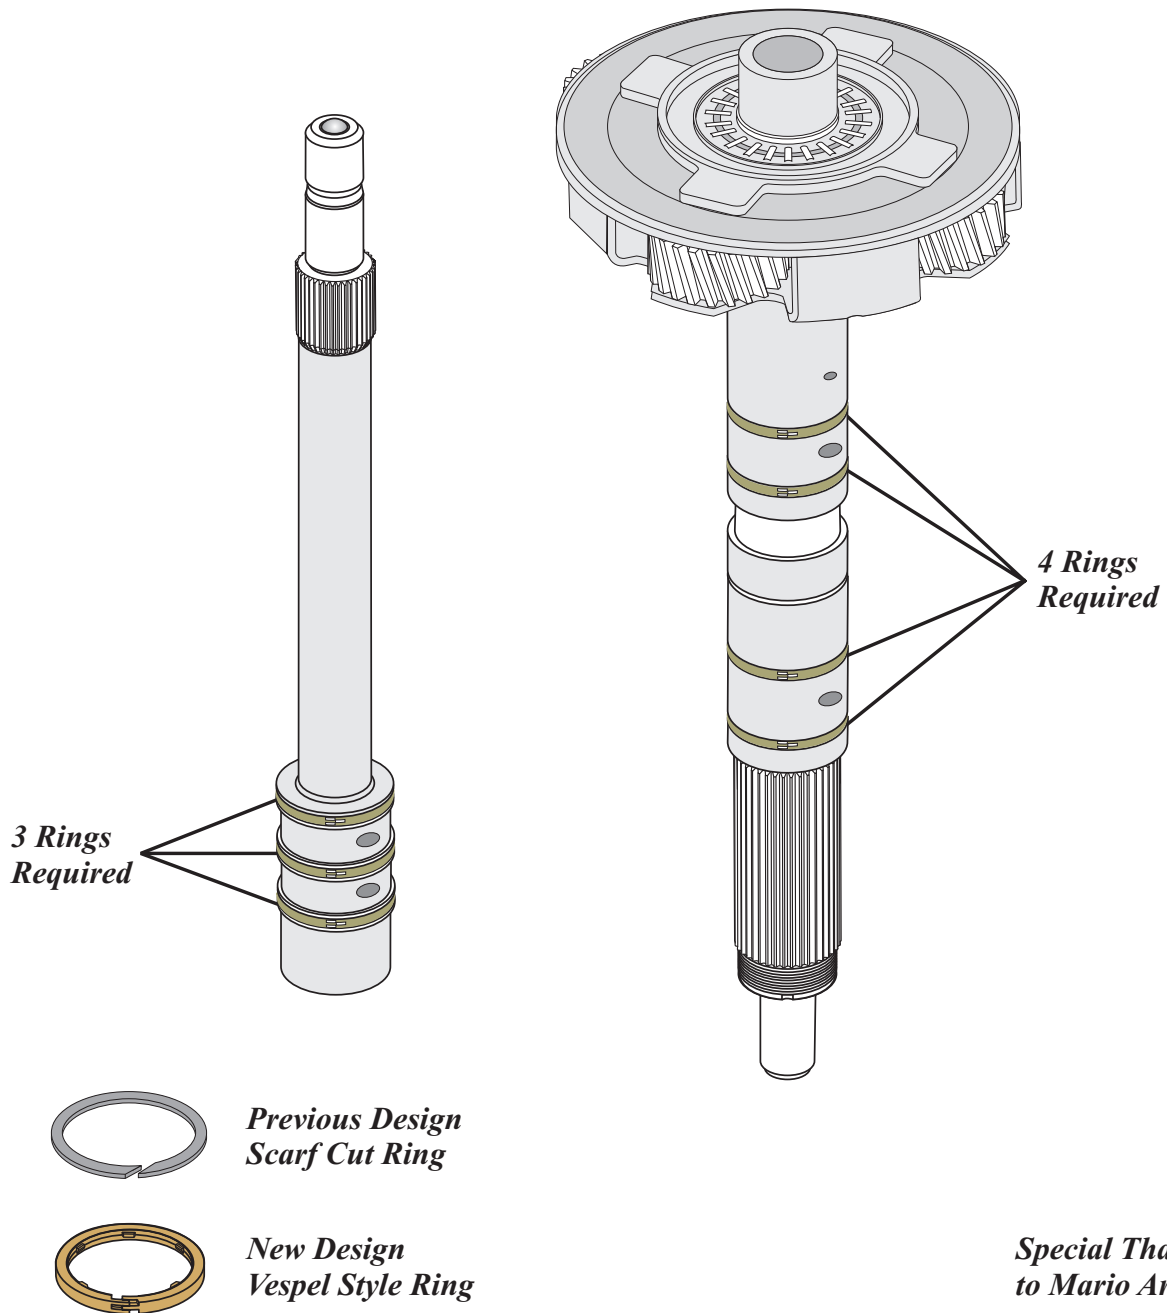
Figure 1

**CAUSE:** Low retention of OEM scarf cut sealing rings for the K2 clutch drum on the input shaft as well as the output shaft rings for the K3 clutch drum (See Figure 1). The rings on the input shaft could cause a loss of pressure for the K2 clutch and/or the converter clutch while the rings on the output shaft could lose K3 clutch pressure. The severity of the leak would determine the degree of shift complaints.

**CORRECTION:** Since pressure testing with a gauge is not available, it is highly recommended to update the rings to the newer style as seen in figure 1 and replace the sprags, especially if the F1 sprag has 16 elements and the F2 has 14. These are early sprags and are prone to slipping. Both sprags have been updated to 20 elements each (See Figure 2 and 3).

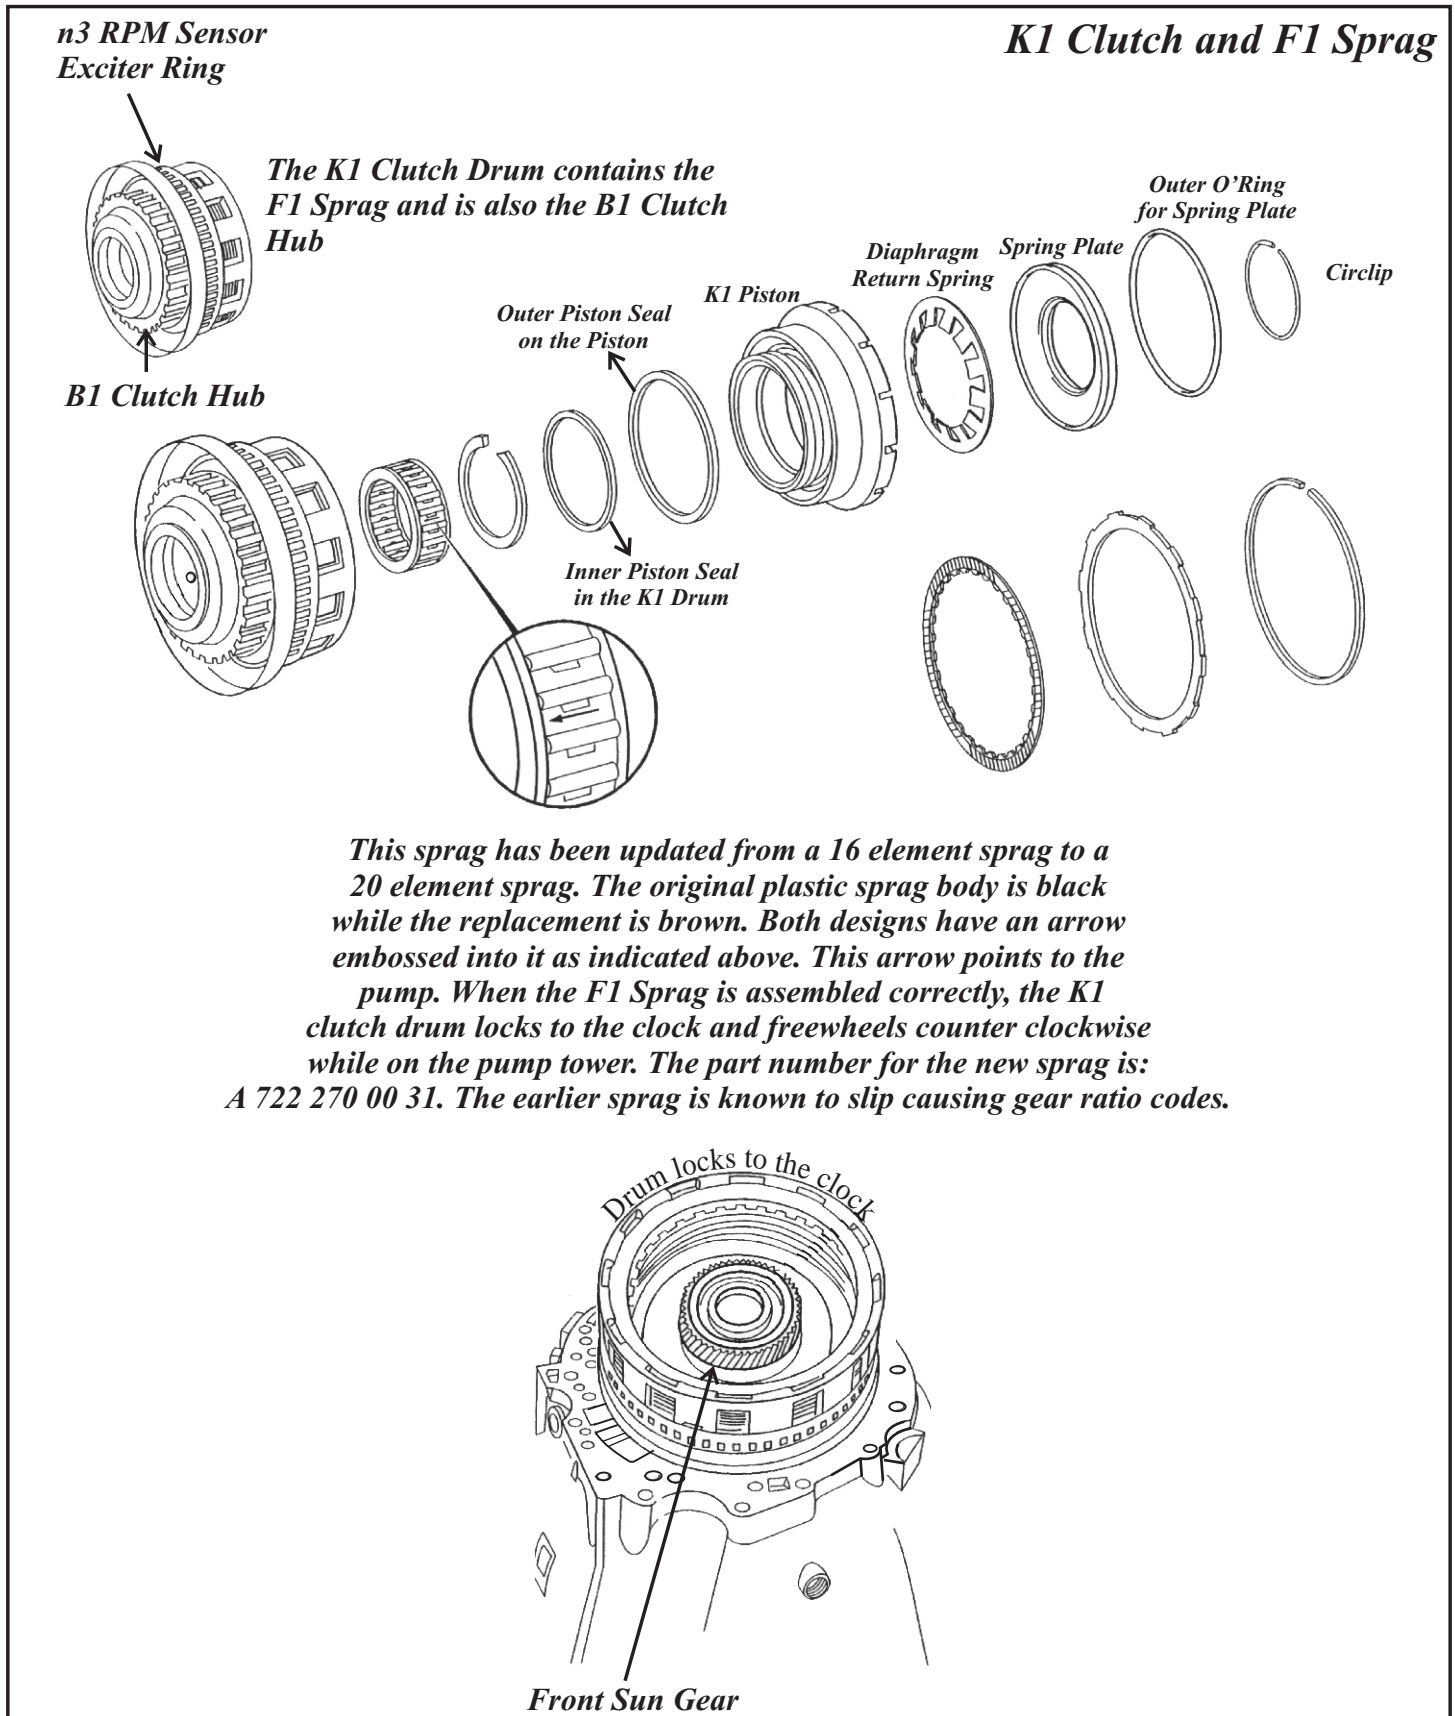
Figure 2

It should be noted that the F1 and F2 sprags are also known to slip causing shift complaints and implausible shift errors (gear ratio errors) especially if they are not the later 20 element design.

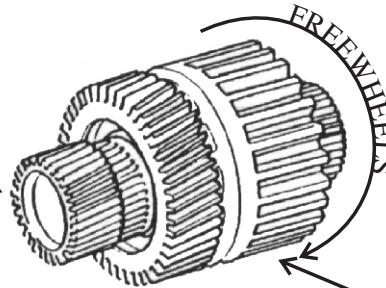
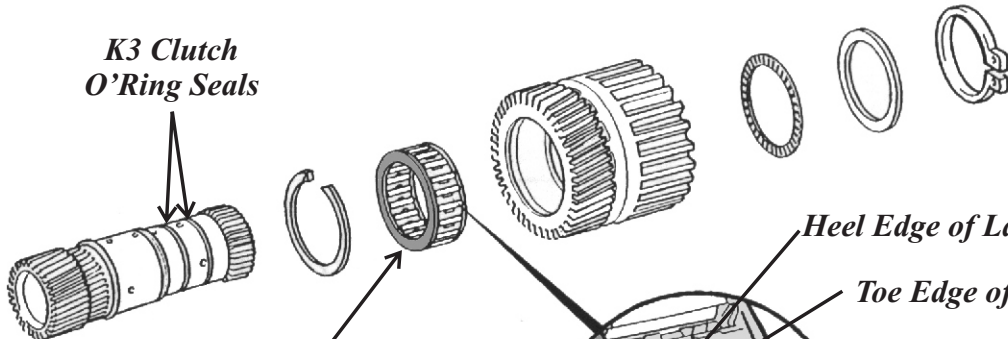
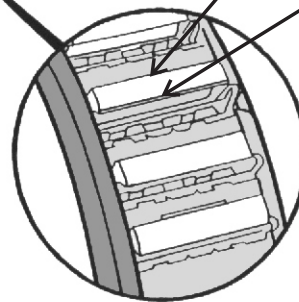
Figure 3

This sprag has been updated from 14 elements to 20. The new 20 element sprag part number is A 220 270 01 31. It is very common to find that some of the elements have fallen out from the retaining cage and laying loose in the package. This does not mean the sprag is defective. It is imperative that you insert the element back into the cage slot correctly. The shorter foot of the element faces the inner race as seen to the right. With the brass cap to the left as seen in the enlarged circled view, the toes face down. The early design sprag is known to slip causing gear ratio codes.
