Technical Service Information

ZF-4HP-22/24

REPEATED LEAK FROM BELL HOUSING AREA

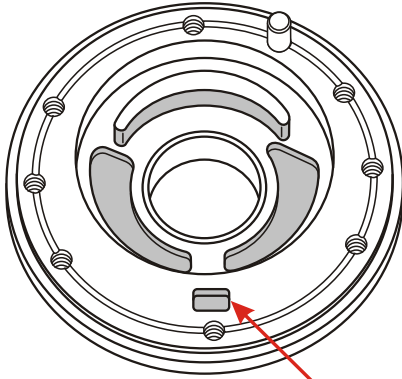
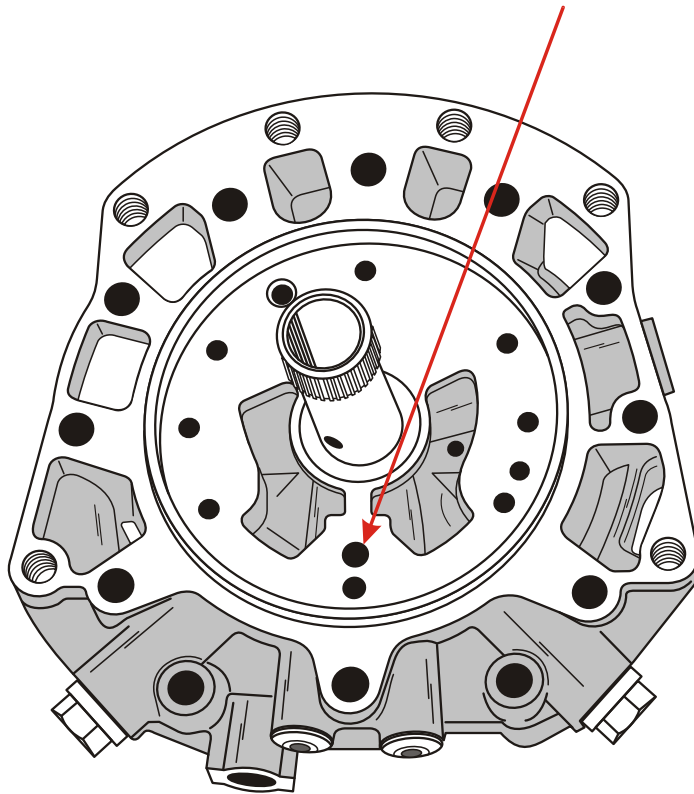
1ST DESIGN PUMP BODY AND PUMP COVER

- COMPLAINT:** Repeated leakage of transmission fluid, coming from the bell housing area on any vehicle equipped with the ZF-4HP-22 or 4HP-24 transmission. This usually occurs after rebuild coupled with pump parts replacement that was necessary.

- CAUSE:** Beginning in the 1989 model year, ZF implemented a running change to the pump body and pump cover on both the 4HP-22 and the 4HP-24 transmissions. This change was made to increase the durability of the converter bushing with increased lubrication to this area. This change however, created the possibility of mis-matching parts that are not compatible. The 1st design pump body and cover has the drain back hole located at the 6 O'clock position and the drain back passage was moved to the 3 O'clock position in the 2nd design pump body and cover, as shown in Figure 1. Installing 2nd design pump body with 1st design pump cover will completely block the drain back passage and the repeated leakage will occur. Installing the 1st design pump body with 2nd design pump cover will function, but you will now be faced with the possibility of premature converter bushing failure.

- CORRECTION:** To eliminate both conditions, always install the 2nd design pump body, matched with the 2nd design pump cover, as shown in Figure 1.
