Technical Service Information

TOYOTA A130 SLIPPING IN 2ND GEAR

The purpose of this bulletin is to aid in the diagnosis and repair of the A140E, A130L and A131L automatic transaxles.

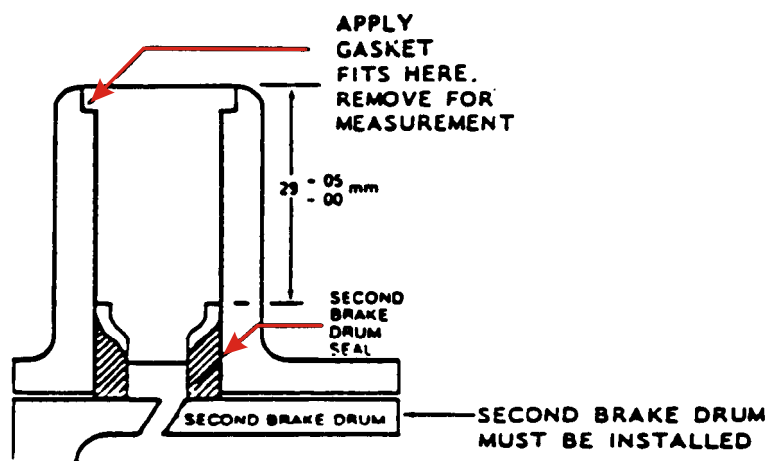
Figure 1

Internal pressure loss at second brake drum (B2) seal.

Install a new second brake drum (B2) seal, (P/N 35159-32010) to the proper designated depth of 29 mm (1.14 in). This measurement must be taken from the case surface with the second brake apply gasket removed.
