MAZDA N4AEL SOFT OR FLARED SHIFTS WHEN WARM

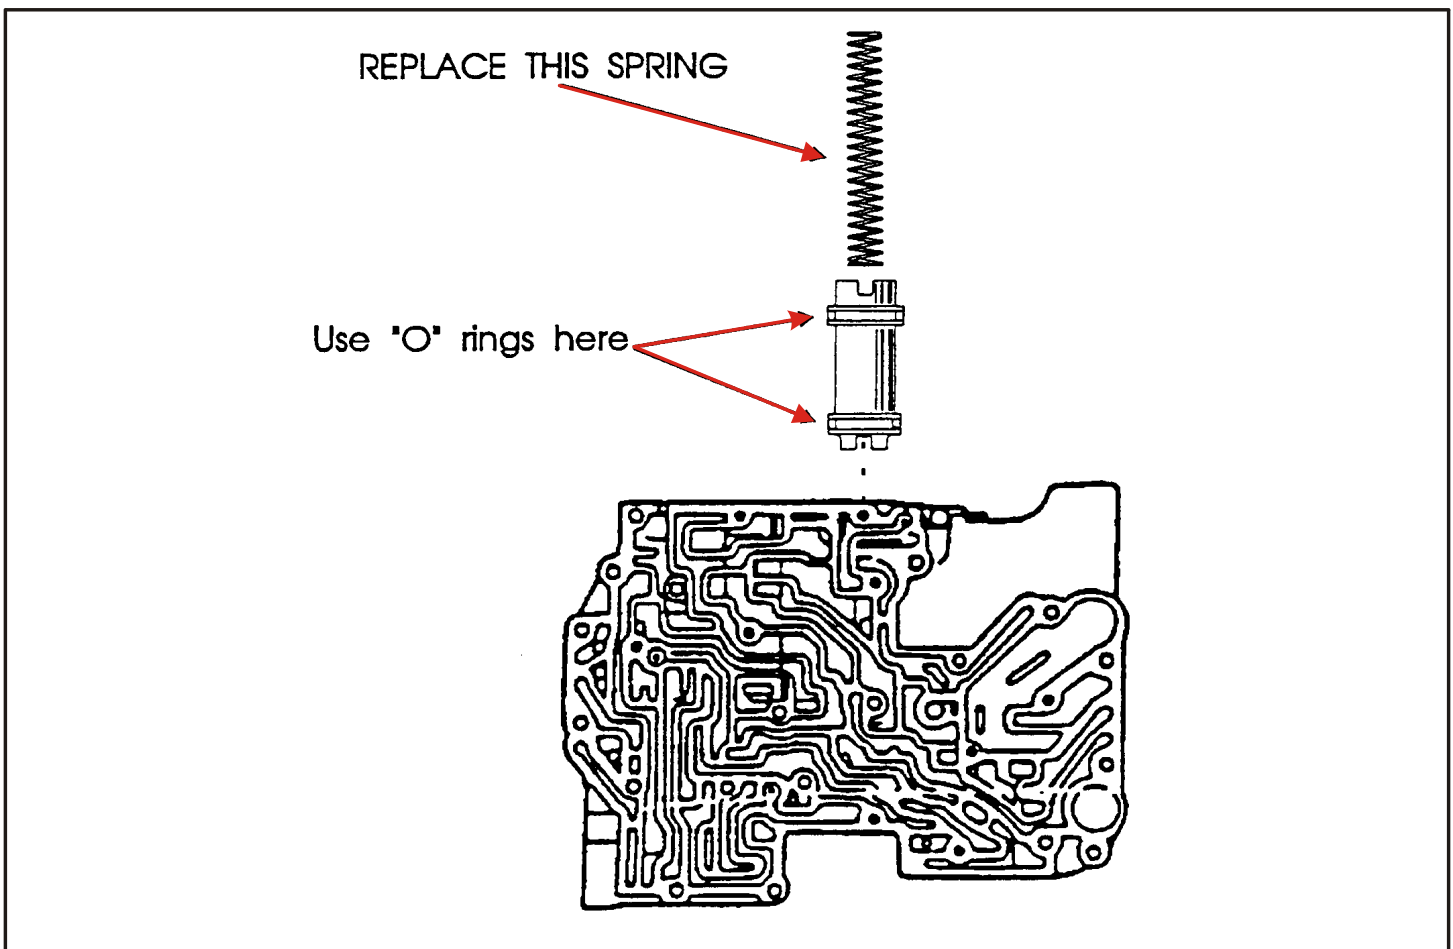
Figure 1

COMPLAINT: Shifts seem fine when cold, but become increasingly drawn out as the transmission warms up

CAUSE: Valve body calibration problems related to fluid temperature.

2. Replace the 1-2 accumulator piston teflon rings with suitable "O" rings. Replace the 1-2 accumulator spring with a stronger spring (A 700-R4 throttle plunger spring is sufficient if it is shimmed 1/4 in. on the piston side). SEE FIGURE 1.
