Technical Service Information

CHRYSLER A404 HARD OUT OF PARK (NEW PARK ROD)

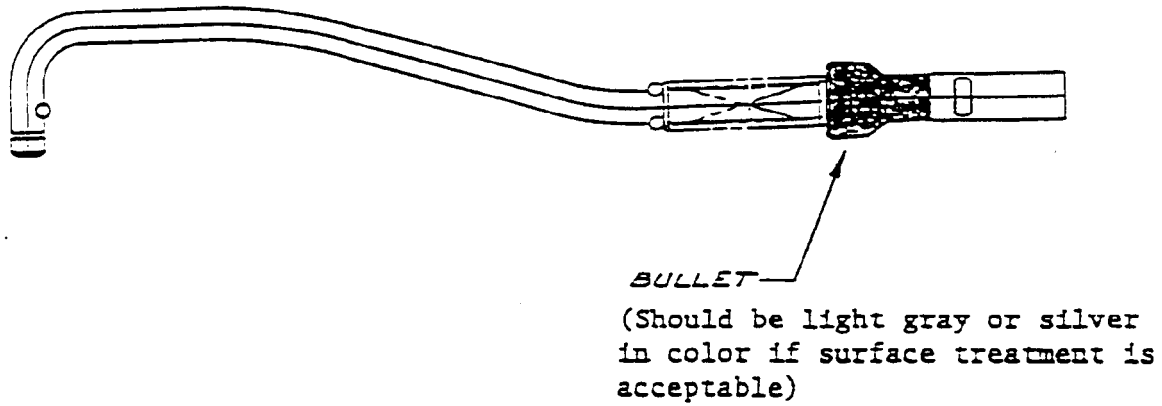
Figure 3

Inspect shift cable and linkage for proper routing and adjustment. If routing and adjustment are proper, the condition may be due to improper surface finish of the bullet end of the park sprag rod (Figure 3).

FWD PARK SPRAG ROD ASSEMBLY

1. Remove the transaxle oil pan.
2. Remove the "E" clip retaining the park sprag rod to the valve body (Figure 4).
3. Remove the park sprag rod from the transaxle assembly and inspect the bullet end of the rod (Figure 1). If the bullet end surface is dark blue or black, replace the park rod assembly with PN 4207130 containing a bullet that is silver or light gray in color.
4. Reinstall "E" clip, install the transaxle oil pan, and refill with automatic transmission fluid.
NOTE: The manual shift lever (at the transmission) may have been bent if the vehicle operator has attempted to force a transmission with an improperly finished rod out of the park position. Therefore, after replacing the park sprag rod, check the shift lever and replace if lever is bent.
5. Check linkage adjustment and road test to verify operation.
