Technical Service Information

MAZDA/FORD G4A-EL

3RD GEAR SHIFT SHUTTLE

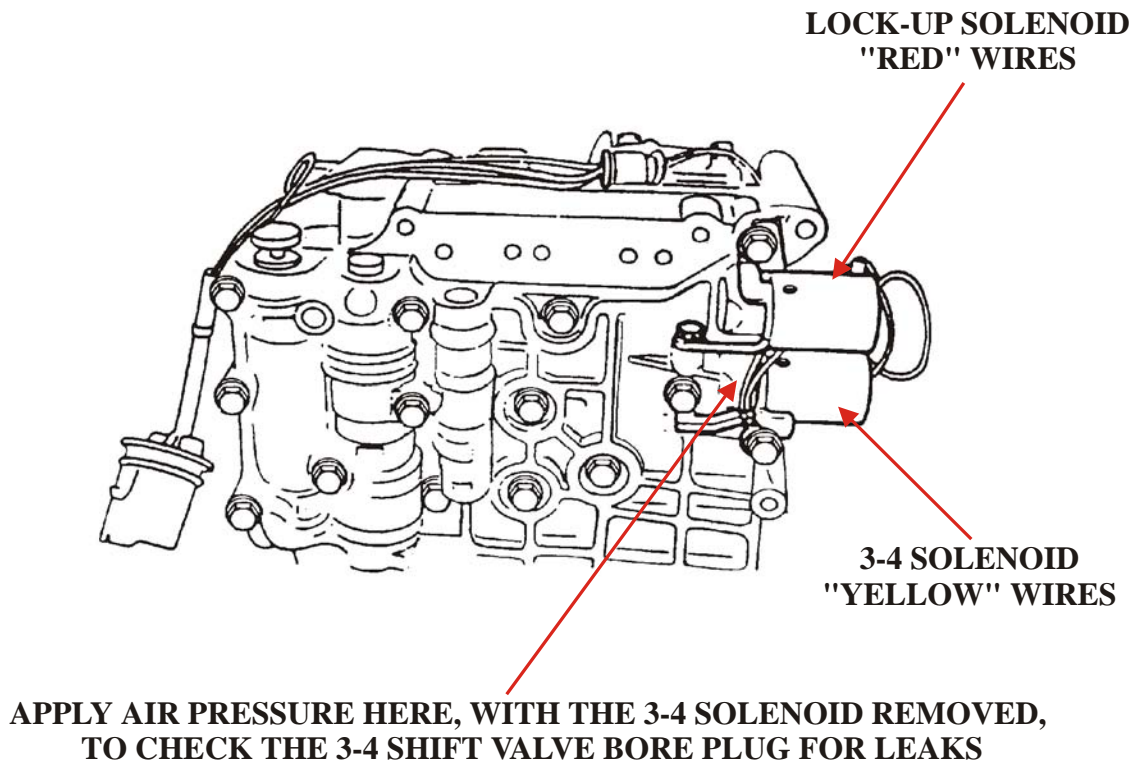
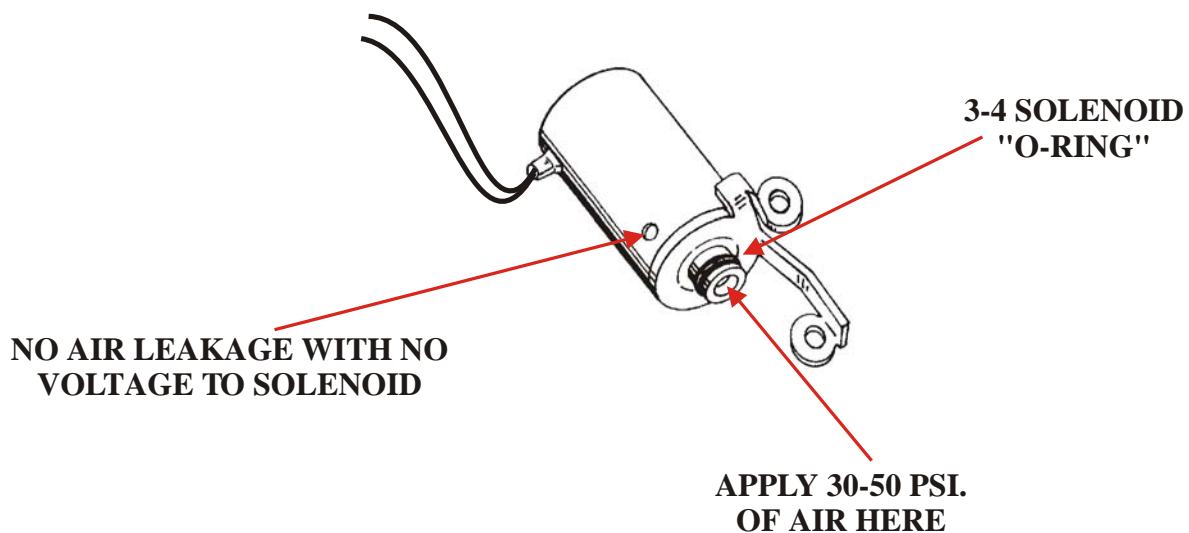
CAUSE: The cause may be, the 3-4 shift solenoid is partially stuck open, the 3-4 shift solenoid "O-ring" is damaged or the 3-4 shift valve bore plug is leaking. This may cause the 3-4 shift valve to **block** Coast Clutch apply oil and to exhaust Servo Release oil. Computer strategy, while in 3rd gear under 25MPH., commands the 1-2 solenoid **off** which in turn **blocks** Servo apply oil. At speeds above 25MPH., while in 3rd gear, computer strategy commands the 1-2 solenoid to be **on** which turns **on** Servo apply pressure in preparation for the upshift to 4th gear. When 1-2 solenoid application occurs, while in 3rd gear above 25 MPH., drum speed or pulse generator output may drop because of the lack of Servo Release oil. When the computer recognizes that Pulse Generator input or drum speed has dropped it may turn the 1-2 solenoid **off**. This on and off cycling of the 1-2 solenoid may continue until the upshift to 4th occurs.

3-4 SOLENOID LOCATION

3-4 SHIFT SOLENOID MECHANICAL FUNCTION

CORRECTION: Refer to Figure 1 to identify the 3-4 shift solenoid placement and to check its mechanical function. Apply air pressure to the end of the solenoid as shown in Figure 1 to ensure that the 3-4 shift solenoid is closed and check the O-ring for damage. With the 3-4 solenoid removed, air check the 3-4 shift valve through the hole where the 3-4 solenoid is placed and ensure that there is no air leakage from the bore plug. Refer to Figure 2 for 3-4 shift valve and bore plug location.
