Technical Service Information

A4AF3/A4BF2

NO FORWARD IN DRIVE AFTER OVERHAUL MANUAL LOW & REVERSE OK

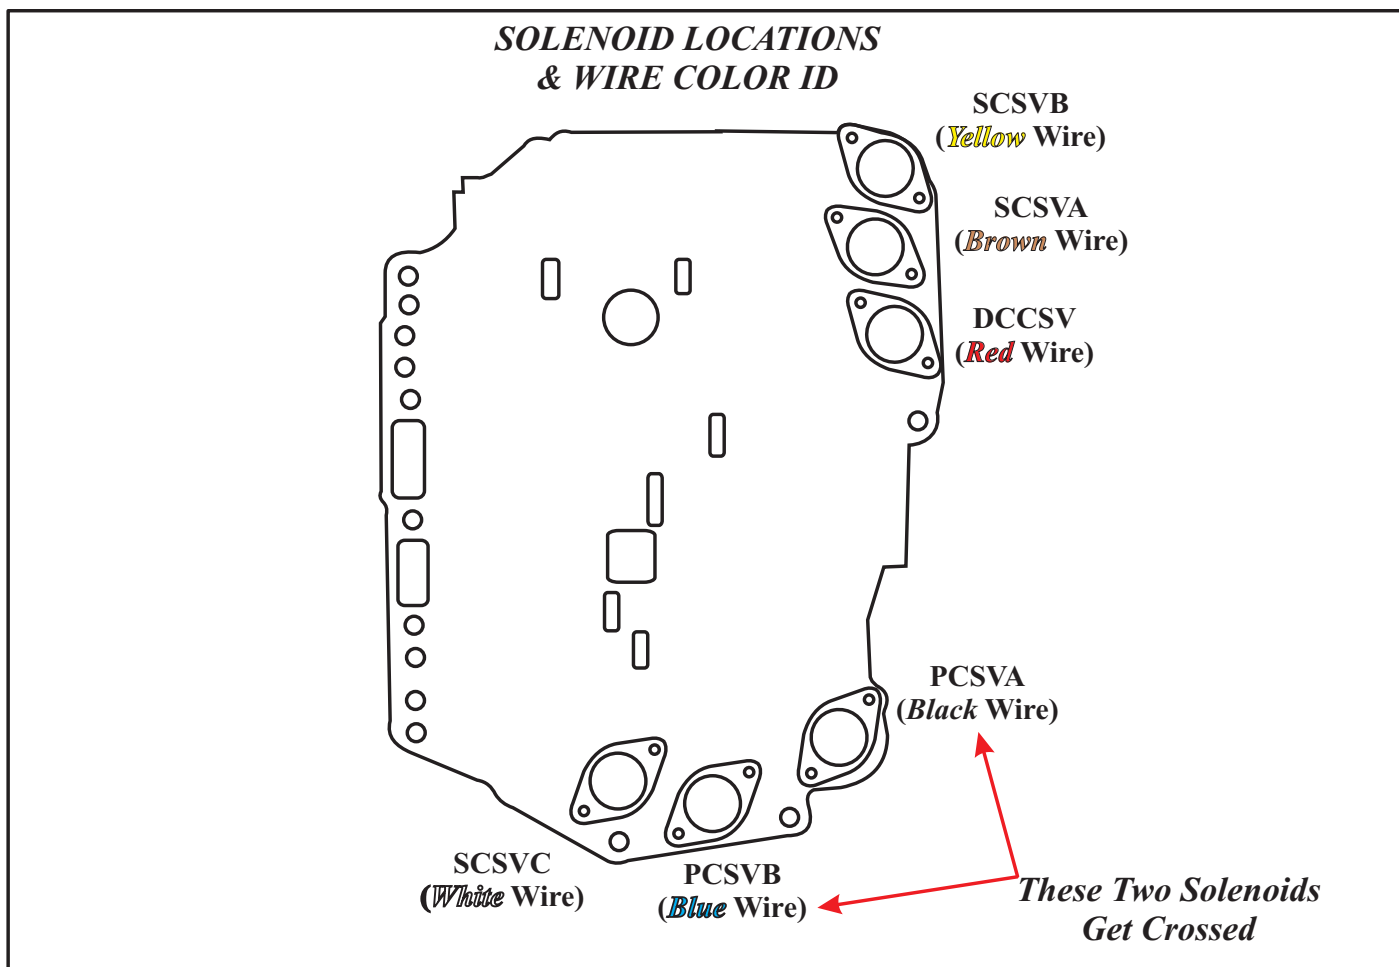
CAUSE: The PCSV-A pressure control solenoid with the black wire being switched with the location of the PCSV-B pressure control solenoid with blue wire during rebuild.

SOLENOIDS IN THE *CORRECT* LOCATIONS

CORRECTION: Replace the solenoids to their correct locations. The diagram in Figure 1 will show the correct location of all six solenoids and wire color. Figure 2 will demonstrate the oil flow and the position of Pressure Control Valve B when the solenoids are in the right location. Allowing oil flow to the rear (forward) clutch drum. The partial oil schematic in Figure 3 will explain why there will be no movement in the Drive range when the solenoids are in the wrong location. Notice that when the PCSV-A solenoid is placed in the location of the PCSV-B in the Drive range. The normal firing order of the solenoids will be incorrect in this location. The PCV-B position will cut off oil flow to the forward drum causing no forward movement in the Drive detent. There may or may not be any movement when engine rpm is increased. Manual low and reverse will be ok.

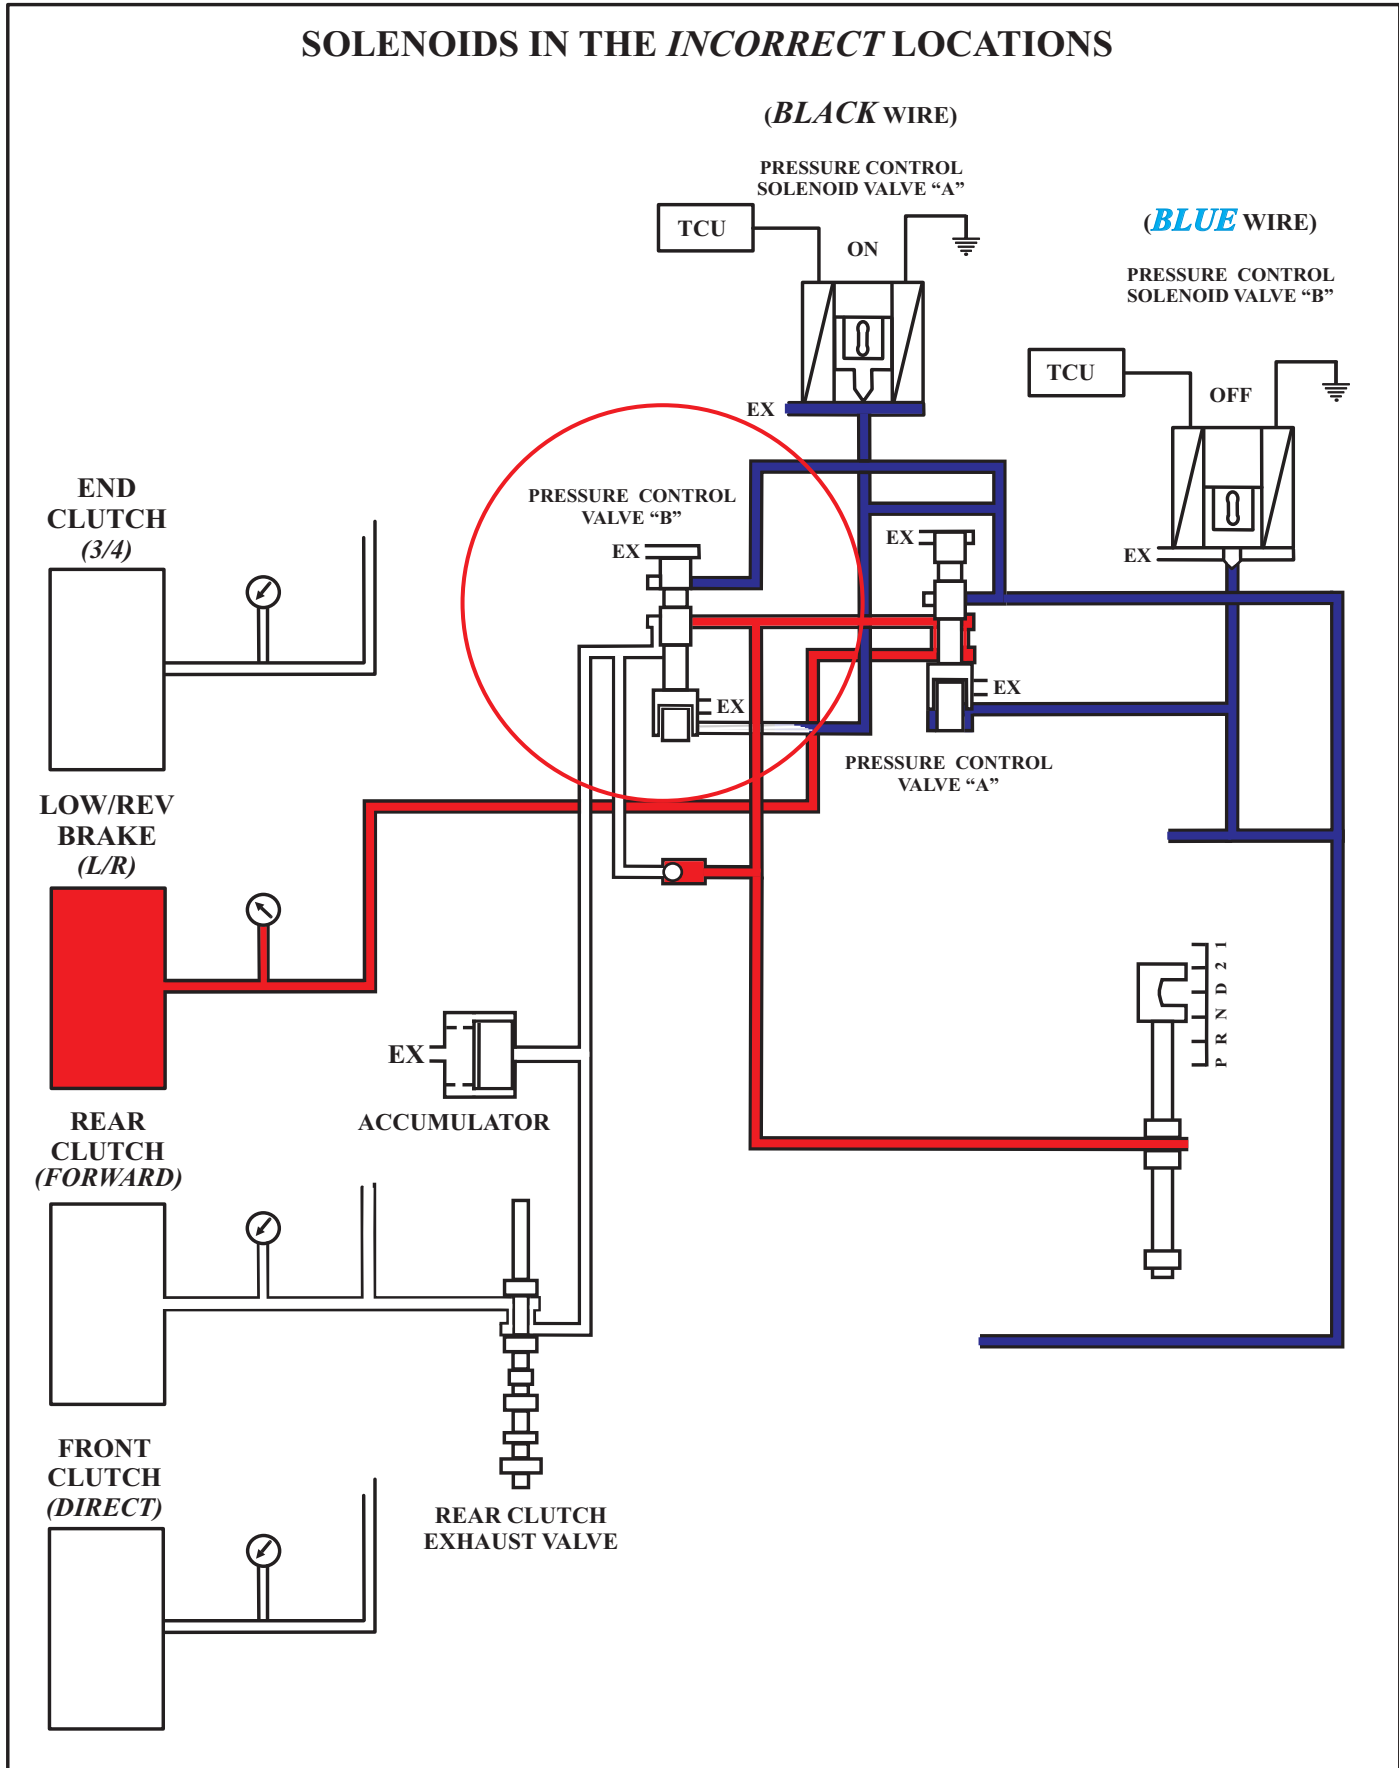
Figure 3

COMPLAINT: A no forward condition in the Drive range after rebuild, reverse and manual low ok. May engage in Drive during high engine RPMs, then neutral out and stop moving.

SOLENOIDS IN THE *INCORRECT* LOCATIONS
