# Technical Service Information

## **CHRYSLER 42RE 1-2 SHIFT SHUTTLE AFTER REBUILD**

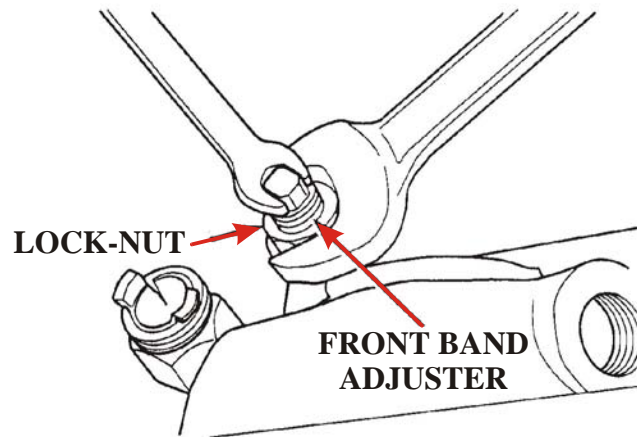
Figure 1

**CAUSE:** The cause may be, that you have adjusted the intermediate band incorrectly, or the seal rings on the 1-2 accumulator piston are leaking.

**CORRECTION:** We have gotten into the habit of adjusting the intermediate band with a visual adjustment during the rebuild process, before we install the bottom pan. This is a grave mistake on the 42RE transmission. You ***must*** tighten the adjusting screw to 72 inch pounds, and then back the adjusting screw off ***exactly*** 3-5/8 turns, as shown in Figure 1. In some cases we have also had to install the previous design 1-2 accumulator piston with steel seal rings as shown in Figure 2.

*Tighten band adjuster to 72 inch pounds,  
and back off "Excatly" 3-5/8 turns.*
