Technical Service Information

THM 4L60 (700-R4)

BURNT 2-4 BAND

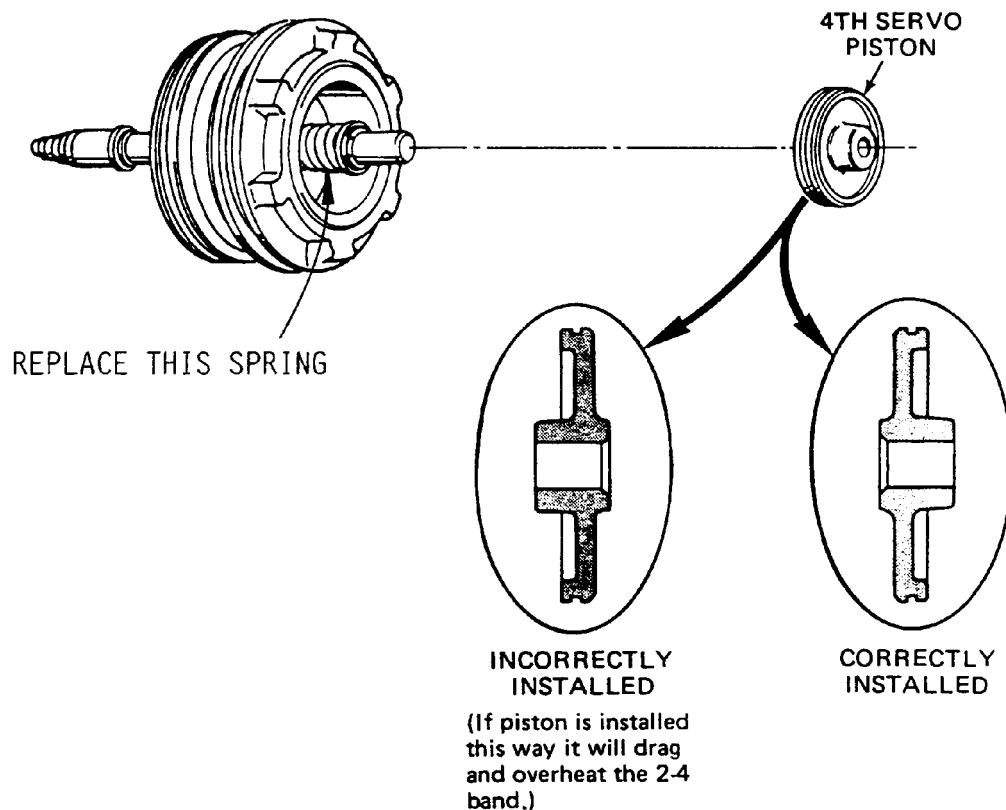
COMPLAINT: Repeated and/or premature burning of the 2-4 band assembly, with nothing else in the transmission showing any signs of burning.

CAUSE: The cause may be, a weak or collapsed 4th apply piston return spring, located on the servo apply pin, that will not allow the band to fully release on a 4-3 downshift.

Compress the spring on the bench, while it is still installed on the servo pin, and hold compressed for about 30 seconds. Release the compression and check for servo pin movement, back and forth, in the piston assembly. If there is servo pin end play, the spring needs to be replaced.

CORRECTION: Remove and discard the OEM spring from the servo apply pin. Replace the 4th apply piston return spring with part number K004, available through Shift Technology Products. Reinstall washer and "E" clip, as shown in Figure 1.
