# Technical Service Information

## FORD AX4S (AXODE) INTERMITTENT NEUTRAL COMING TO STOP

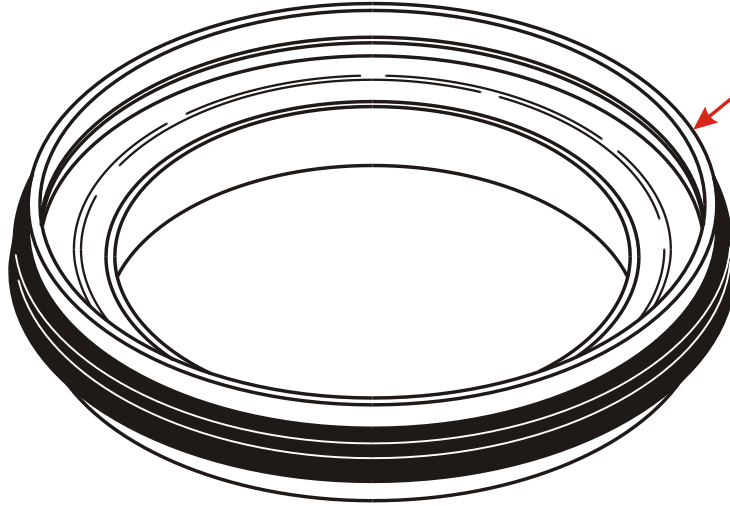
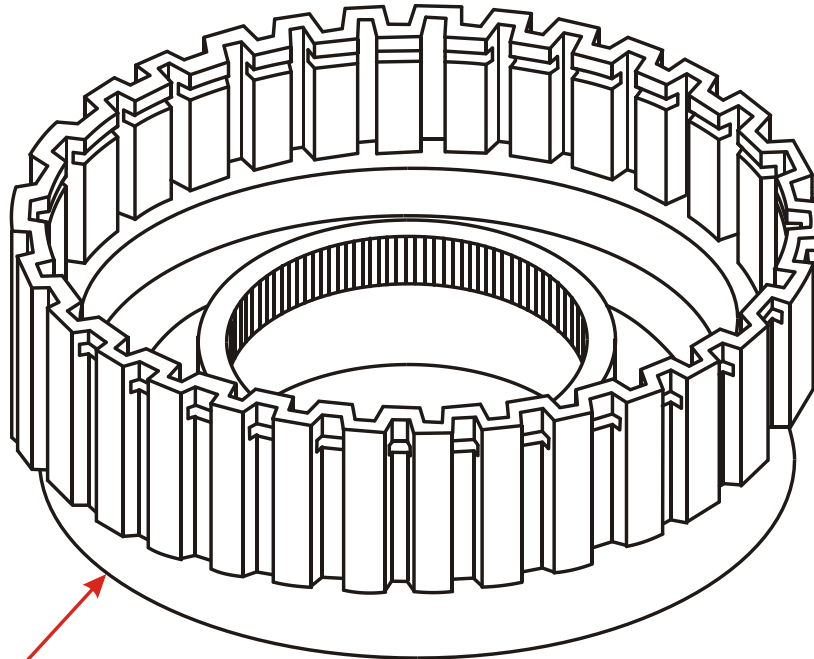
Figure 1

**CAUSE:** The cause may be, the molded rubber seal on the forward clutch piston intermittently not sealing during the 3-2 downshift (See Figure 1).

**FORWARD CLUTCH  
MOLDED PISTON  
F8DZ-7A262-AB**

**FORWARD CLUTCH CYLINDER  
F5DZ-7A360-A**

**CORRECTION:** Replace the forward clutch piston *and* the forward clutch cylinder with the OEM part numbers listed below. Refer to Figure 1.
