Technical Service Information

THM 325

SLIDE BUMP 1-2 AND 3-4 SHIFT

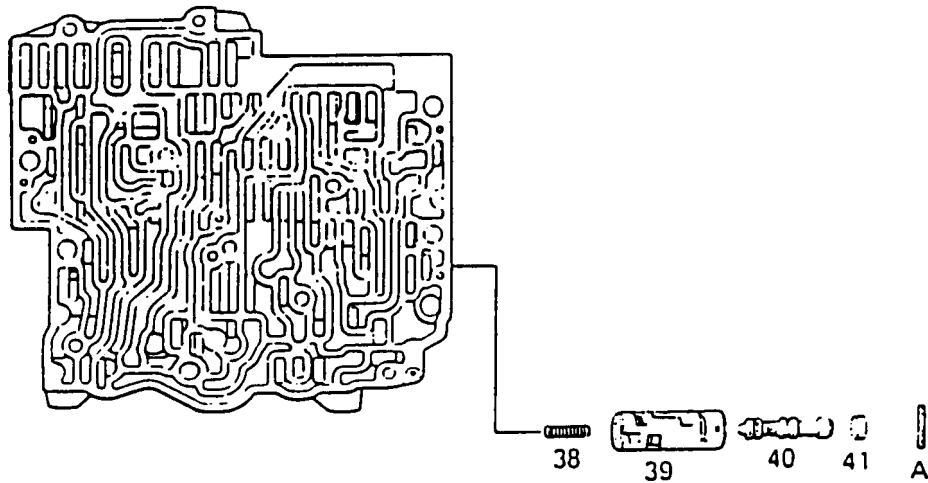
Some 1983 THM 325-4L AJ Model Transmissions may exhibit a slip bump 1-2 and 3-4 shift. A slip-bump is best described as a shift that starts out long and soft, but ends abruptly. This condition may be caused by the accumulator spring having slipped off the end of the accumulator valve. Beginning May 5, 1983, with transmission serial no. AJ=78258, a new control valve assembly went into production for the THM 325 4L AJ Model Transmission. This new control valve assembly has an accumulator valve (Figure 1), with a stem on the end of it that will retain and pilot the spring when it shifts. When servicing a 1983 THM 325 4L AJ Model Transmission built prior to transmission serial no. AJ=78258 for a slip bump 1-2 and 3-4 shift, order service part no. 8635969. Refer to Figure 2 and your service manual for the proper disassembly and reassembly of the accumulator valve train.
