NISSAN RE4R01A/3A PLANETARY FAILURE DUE TO LACK OF LUBE

Technical Service Information

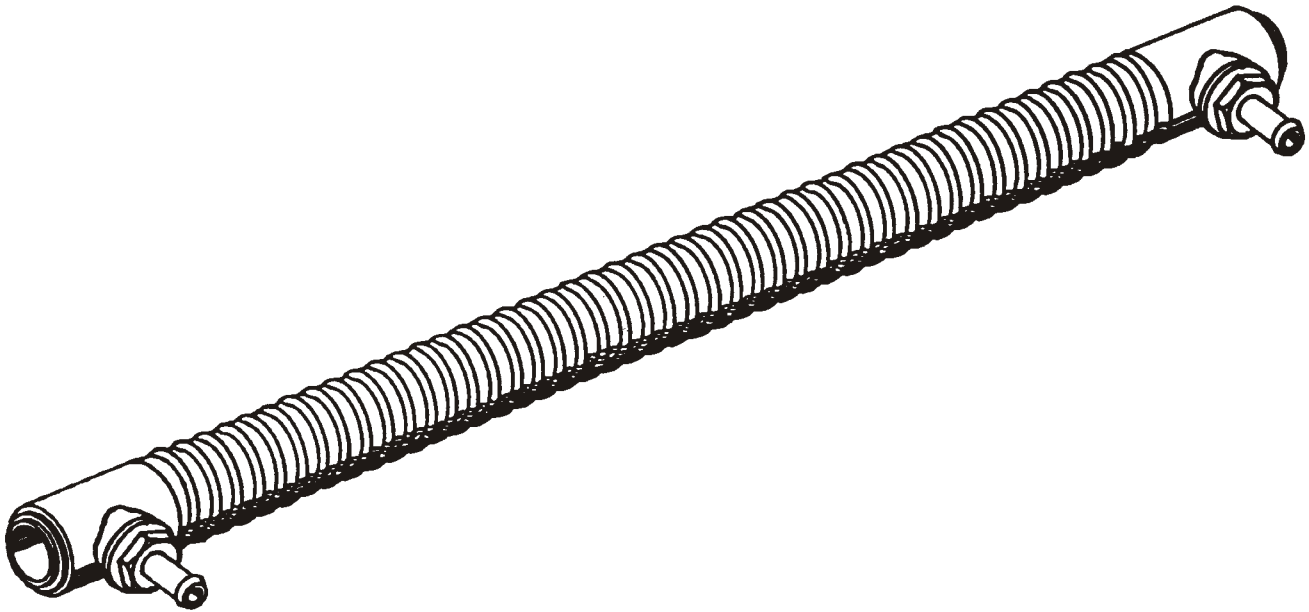
Most Nissan vehicles have what is known as a fin type cooler. This type cooler becomes easily restricted causing poor cooler flow resulting in lack of lubrication to the planetary gear train. Cooler line flushing machines cannot sufficiently flush this type of cooler. The spiral cooler shown in Figure 1 below is a replacement cooler. This cooler may be installed instead of replacing the entire radiator.

Spiral Cooler **Part Number 21606-15V25**

1. Insure that the vehicle has sufficient cooler flow. Minimum cooler flow must be no less than 1 quart per 20 seconds when the vehicle is "**HOT**".
Warm vehicle until operating temperature is over 160 degrees. Raise and securely support vehicle on a lift (*For safety concerns, do not attempt this test on the ground*). Once operating temperature has been reached, shut motor off.
Disconnect the "Rear" cooler line from the transmission and place the end of the line into a bucket or suitable apparatus to keep oil from spilling or splashing. Have a helper get into the vehicle and start the engine. Apply the parking brake then hold the brake pedal and move the selector lever into the D position. While holding the brake pedal on, allow the vehicle to idle in drive. **IMPORTANT:** Visually check the rear cooler line fitting at the transmission. **THERE MUST BE NO OIL COMING FROM THE CASE.** If there is oil coming from the case, the most likely cause is a leak at the forward clutch rings on the low sprag inner race. Count for approximately 20 seconds then move the selector lever back to park and shut the motor off. Measure the amount of oil in the container. There must be a minimum of 1 quart of oil in the container. If less oil flowed from the radiator, disconnect the front cooler line and repeat the test. If the test still shows insufficient cooler flow, the problem is most likely a restriction in the valve body. If cooler flow is now sufficient the problem is a plugged radiator. Repair or replace the radiator as necessary (Refer to Figure 1 for information on replacement cooler element).

This cooler is available from Nissan the part number is 21606-15V25.

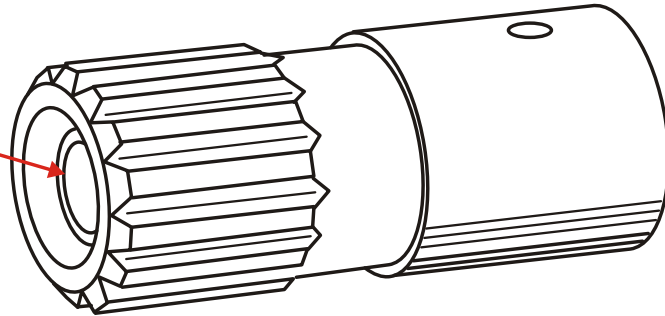
Figure 3

Inspect this bushing closely for wear or damage. All gear train lube for the front of the transmission must pass through this bushing. Insert turbine shaft into bushing to determine amount of side clearance.

3. Inspect the output shaft bushing where turbine shaft rides (*Refer to Figure 3*). Insert the turbine shaft into the output shaft and move the turbine shaft from side to side. If excess movement is detected, replace the output shaft bushing.

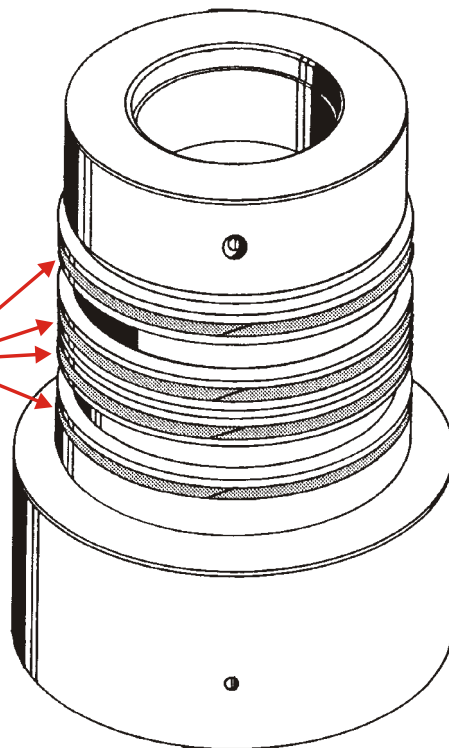
Figure 4

Inspect these rings for nicks and cuts. Also bore fit the rings in the Forward Drum. End gap between the butt ends of the rings must be less than .003". Rings with excessive gap must be replaced.

4. Inspect the forward clutch sealing rings that are installed on the low sprag inner race (*Refer to Figure 4*). Make sure there are no cuts or nicks in the rings. Carefully remove the ring from the inner race and bore fit the rings in the drum. **IMPORTANT:** There must be no more than .003" end gap between the butt ends of the rings. Replace the rings, or the low sprag inner race if necessary.
