## THM 440-T4 2ND GEAR START (SHIFT VALVE CLIP)

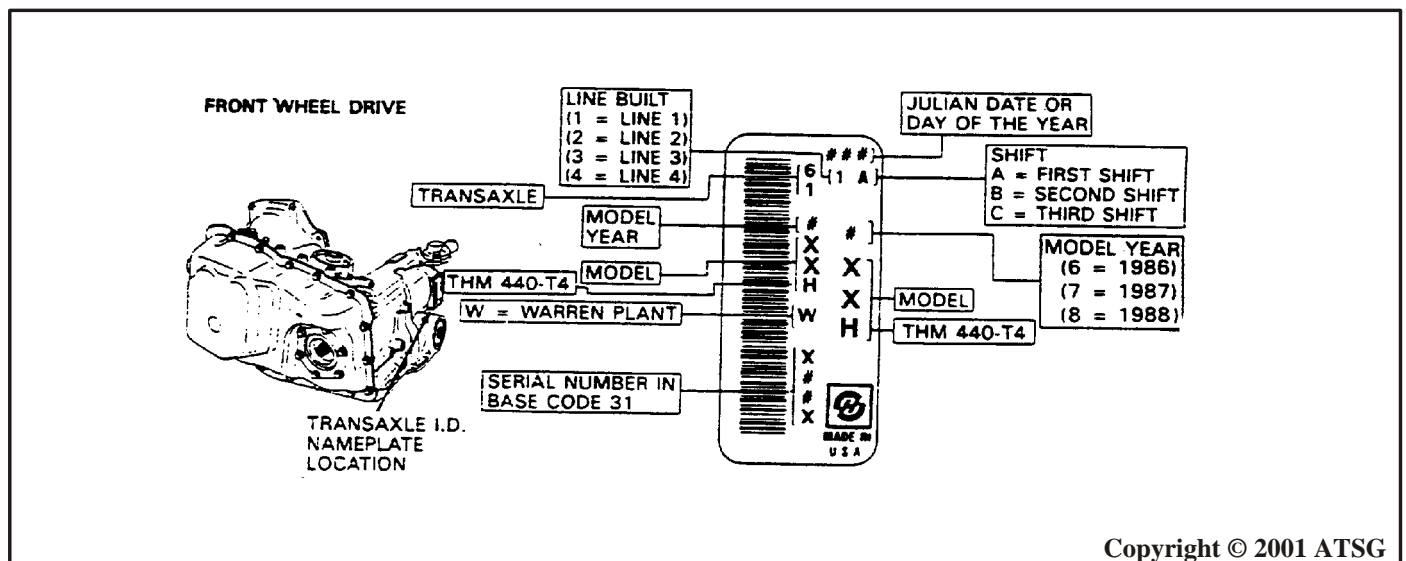
Figure 1

A 1984-87 vehicle equipped with a THM 440-T4 (Figure 1) may start out in 2nd gear instead of 1st gear. This condition could occur intermittently or all

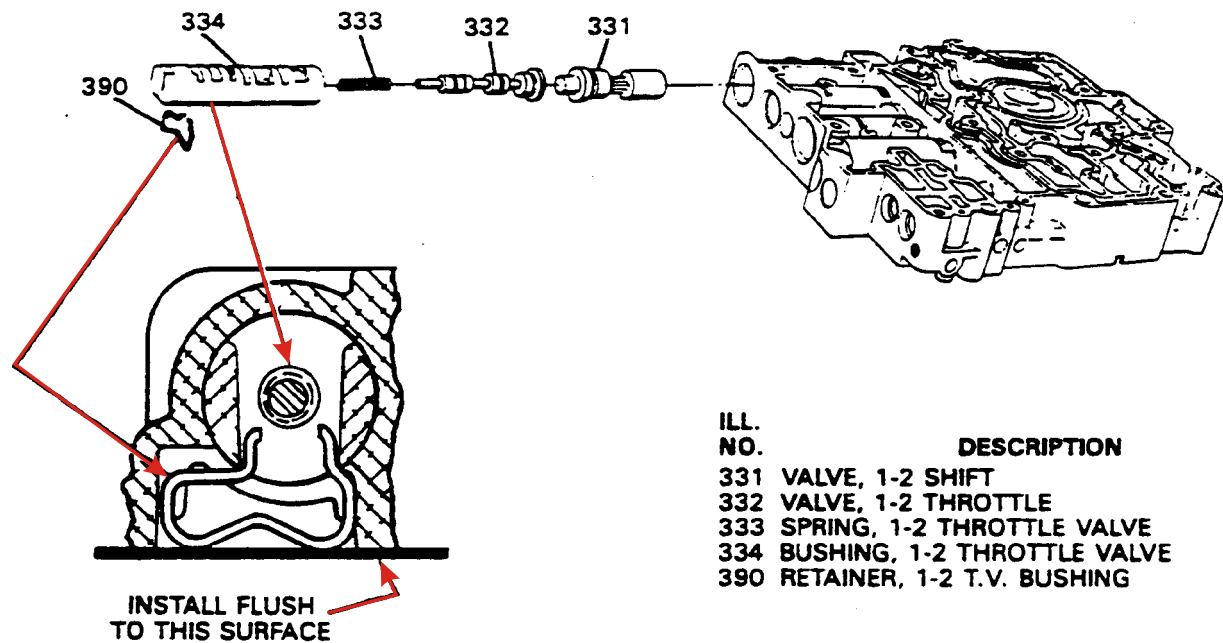
Figure 1

If governor pressure is okay, the 1-2 shift valve (331) may be stuck in the upshifted position. Remove the control valve assembly and check for a sticking 1-2 shift valve (331), 1-2 throttle valve (332), or the 1-2 throttle valve spring (333) caused by the 1-2 throttle valve bushing retainer pushed in too far. (390) The retainer should be installed flush with the machined surface of the valve body. (Figure 2)
